Plate A.1. Cochiti Dam at about RM 232.

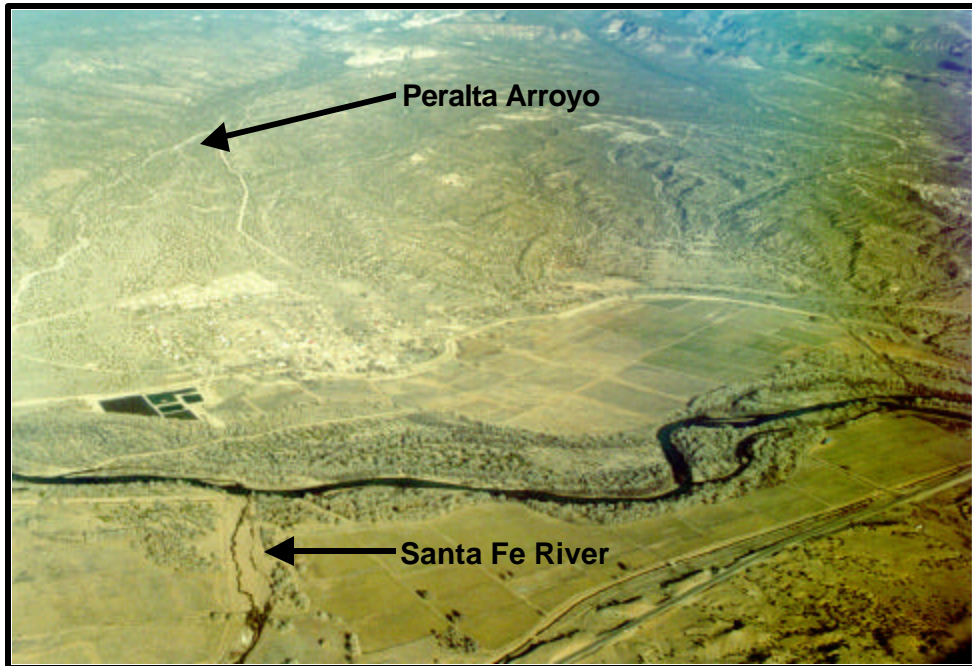
Plate A.2. View of Rio Grande in vicinity of Cochiti Pueblo at about RM 230. The Santa Fe River channel is on the left bank and Peralta Arroyo and fan are on the right bank. Note the split flow and heavily vegetated floodplain.

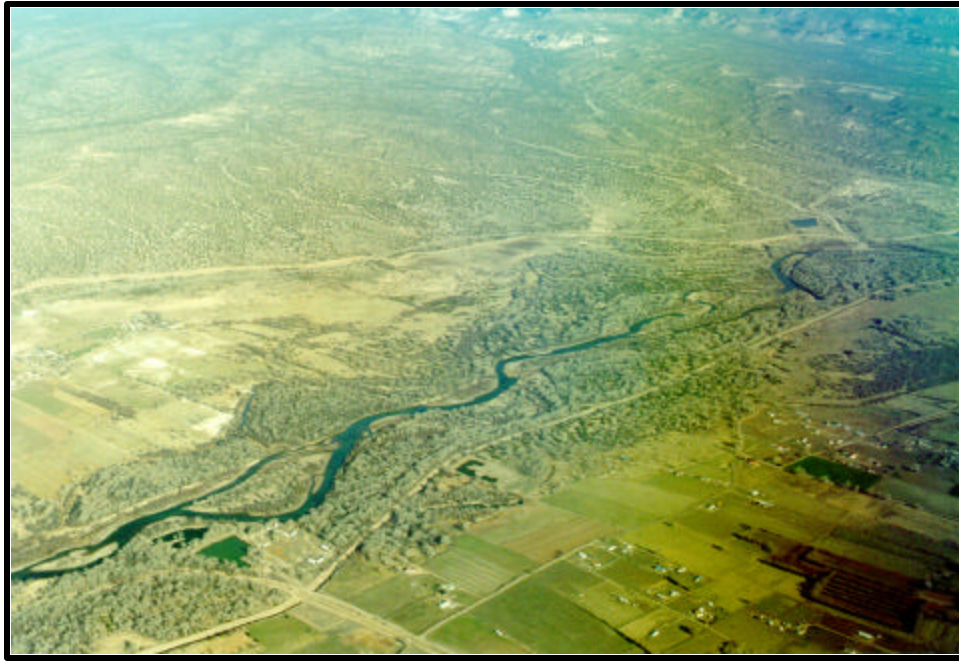
Plate A.3. View of Rio Grande in the Pena Blanca reach between RM 227 and 230. Split flows and a heavily vegetated floodplain are characteristic of the reach.

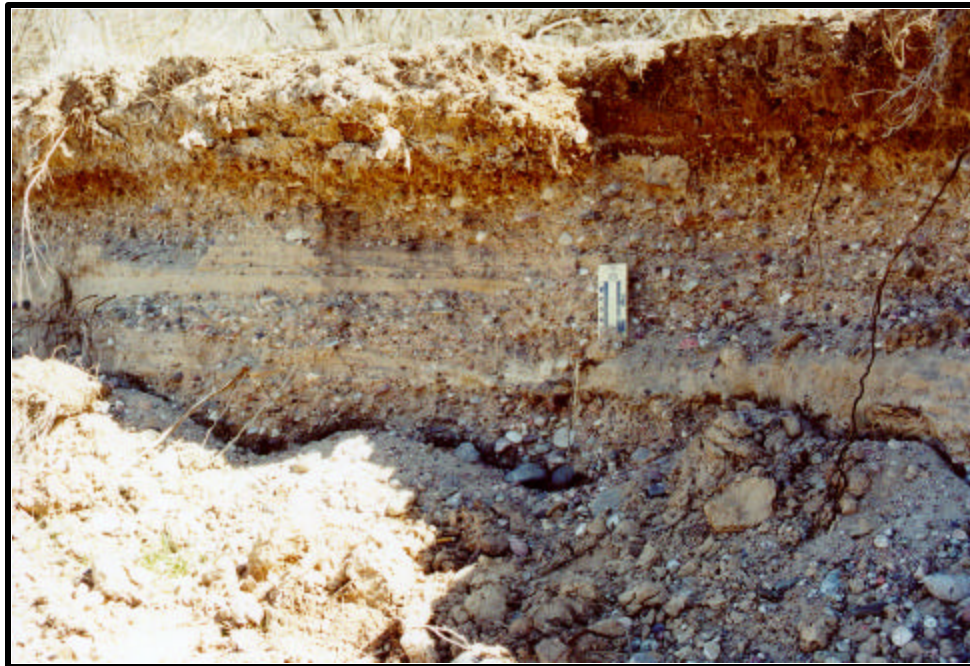
Plate A.4. View of bank stratigraphy at Pena Blanca (RM 227). Note the interbedded sands and gravels that reflect the caliber of the sediments that were being transported by the river when the floodplain was formed.

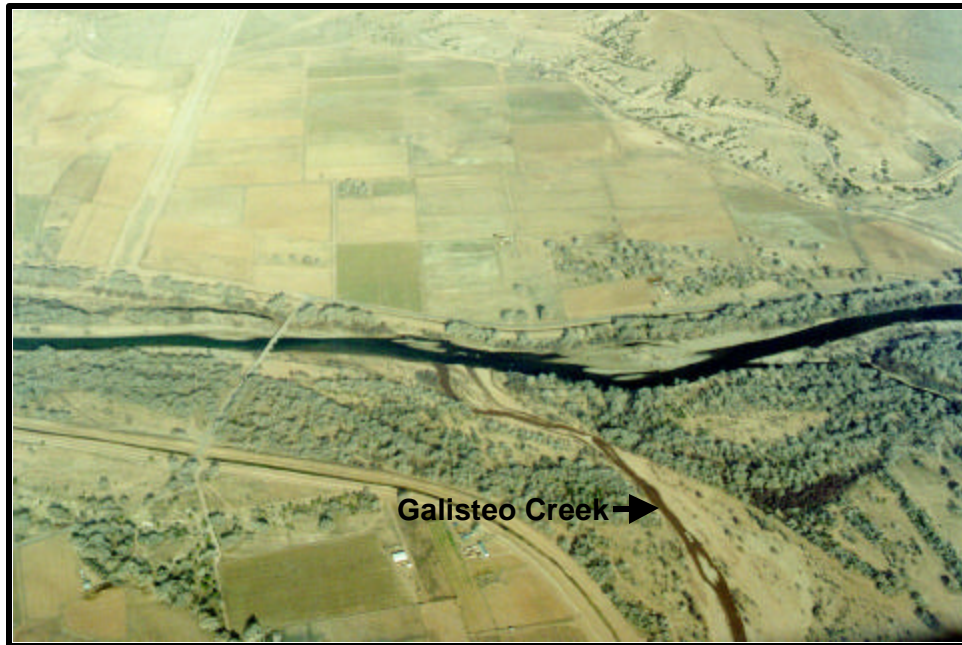
Plate A.5. View of Rio Grande at the Santo Domingo Bridge and confluence with Galisteo Creek at RM 224.5. The constriction caused by the tributary fan is causing some sediment deposition in the channel upstream of the confluence, as is evidenced by the un-vegetated bank-attached bar.

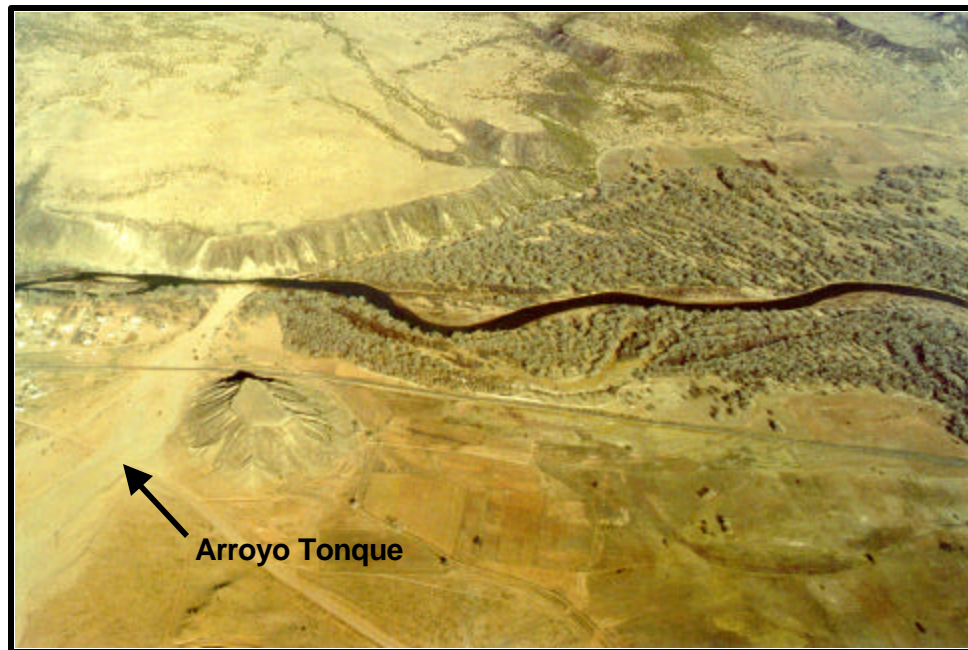
Plate A.6. View of Rio Grande at San Felipe Pueblo and Arroyo Tonque confluence at RM 216.2. The valley constriction formed by the bedrock outcrop and alluvial fan at San Felipe is the boundary between geomorphic Subreaches 1 and 2. Note the absence of unvegetated bars upstream of the confluence.

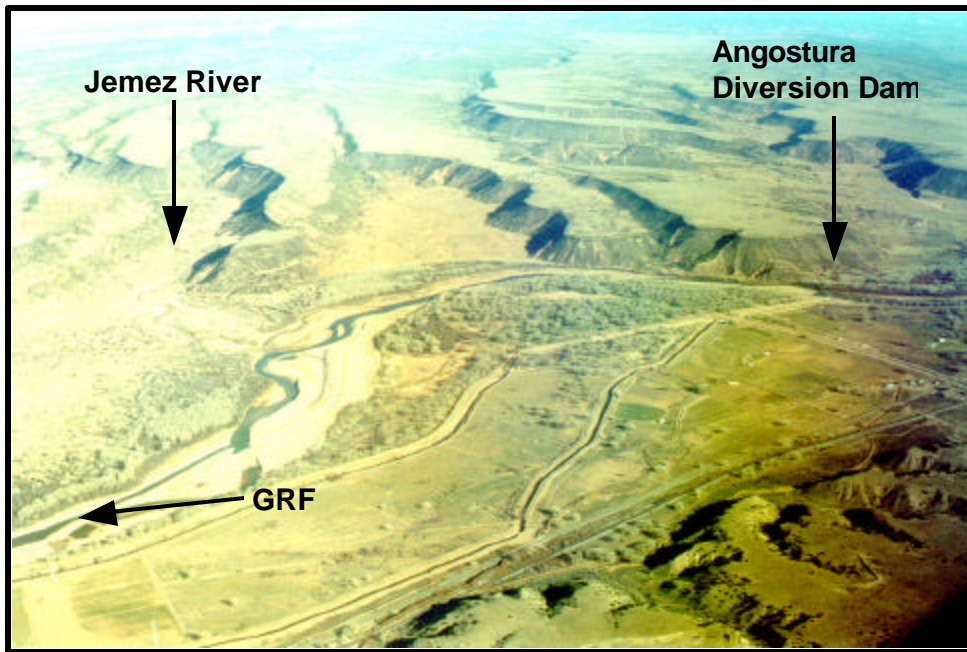
Plate A.7. View of Rio Grande at the confluence of the Jemez River at RM 208.2. The recently constructed GRF and channel modifications on the Santa Ana Pueblo can be seen in the center of the photo. Angostura Diversion Dam, located towards the upper right part of the photo at RM 209.7 is the boundary between geomorphic Subreaches 2 and 3.

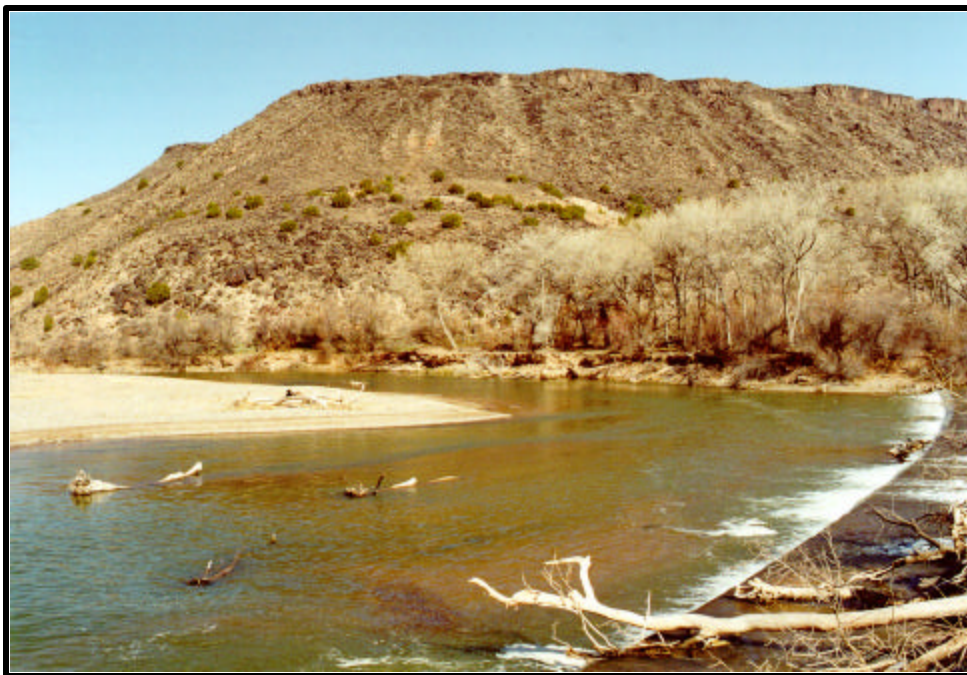
Plate A.8. View of Rio Grande at the Angostura Diversion Dam at RM 209.7. Note a bank height of about 6 to 8 feet, indicating some channel degradation below the diversion.

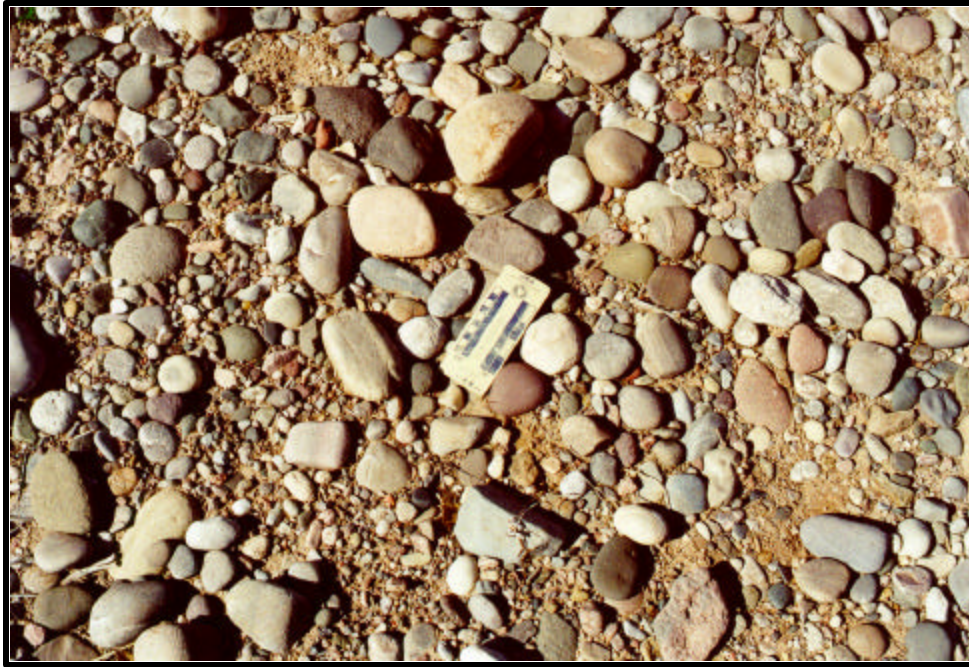
Plate A.9. View of bed material at the head of the mid-channel bar downstream of the Angostura Diversion Dam. The maximum cobble size is 90 mm (Scale is 10 cm long).

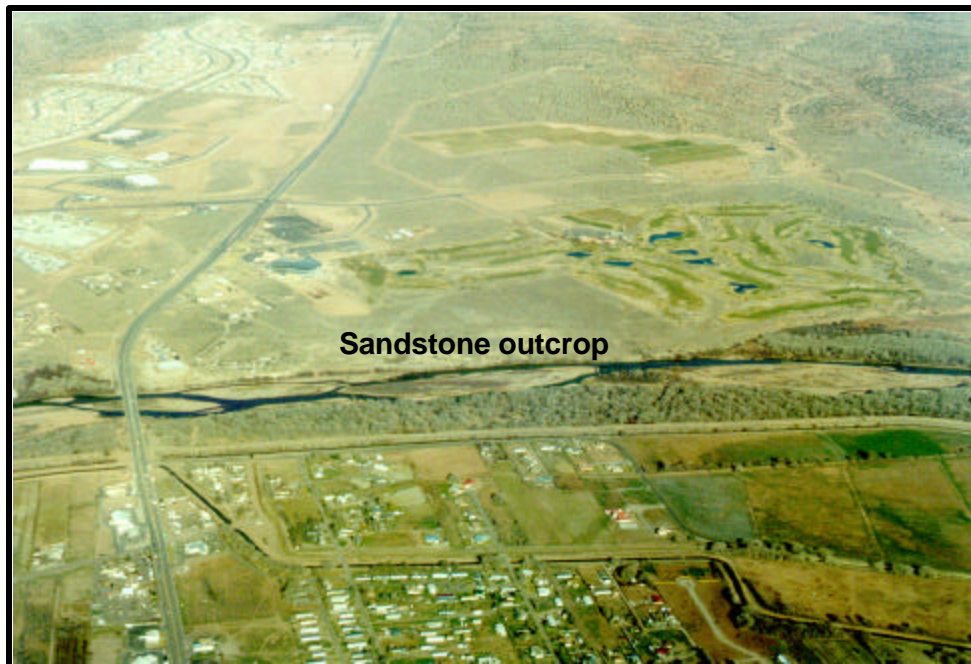
Plate A.10. View of Rio Grande at Highway 44 Bridge at Bernalillo (RM 204). The Coronado State Monument is located along the right bank, and it is at this location that sandstone outcrop in the Santa Fe Formation prevents westward migration of the river. Note the partially vegetated sand and gravel bars in the channel.

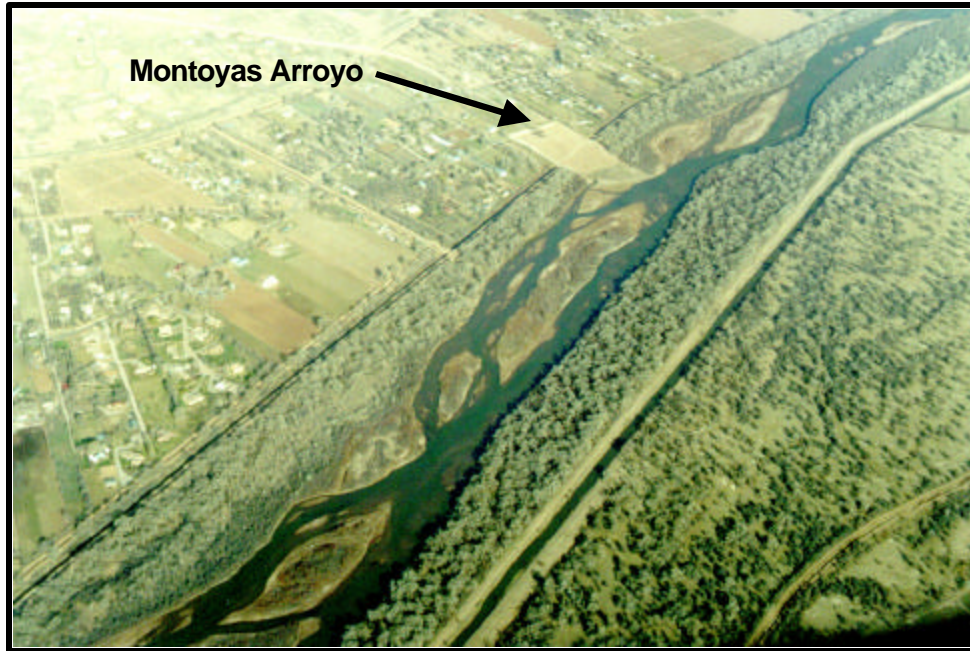
Plate A.11. View of Rio Grande with the confluence with Montoyas Arroyo at RM 198.3. Note the large, relatively high elevation vegetated mid-channel bars. Local sediment supply from Montoyas Arroyo permits the formation of braid bars locally.

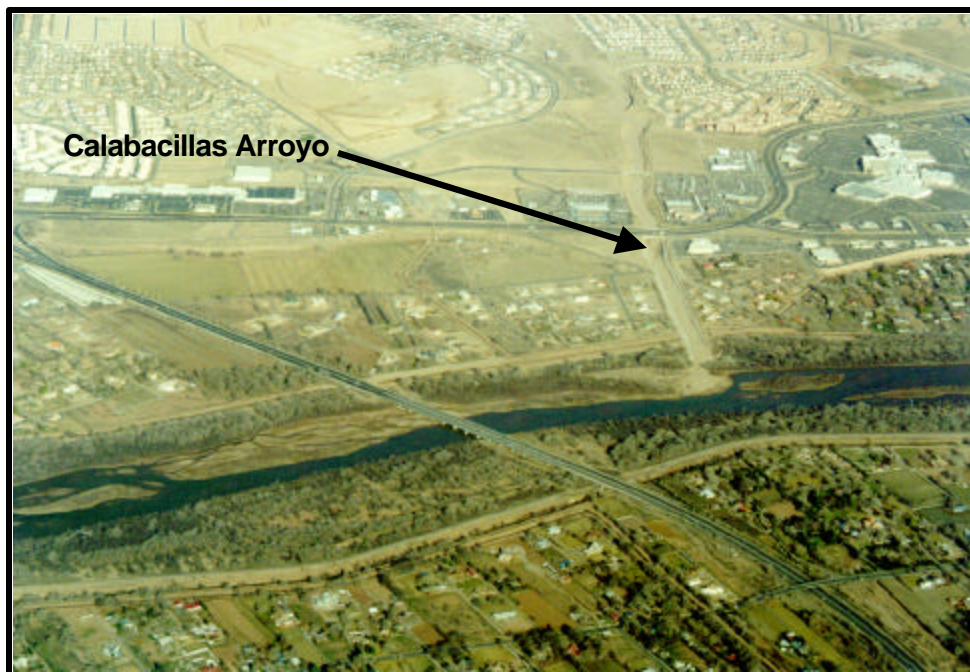
Plate A.12. View of Rio Grande at the confluence with Calabacillas Arroyo located just upstream of the Paseo del Norte Bridge (RM 191). Note the high vegetated mid-channel bars upstream of the arroyo, and the lower elevation, less vegetated bars downstream.

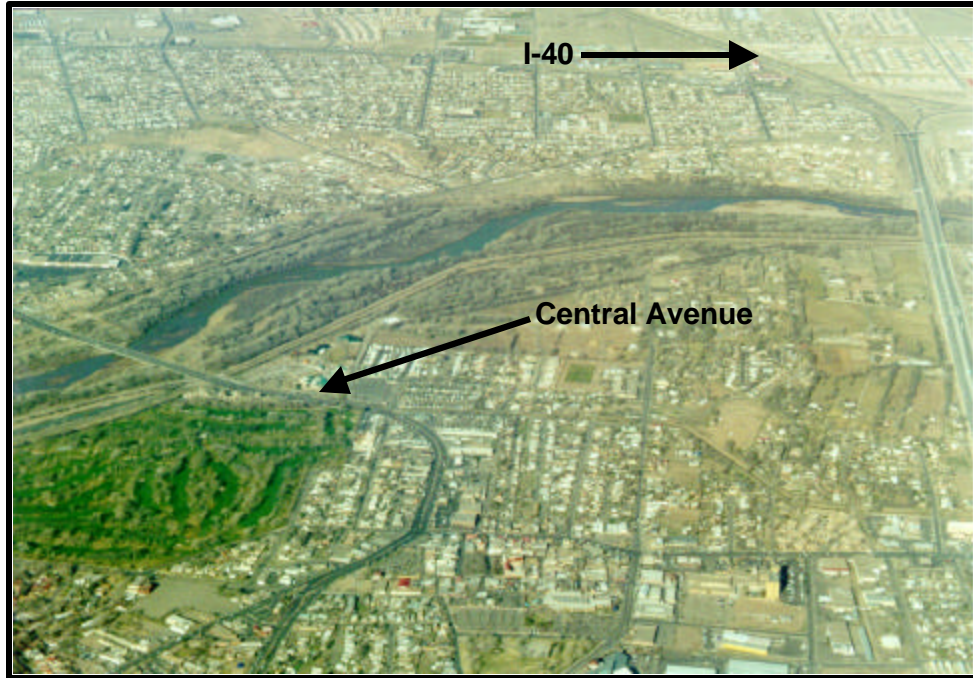
Plate A.13. View of Rio Grande in the vicinity of Central Avenue Bridge, where the USGS Albuquerque gaging station is located (RM 183.4). Note the heavily vegetated bank-attached alternate bars in the reach that constrain the low-sinuosity meandering channel.

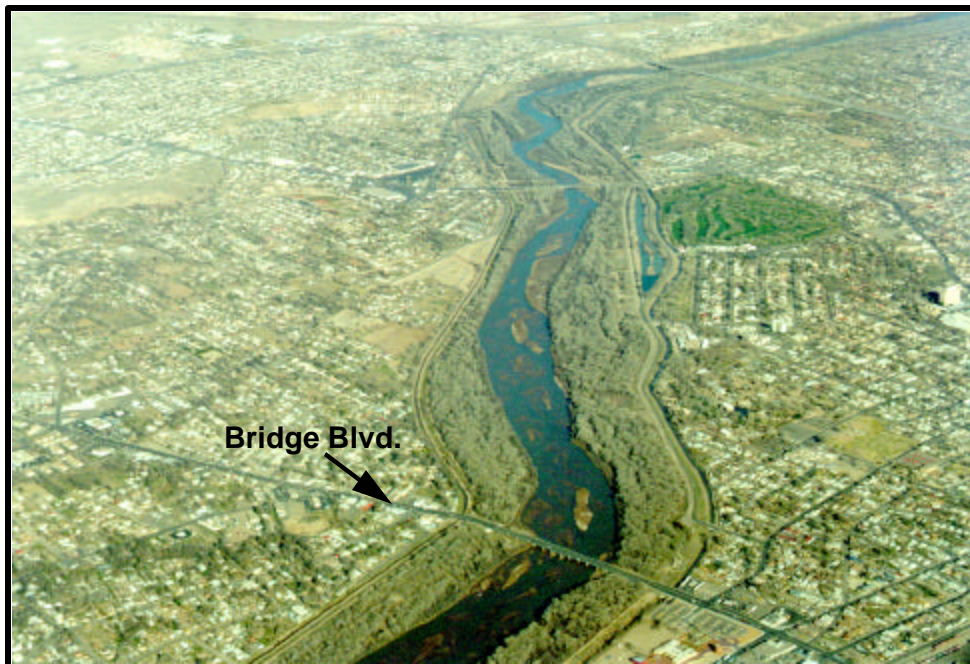
Plate A.14. View of the Rio Grande in the vicinity of Bridge Blvd (RM 182). Note the presence of relatively high vegetated bars as well as lower height braid bars.

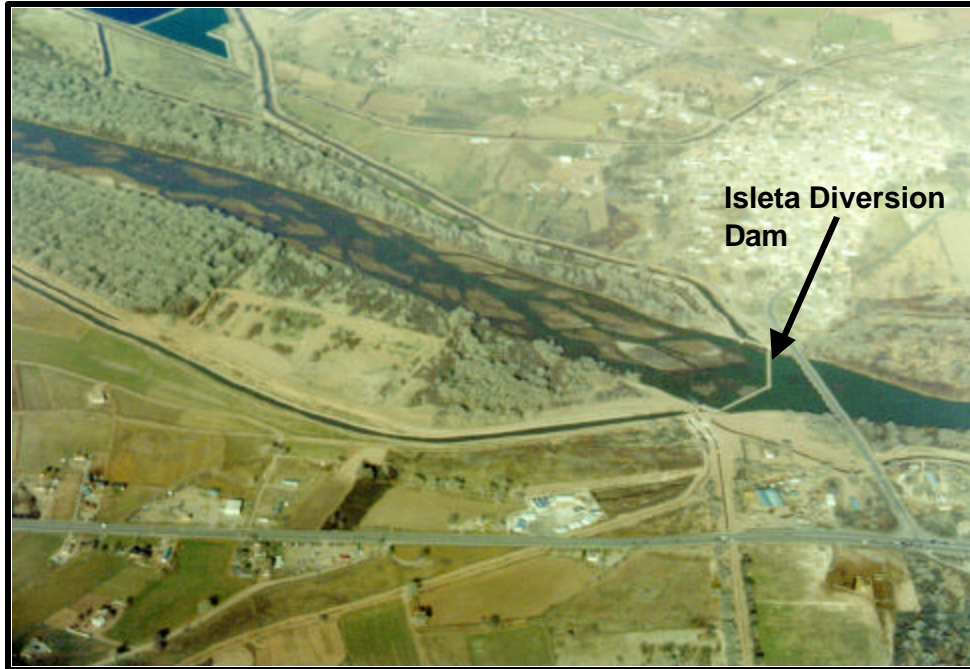
Plate A.15. View of Rio Grande downstream of the Isleta Diversion Dam at RM 169.2. Note the numerous unvegetated braid bars across the entire bed of the channel. The diversion dam is the boundary between geomorphic Subreaches 3 and 4a.

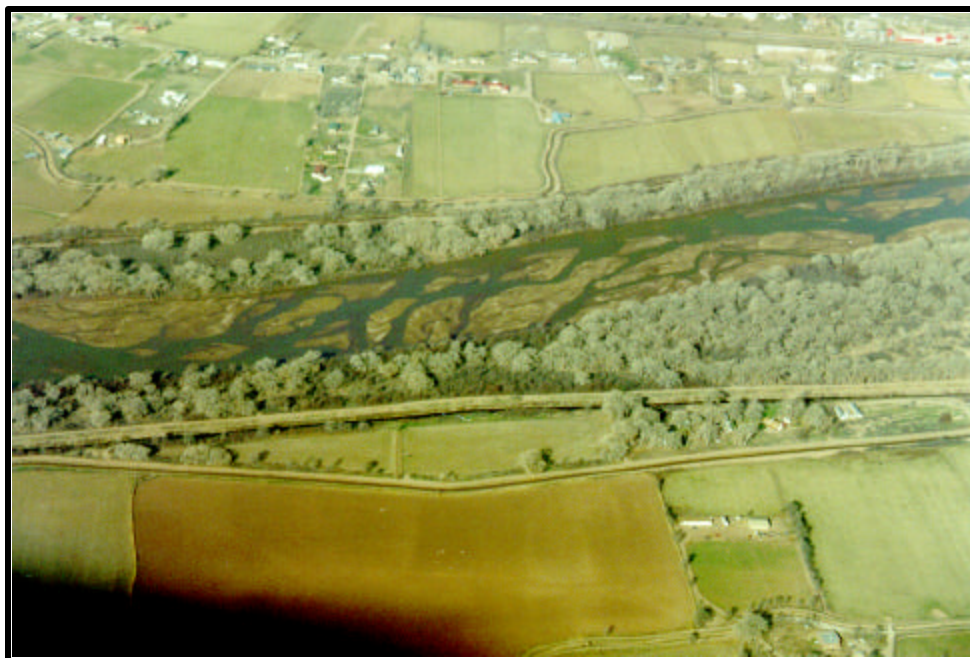
Plate A.16. View of Rio Grande between Isleta and Belen at about RM 164. Note the presence of bank-attached alternate bars and mid-channel braid bars.

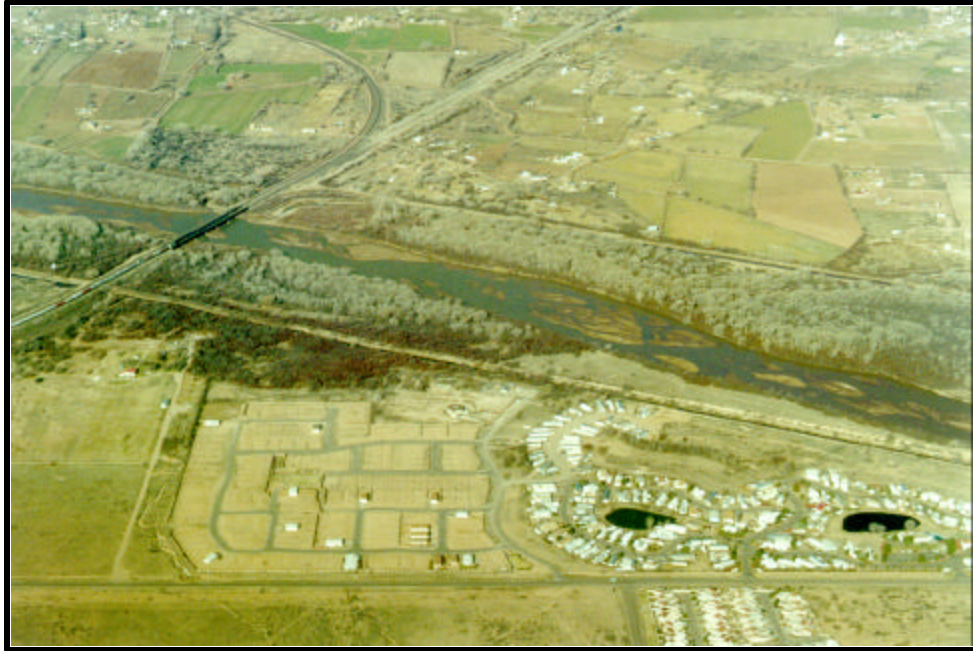
Plate A.17. View of Rio Grande in the vicinity of the BNSF Railroad bridge at Belen (RM 147.7). Note the numerous braid bars in the channel. This is the boundary between geomorphic Subreaches 4a and 4b.

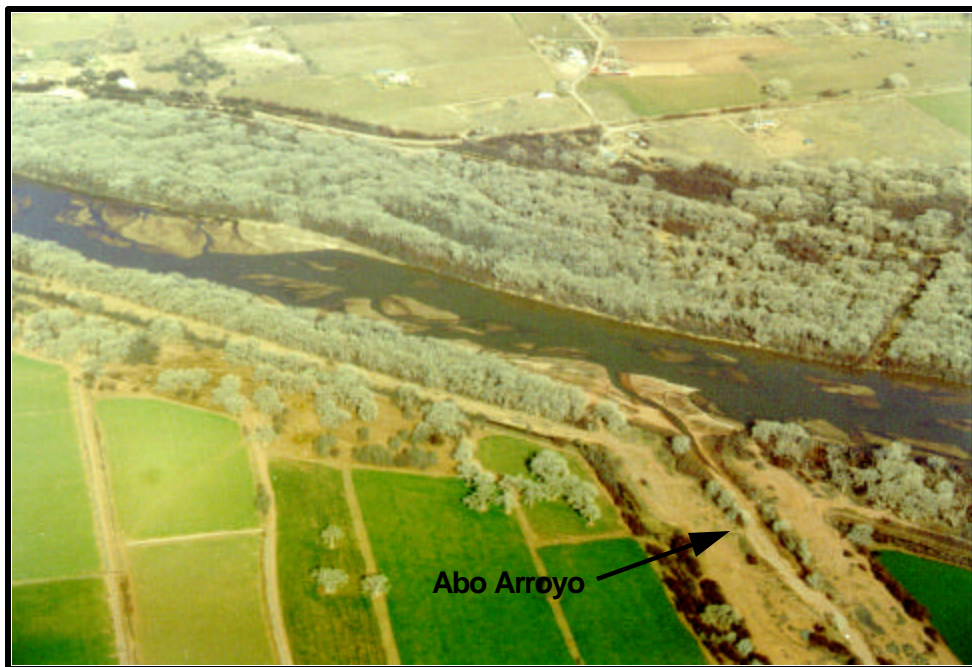
Plate A.18. View of Rio Grande at the confluence of Abo Arroyo at RM 139.2. Note the tributary mouth bar that has built out into the Rio Grande and the presence of numerous braid bars in the channel.

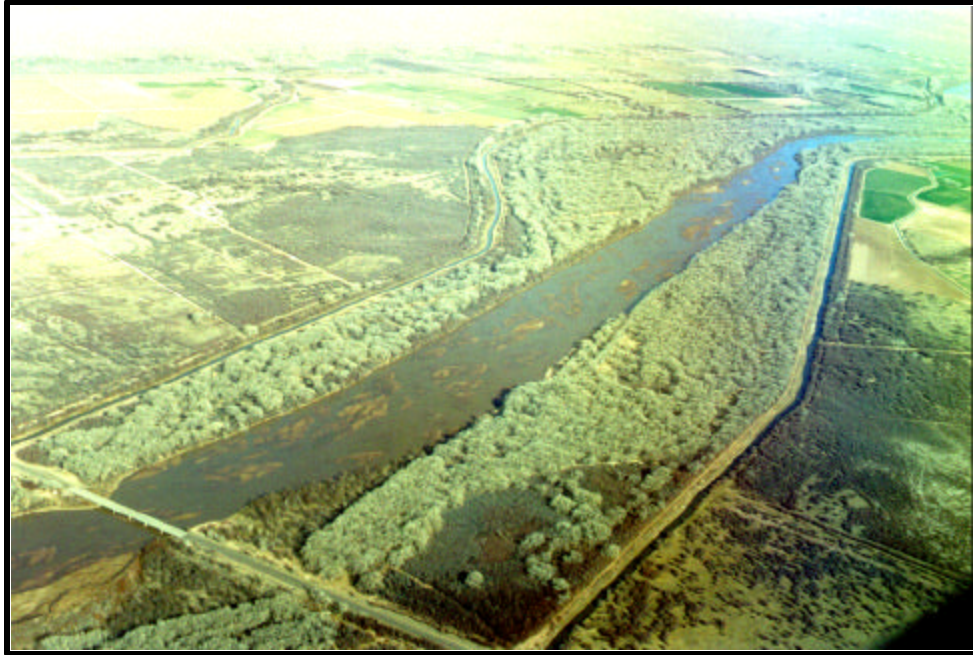
Plate A.19. View of Rio Grande at the US Highway 60 Bridge near Bernado (RM 130.6). The USGS gaging station is located at this bridge. Note the presence of numerous braid bars in the channel.

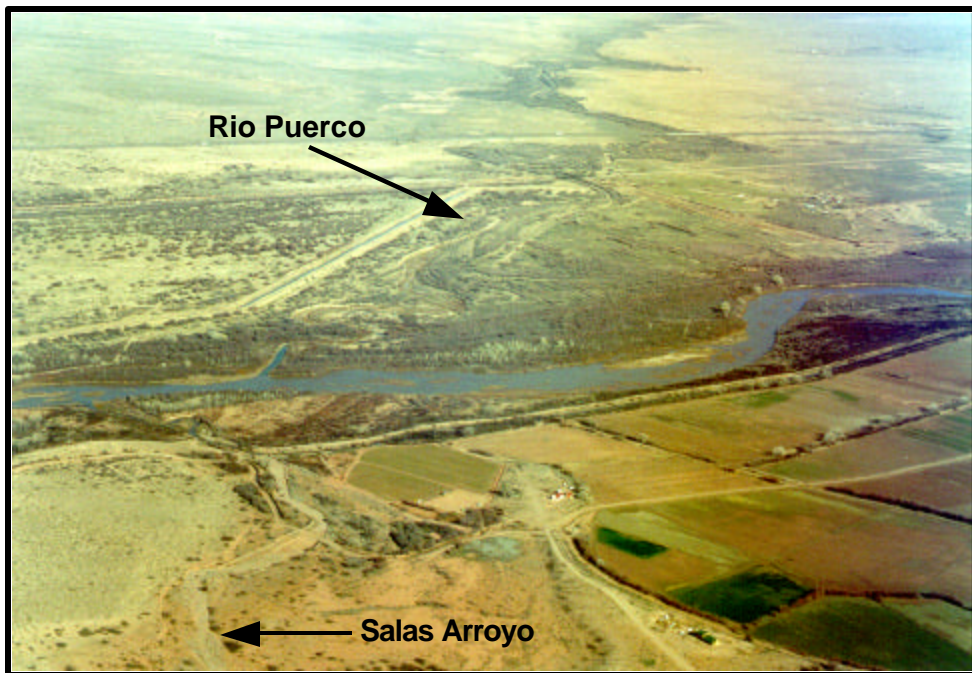
Plate A.20. View of Rio Grande at the confluences of the Rio Puerco and Salas Arroyo at about RM 126.8. Numerous braid bars are present in the channel upstream of the confluences.

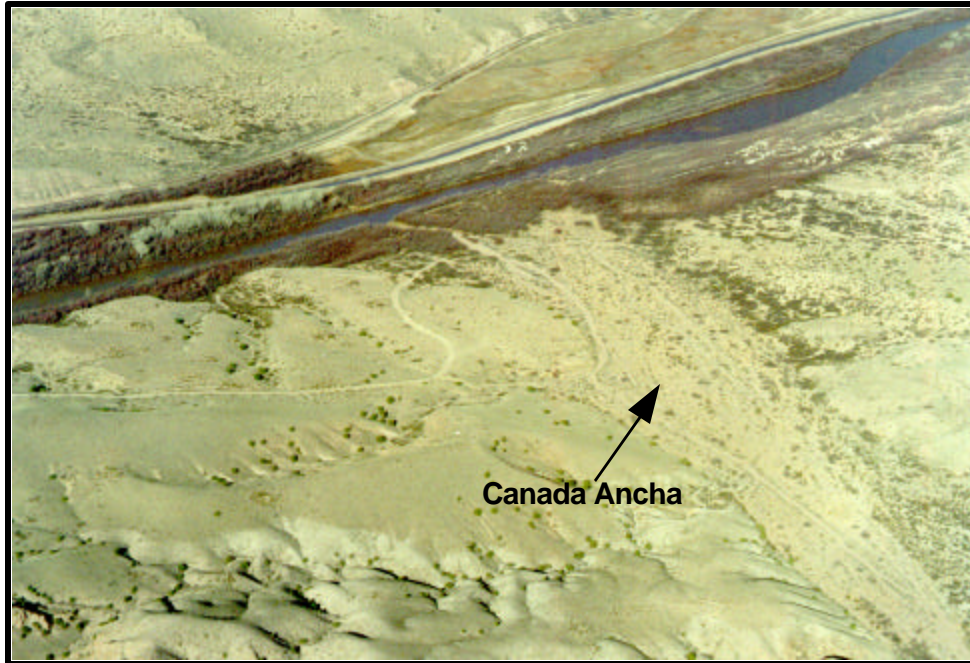
Plate A.21. View of Rio Grande at the confluence with Canada Ancha (RM 120.6) that forms the boundary between geomorphic Subreaches 4a and 5. Note the very narrow valley between outcrops of Santa Fe Formation, and the virtual absence of braid bars in the very narrow channel.

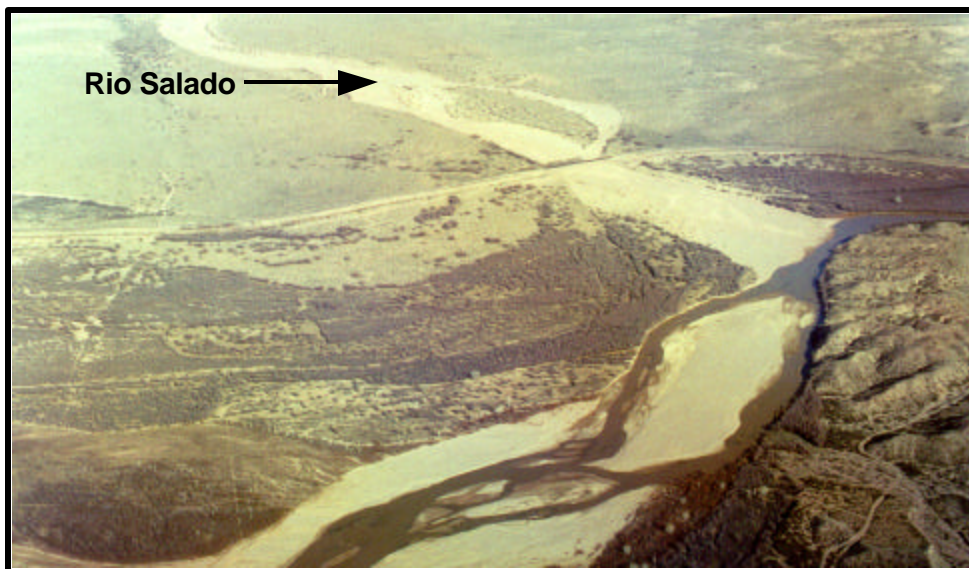
Plate A.22. View of the Rio Grande and the confluence with the Rio Salado at about RM 118.5. Note the size of the mid-channel bars that are composed of sand and gravel.

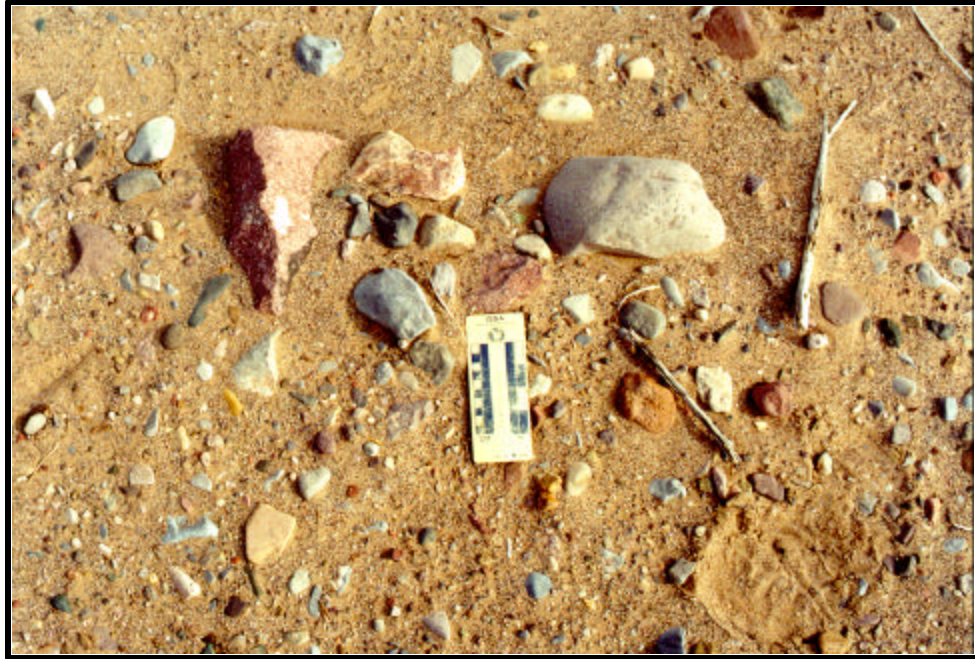
Plate A.23. View of bed material in Rio Salado. Clasts up to 120 mm are present in the bed, but the bulk of the material delivered to the Rio Grande is sand-sized (Scale is 10 cm).

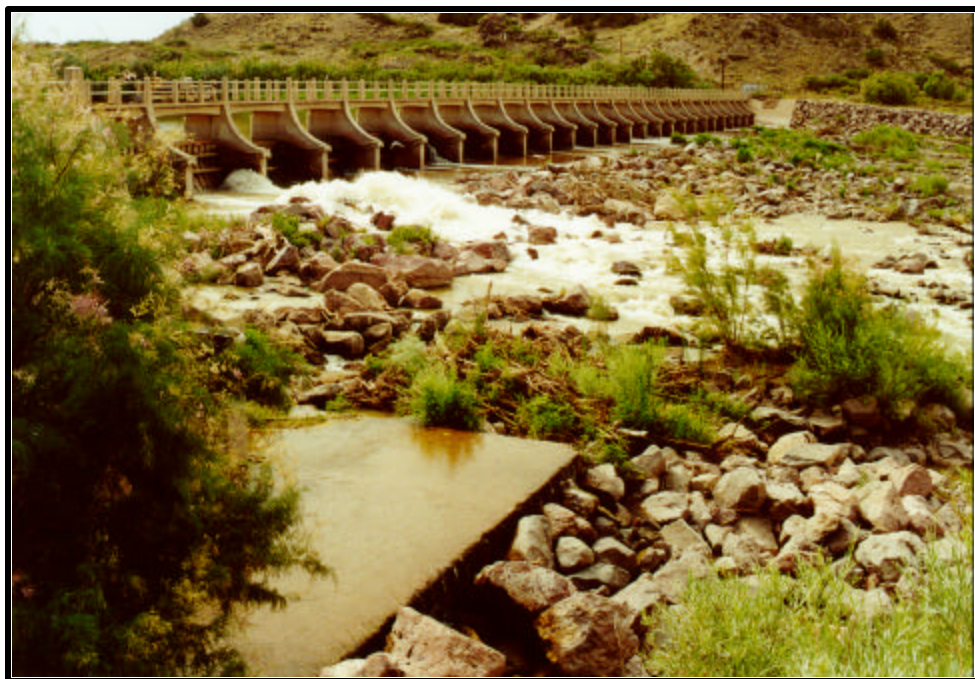
Plate A.24. View of San Acacia Diversion Dam (RM 116.2) that forms the boundary between geomorphic Subreaches 5 and 6. Note the riprap emplaced to counter the effects of channel degradation downstream of the structure.

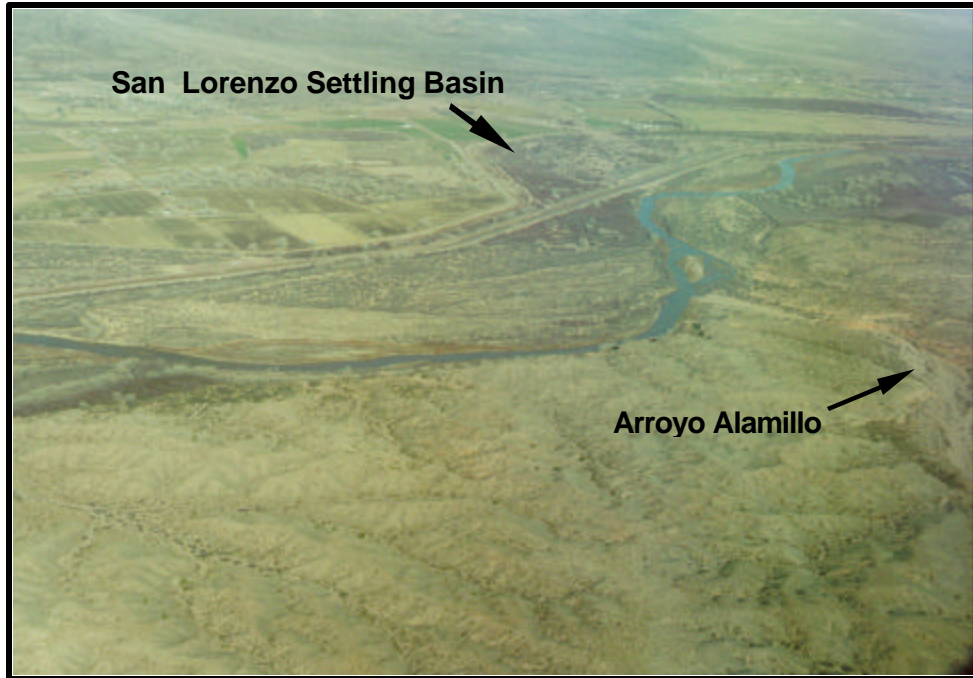
Plate A.25. View of the Rio Grande downstream of San Acacia at about RM 112. The San Lorenzo Settling Basin is located on the west side of the river and Arroyo Alamillo enters from the east. The arroyo is a point source of both sand and gravel. Note the general absence of braid bars in the channel.

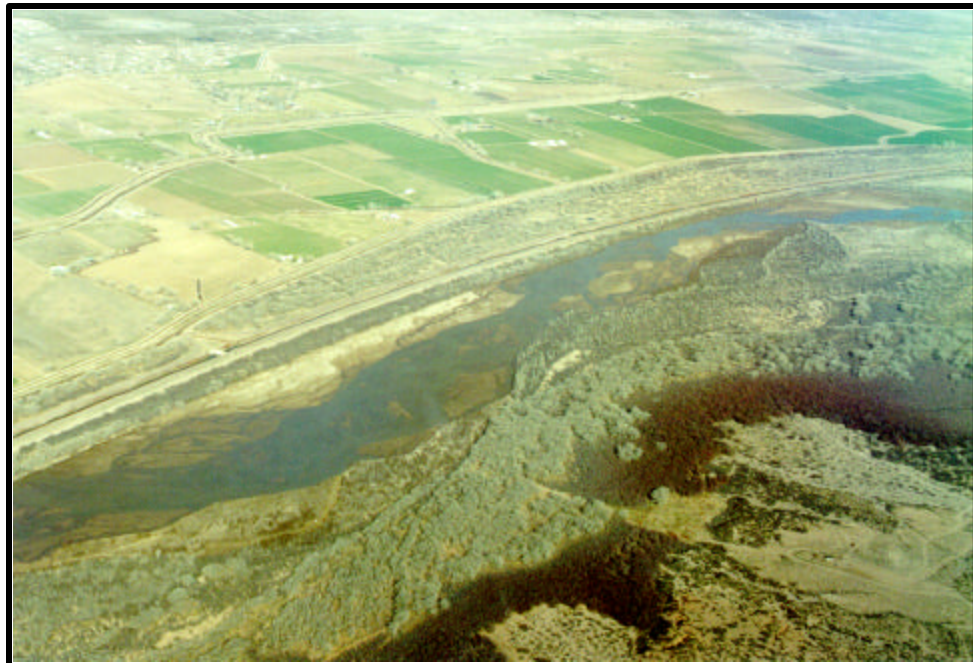
Plate A.26. View of the Rio Grande in the vicinity of Lemitar at about RM 108. Note the wide channel and the presence of numerous braid bars.

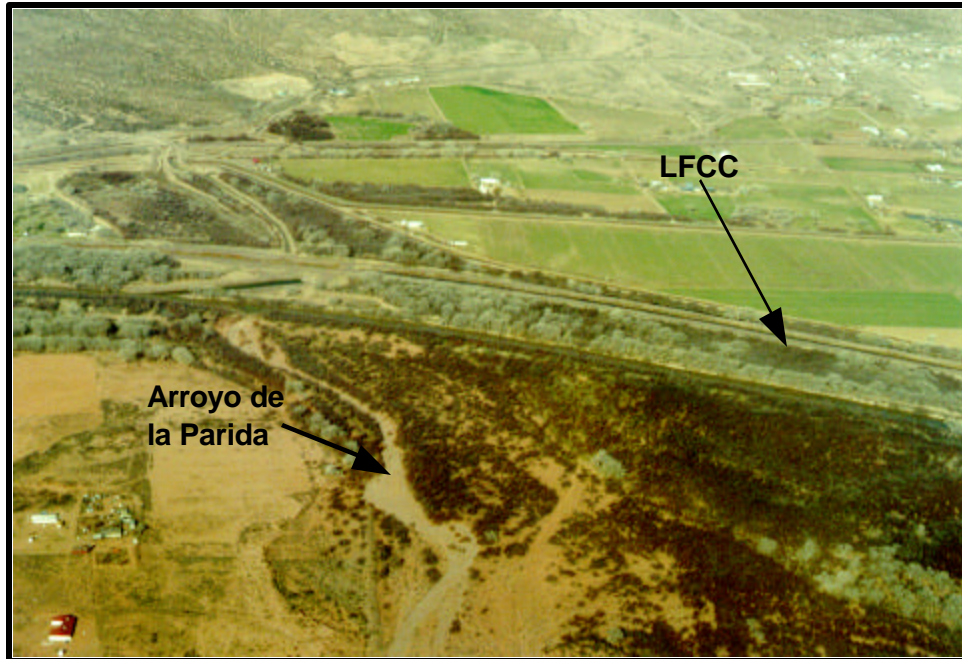
Plate A.27. View of the Rio Grande at the confluence with Arroyo de la Parida at RM 104.8. The alluvial fan constricts the channel of the Rio Grande at this location. This is the boundary between geomorphic Subreaches 6 and 7.

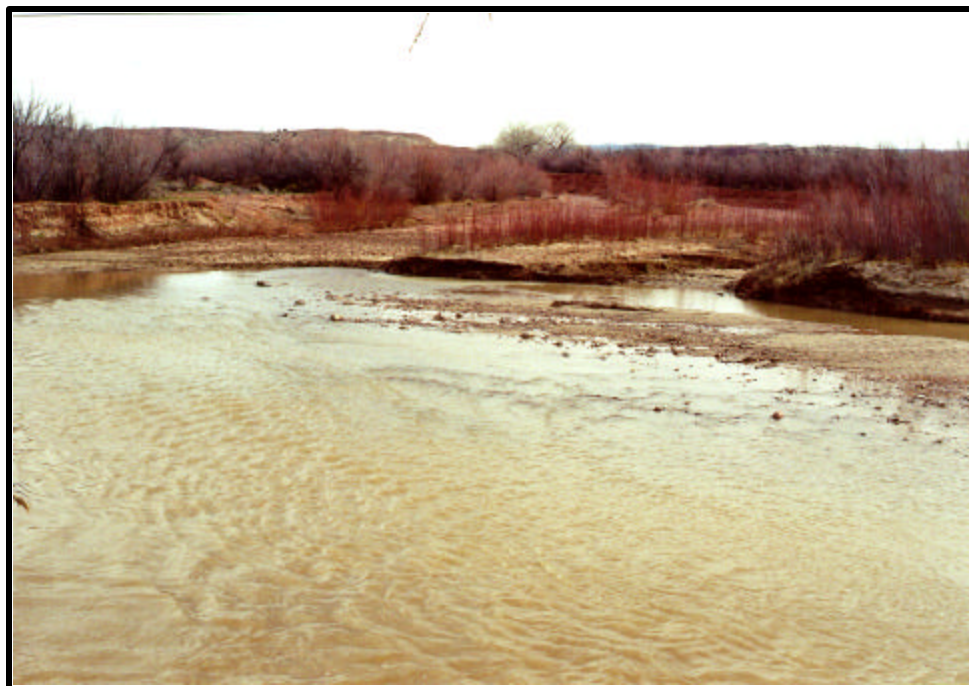
Plate A.28. View of the mouth of Arroyo de la Parida. Note the gravel bar in the bed of the Rio Grande that has been formed by coarse sediments introduced by the arroyo.

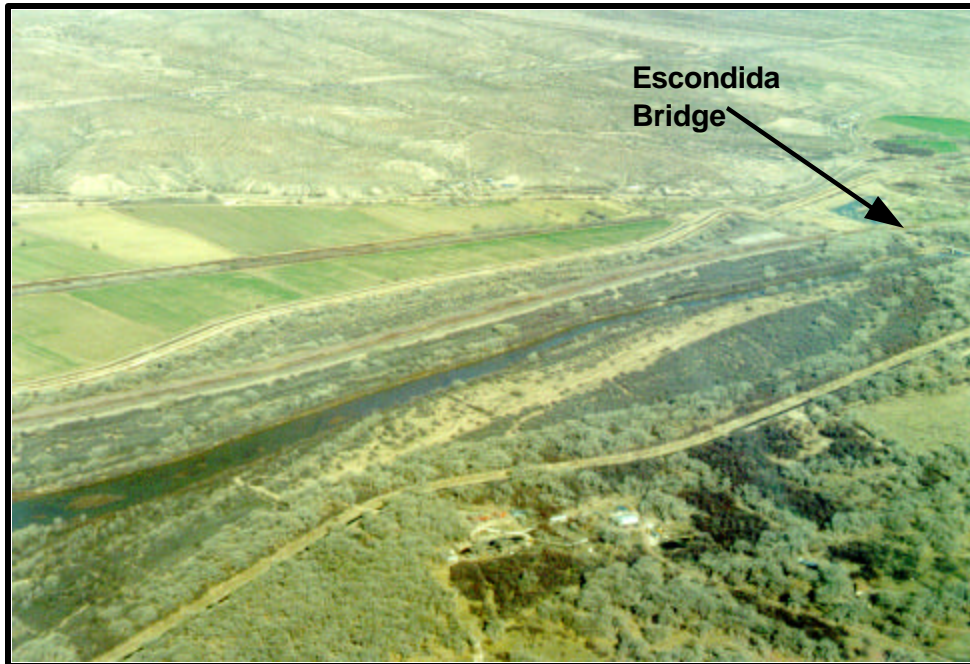
Plate A.29. View of the Rio Grande downstream of the Escondida Bridge at about RM 104. Note the very narrow channel and very limited number of braid bars.

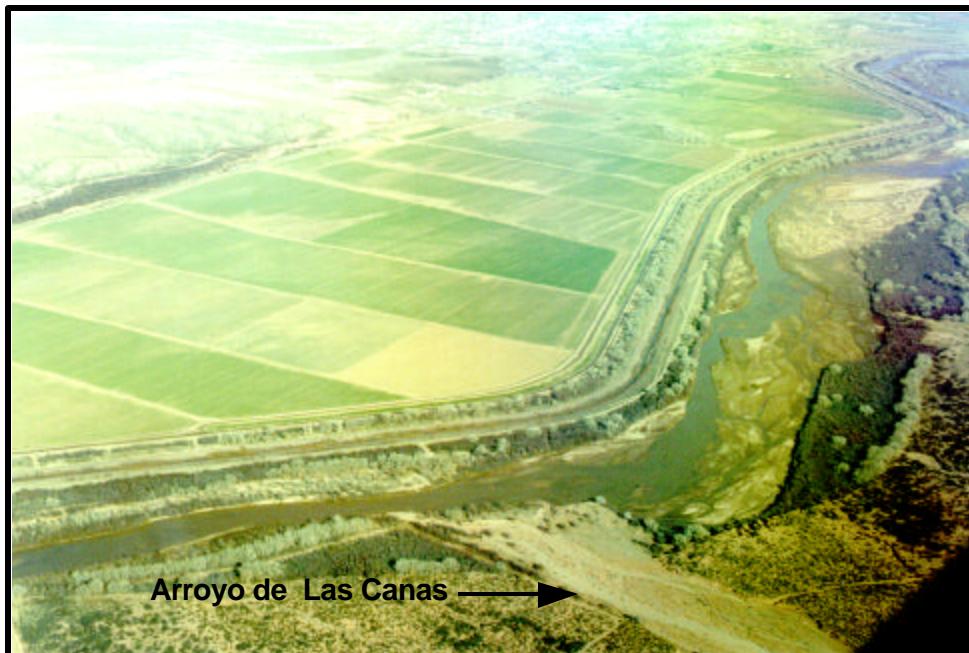
Plate A.30. View of Rio Grande at the confluence with Arroyo de Las Canas (RM 95.2). Note the size of the tributary mouth bar and the sediment deposition upstream, as well as the number of braid bars in the wide channel.

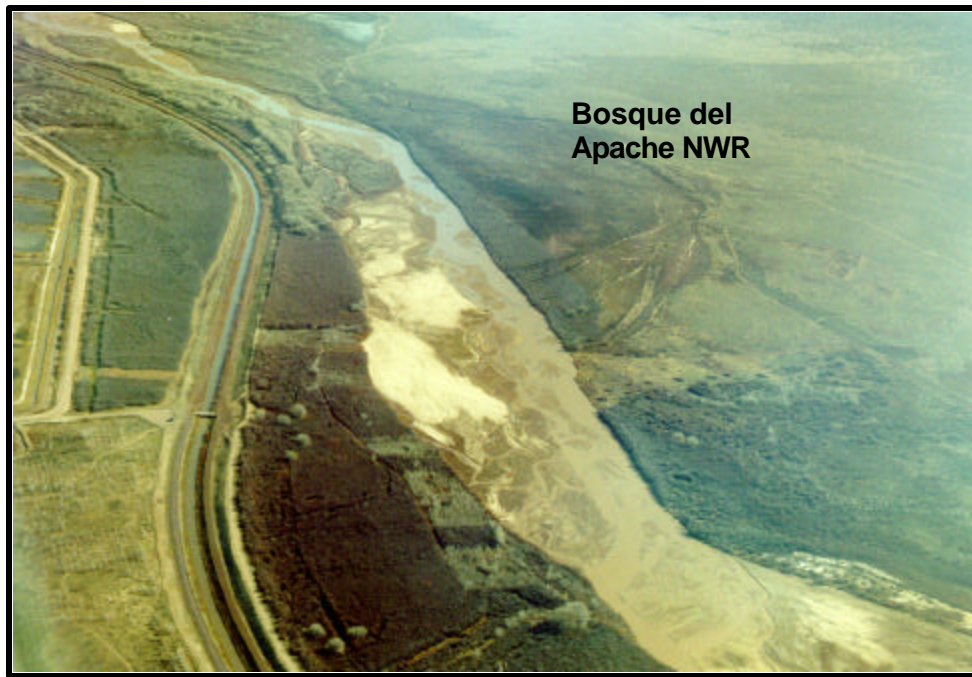
Plate A.31. View of the Rio Grande within the Bosque del Apache National Wildlife Refuge (RM 81) (geomorphic Subreach 8). Mechanical removal of vegetation on the right bank has increased the width of the river with a commensurate increase in the number of braid bars.

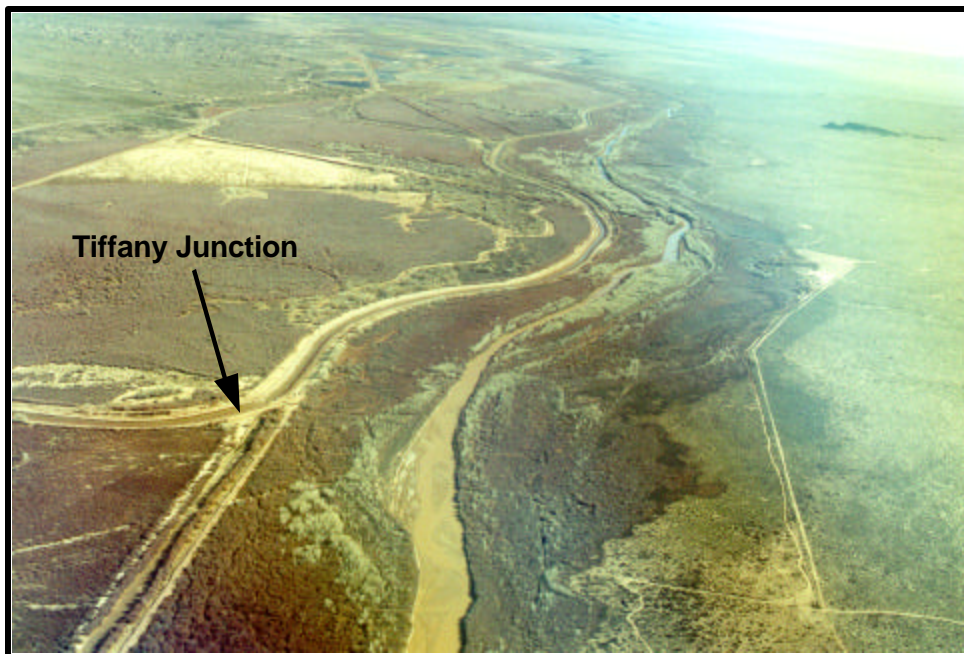
Plate A.32. View of Rio Grande in the vicinity of Tiffany Junction (RM 72.5). Note the narrow channel and the virtual absence of braid bars in the channel.

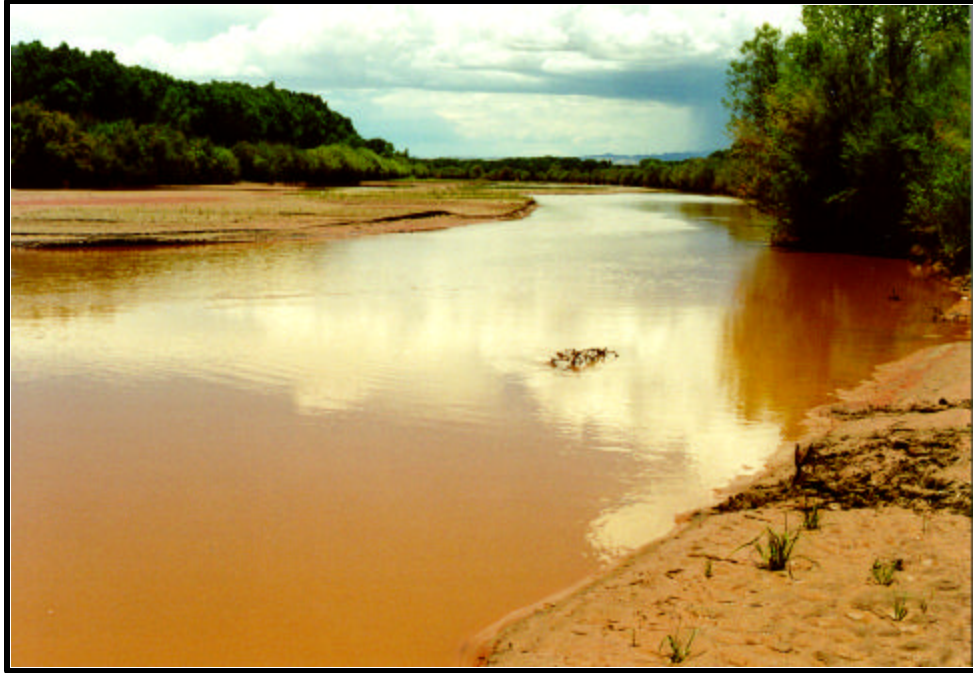
Plate A.33. View of Rio Grande at about RM 70. The channel is somewhat wider than average in Subreach 8, but the braid bars are covered with a thick drape of mud.

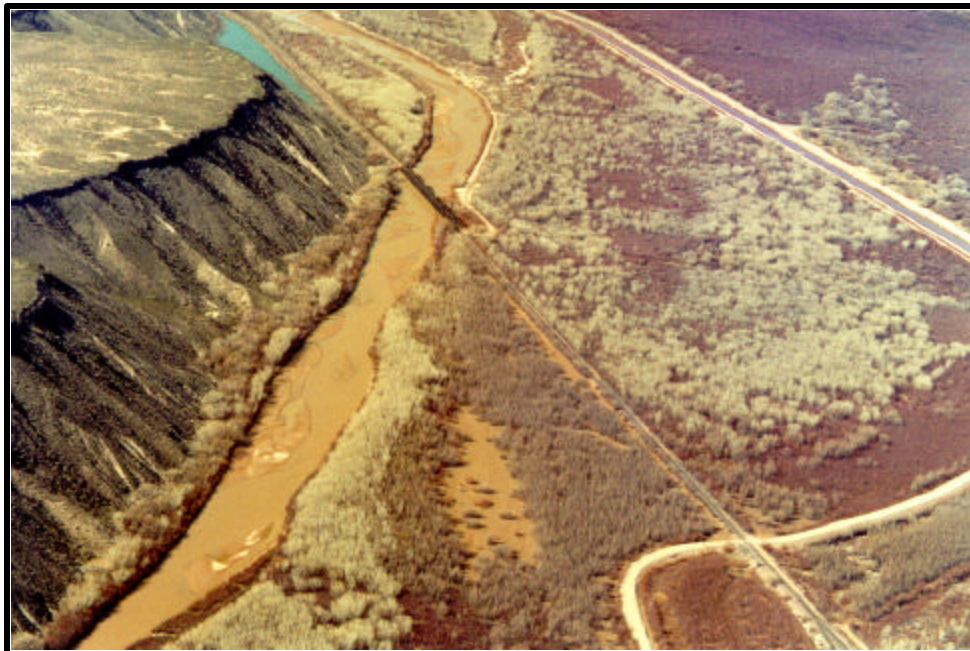
Plate A.34. View of the Rio Grande at the San Marcial Railroad Bridge and USGS gaging station at about RM 68.6. The reach is actively aggrading due to the backwater effects of Elephant Butte Reservoir. Note the extensive braid bars in the channel.
