Plate A.1. Cochiti Dam at about RM 232.

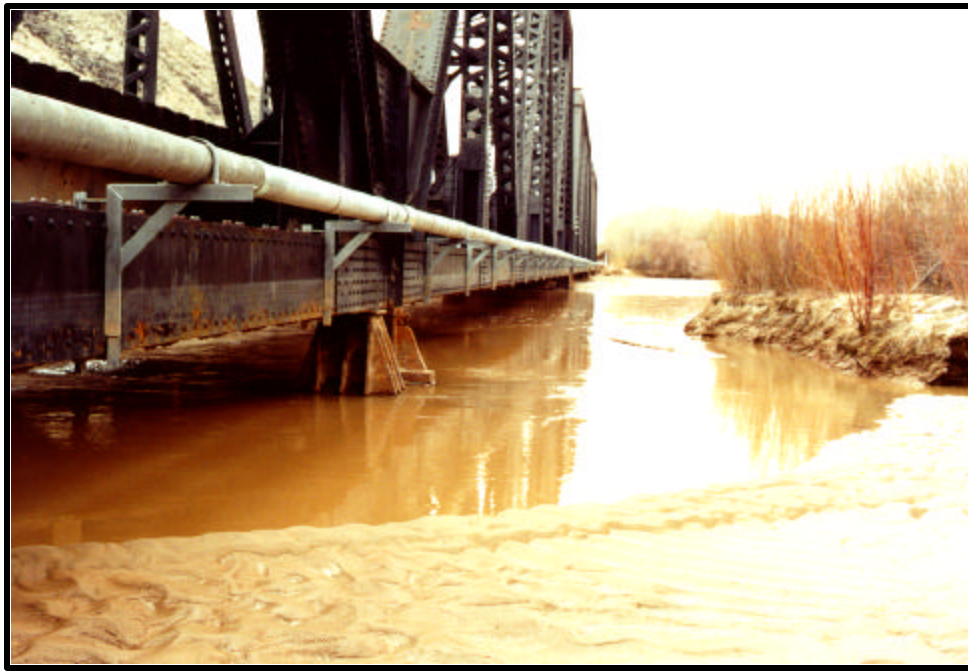
Plate A.35. View of the downstream face of the San Marcial Railroad Bridge showing the effects of aggradation.

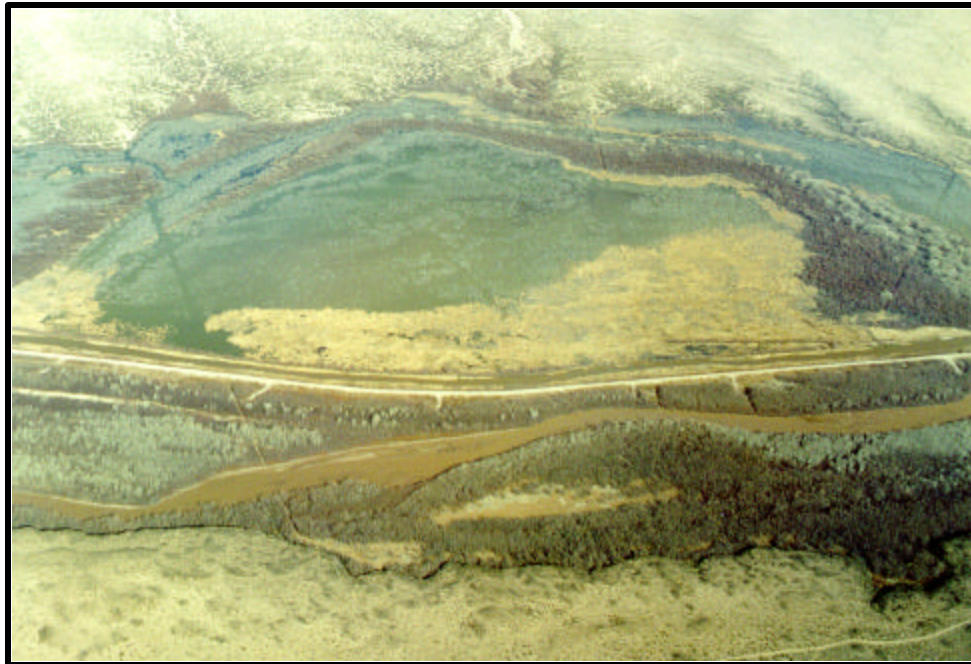
Plate A.36. View of the Rio Grande downstream of Fort Craig at about RM 62. The channel is aggraded and contains numerous braid bars.
