# 1. INTRODUCTION

## 1.1. Background

The Middle Rio Grande, as defined in this report, is that part of the Rio Grande in New Mexico that extends from Cochiti Dam to Elephant Butte Reservoir, a distance of about 165 miles (**Figure 1.1**). The Rio Grande valley has been a home to the Pueblo people, Spanish colonizers, and Americans (Horgan, 1954; Crawford et al., 1993). The valley has a complex geomorphic and geologic history (Belcher, 1975) and hydrologic conditions are unusual (Graf, 1994). For example, discharge decreases as the river flows from areas of higher to lower precipitation (**Figure 1.2**). However, contributions from Rio Puerco and Rio Salado increase flood peaks between Albuquerque and San Marcial (**Figure 1.3**). Both suspended load and bed load are increased dramatically by contributions from the Rio Puerco and Rio Salado (**Figures 1.4 and 1.5**).

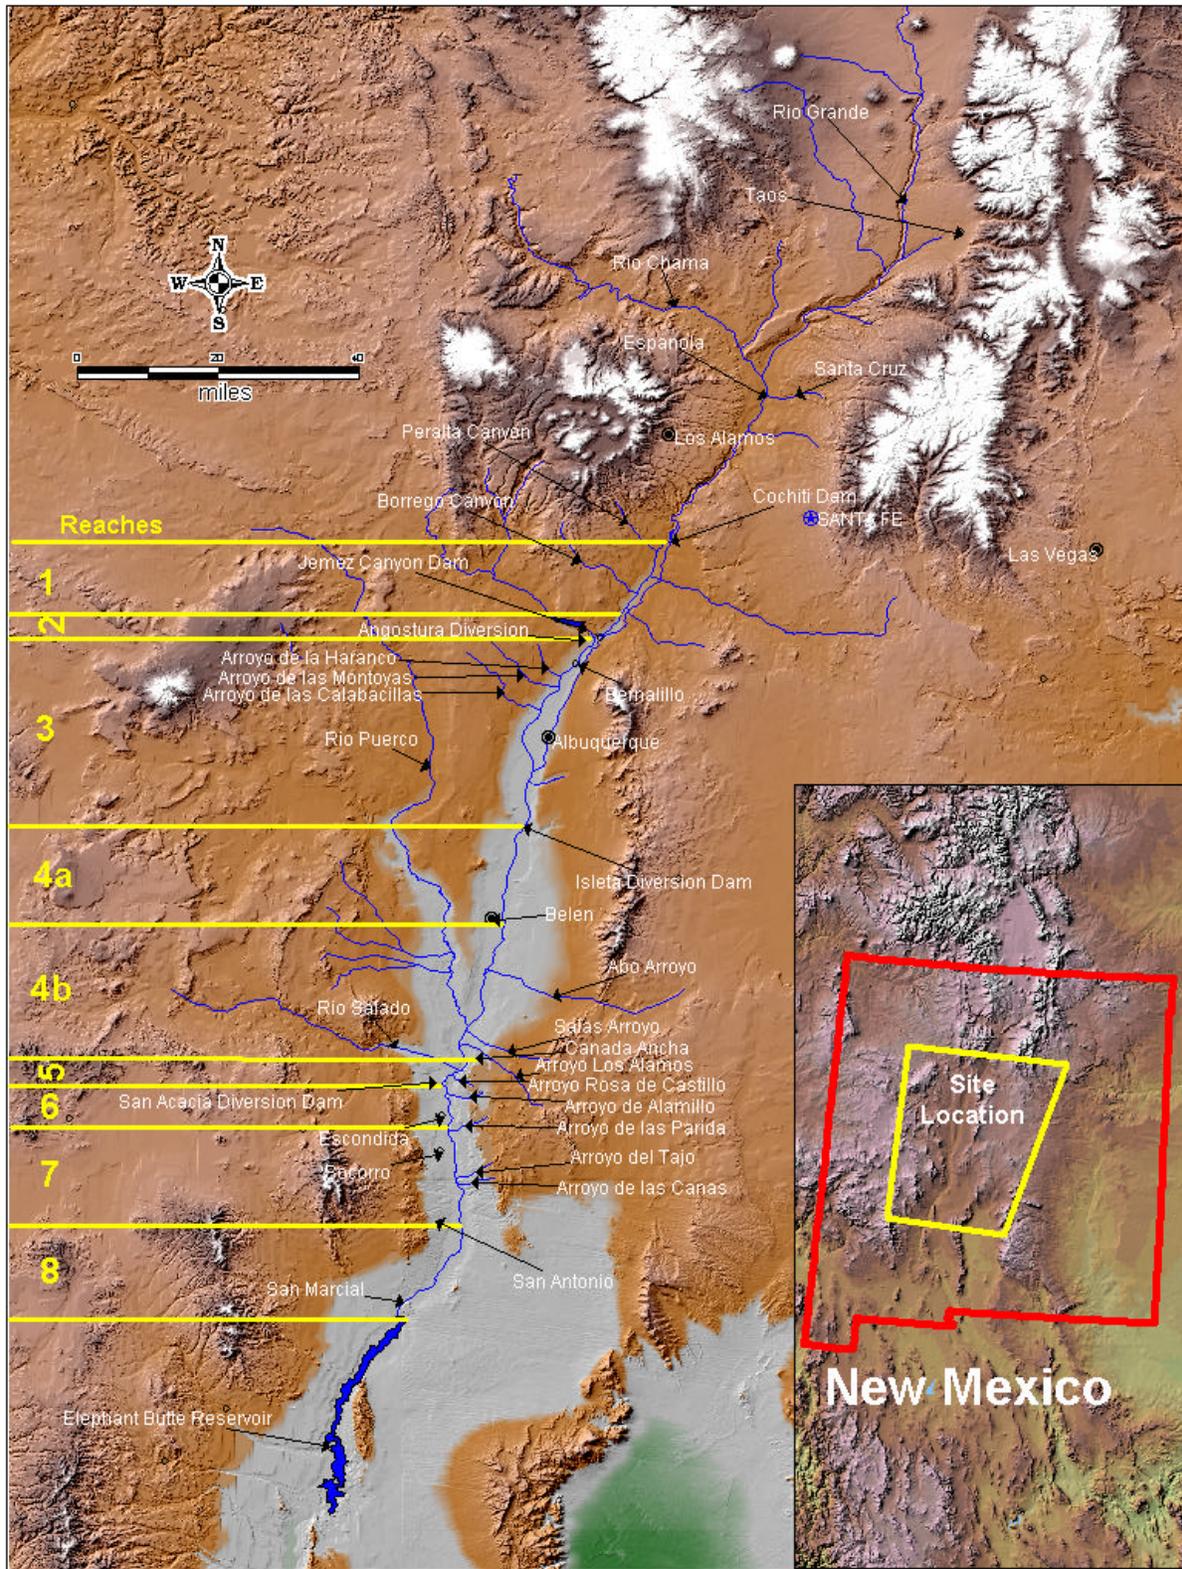
Figure 1.1. Map of the project Reach of the Rio Grande showing the locations of features identified and discussed in the report, as well as the reach boundaries identified by MEI.

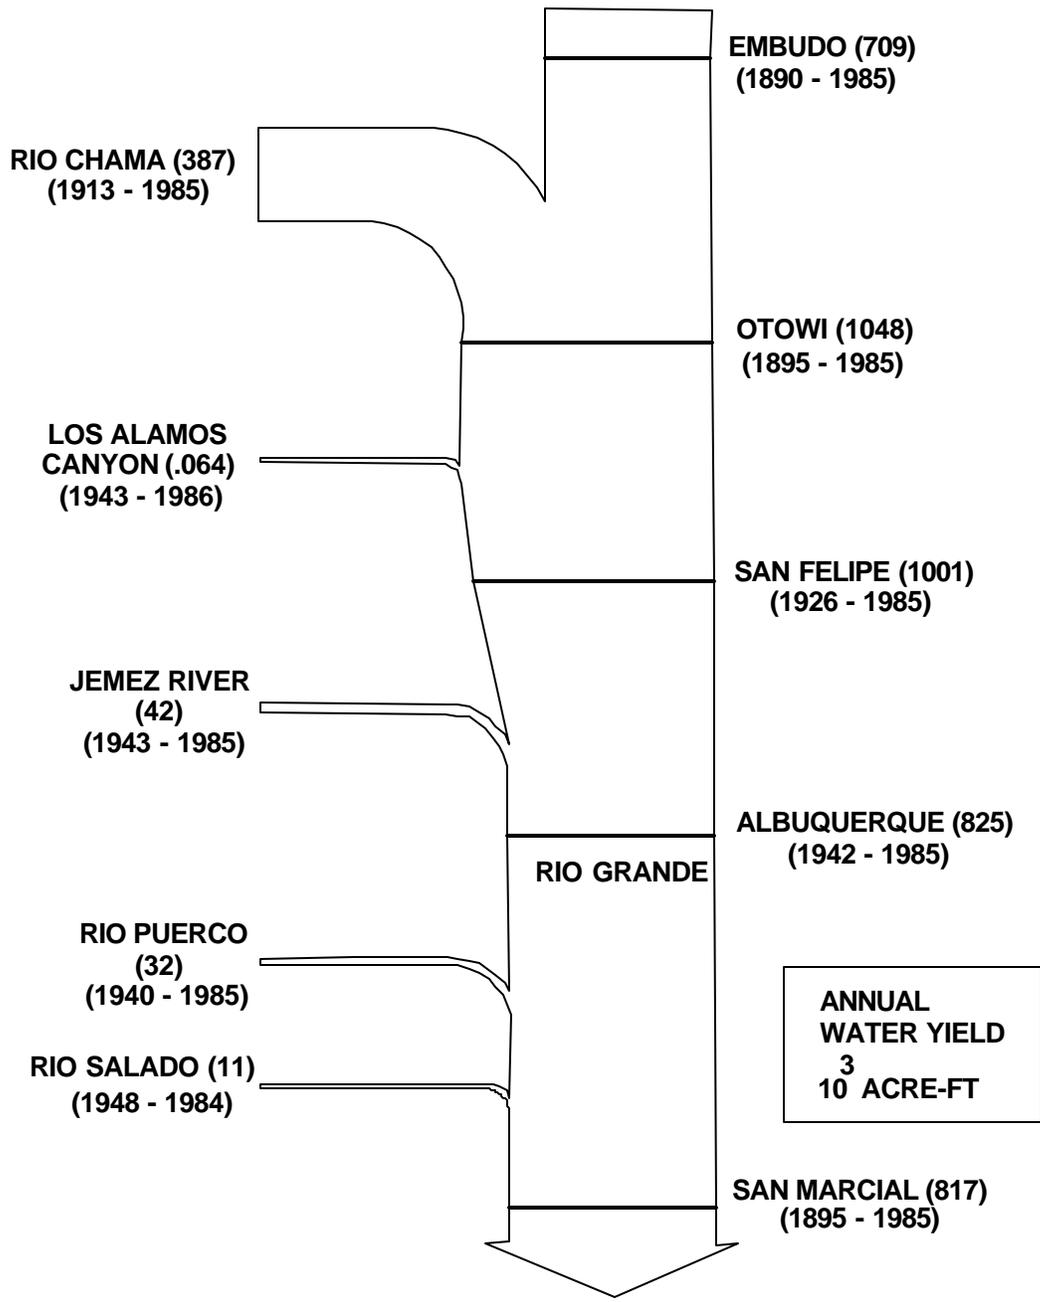
Figure 1.2. Flow diagram for the annual water yield budget of the Northern Rio Grande (Graf, 1994). The indicated values are averages based on the indicated periods of record for each of the gages.

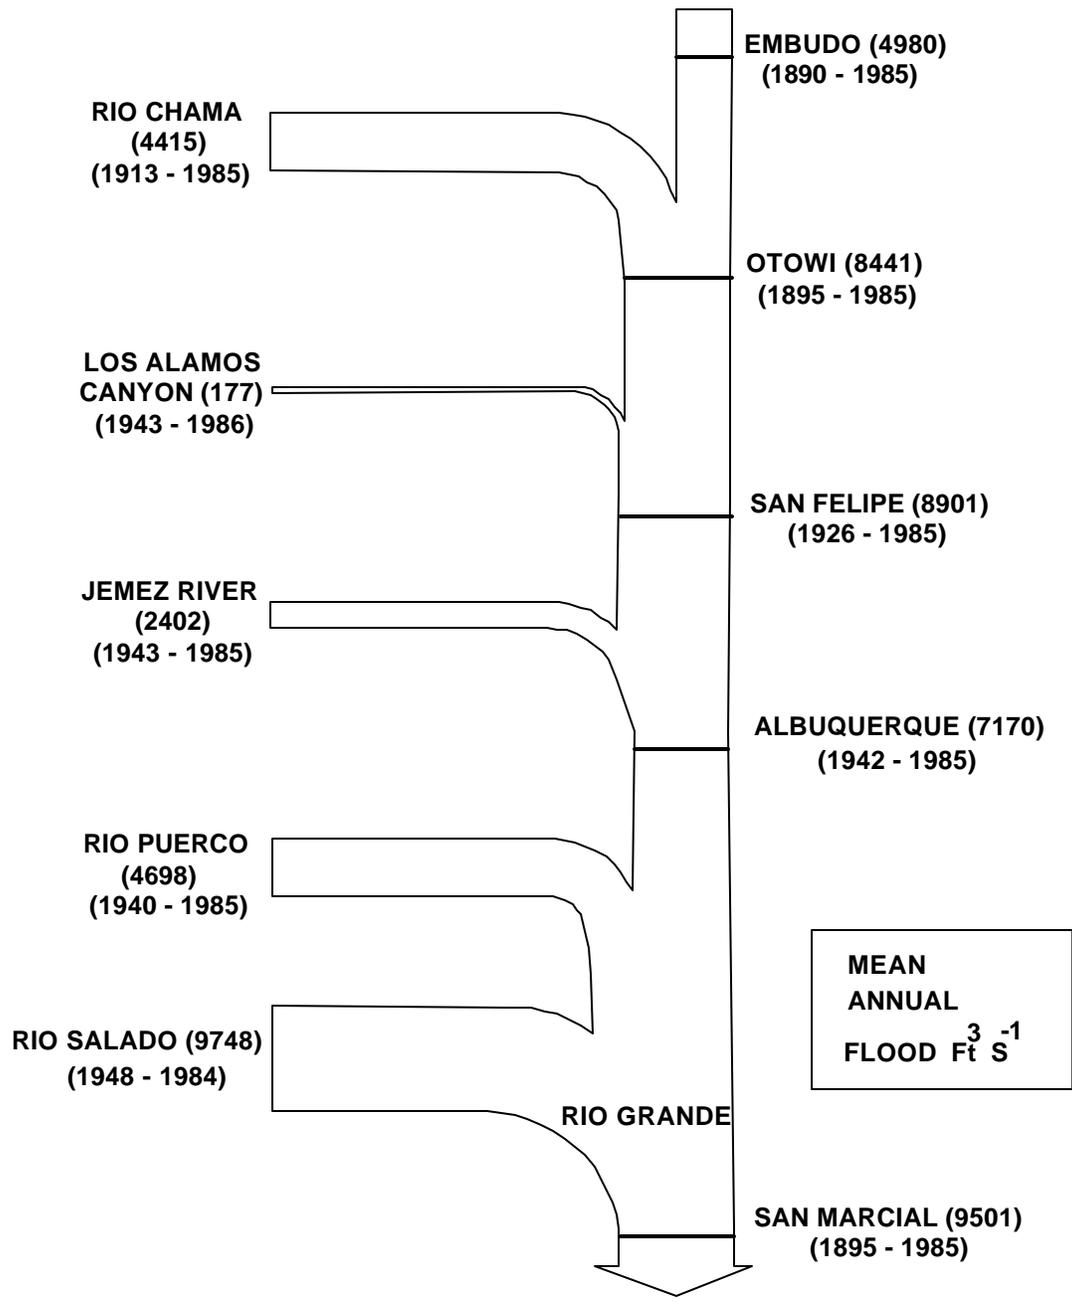
Figure 1.3. Flow diagram for the annual maximum flood series of the Northern Rio Grande (Graf, 1994). The indicated values are averages based on the indicated periods of record for each of the gages.

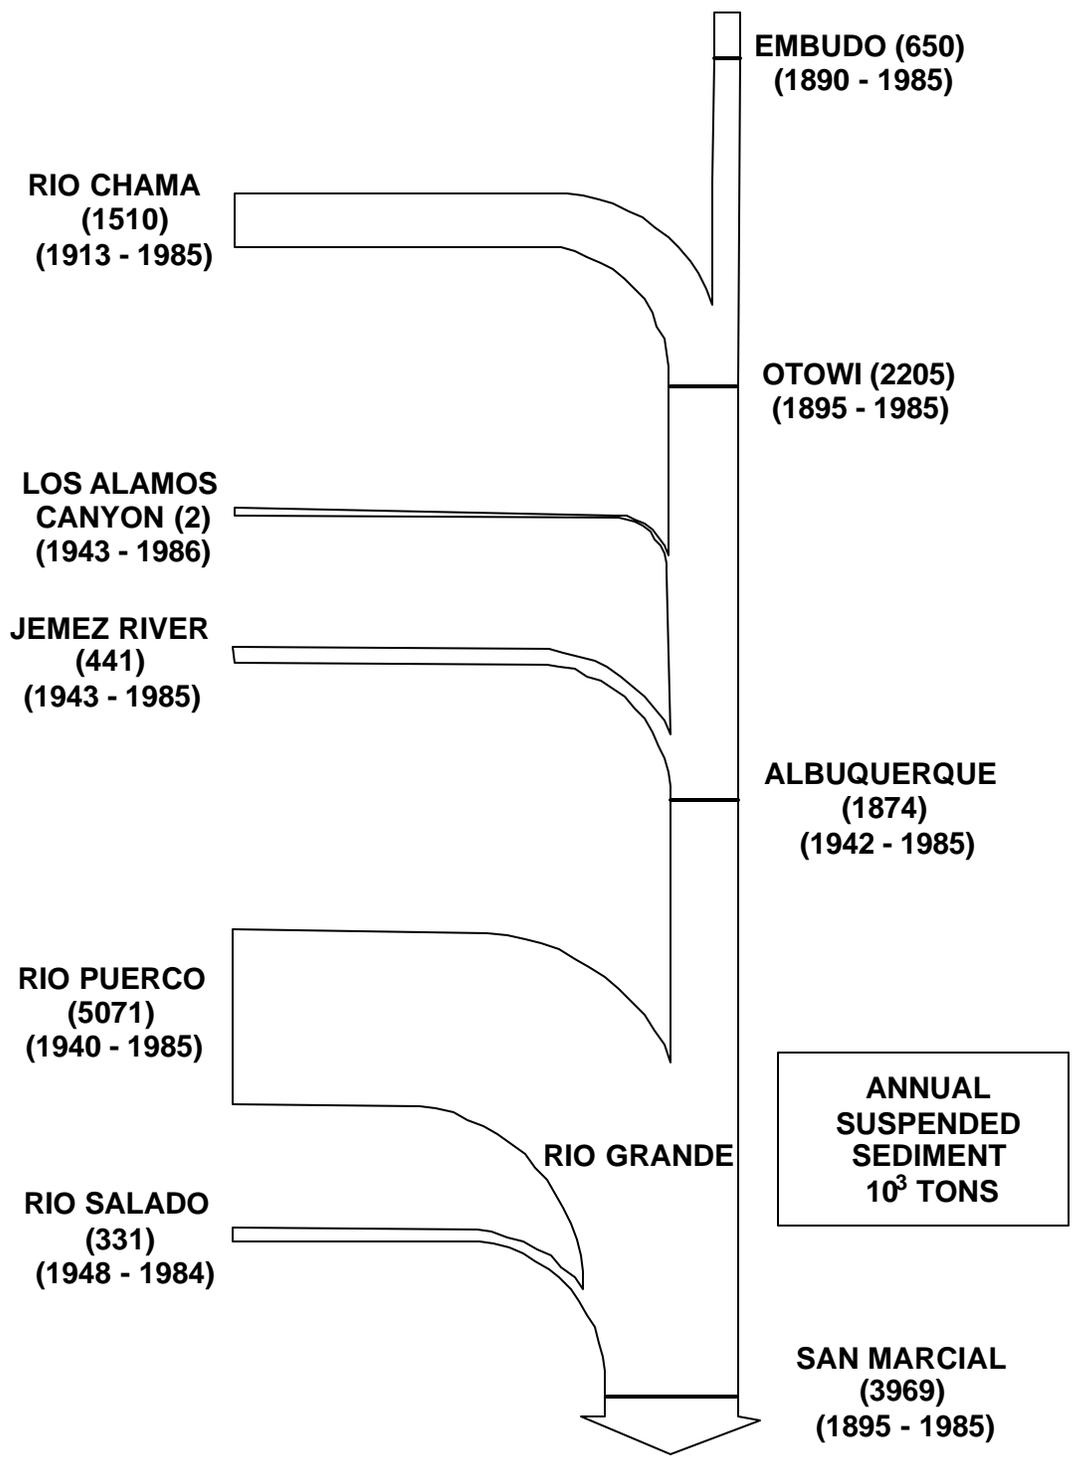
Figure 1.4. Flow diagram for the annual budget for suspended sediment in the Northern Rio Grande (Graf, 1994). The indicated values are averages for the period between 1948 and 1984.

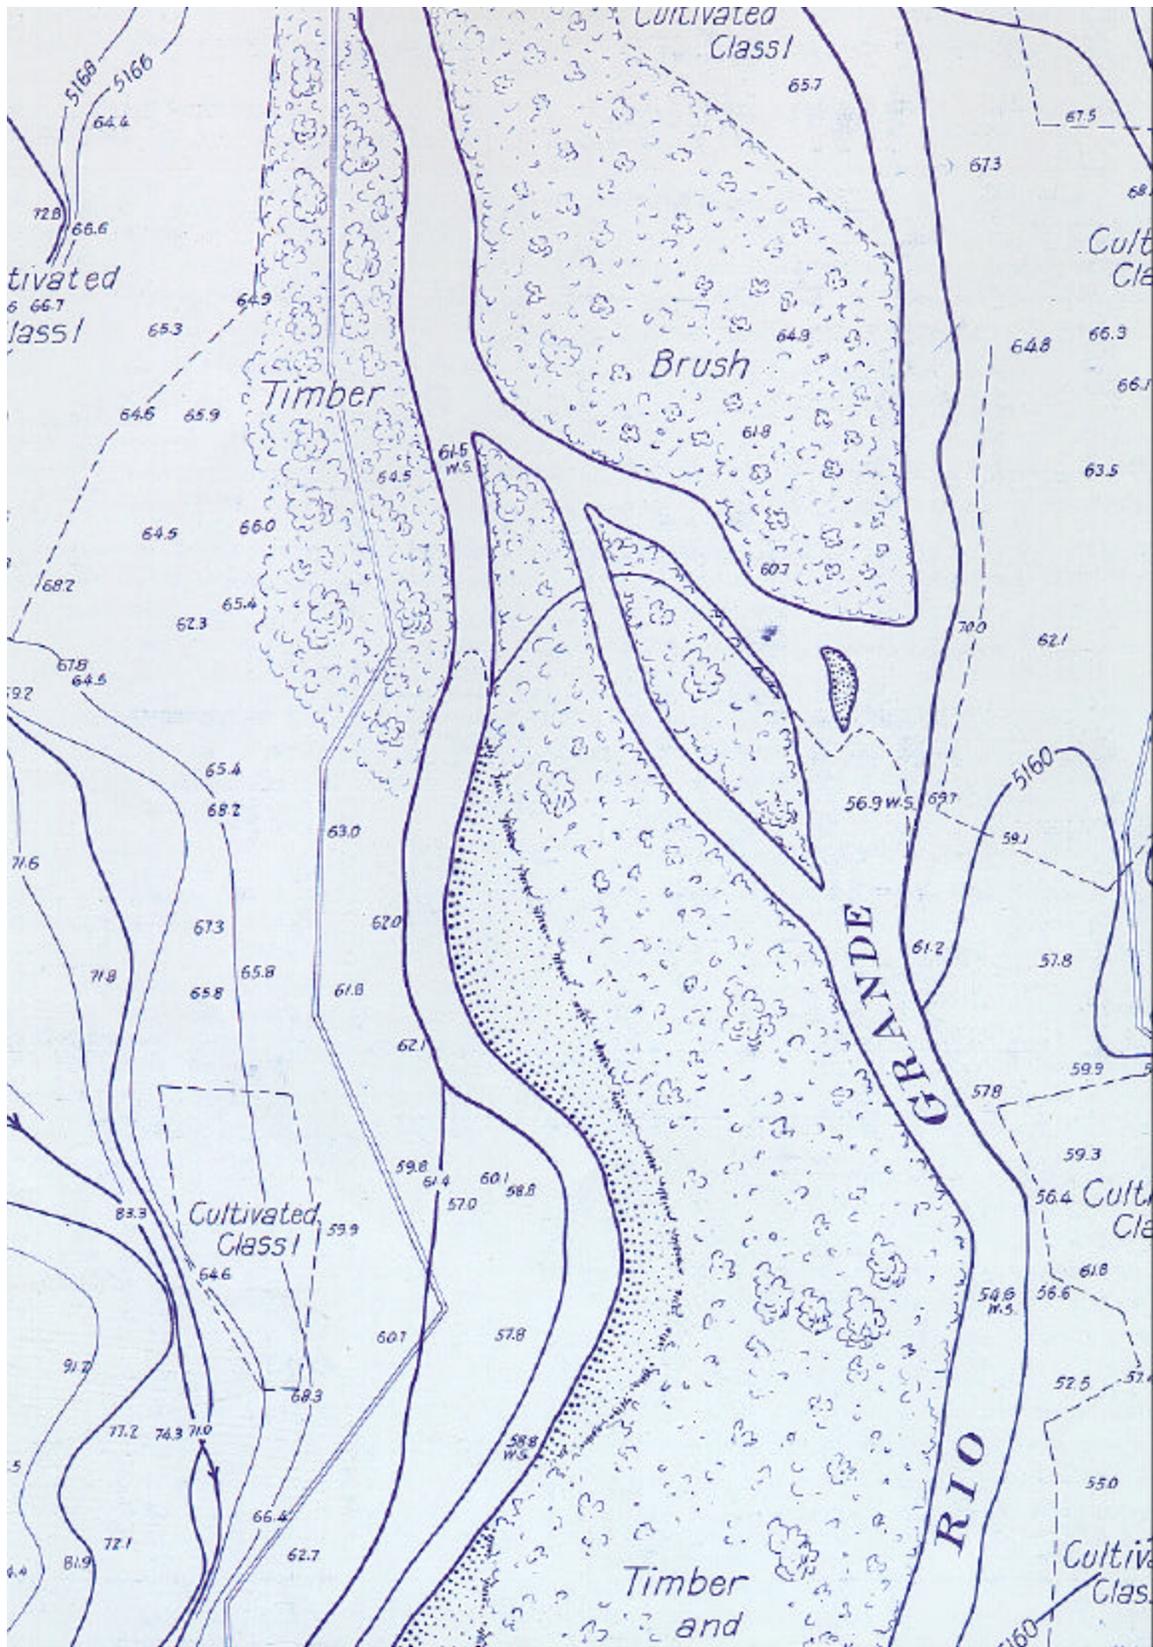
Figure 2.1. A portion of the 1917/1918 map of the Rio Grande showing the anastomosed channel planform in Reach 1. The channels appear to be the same size.

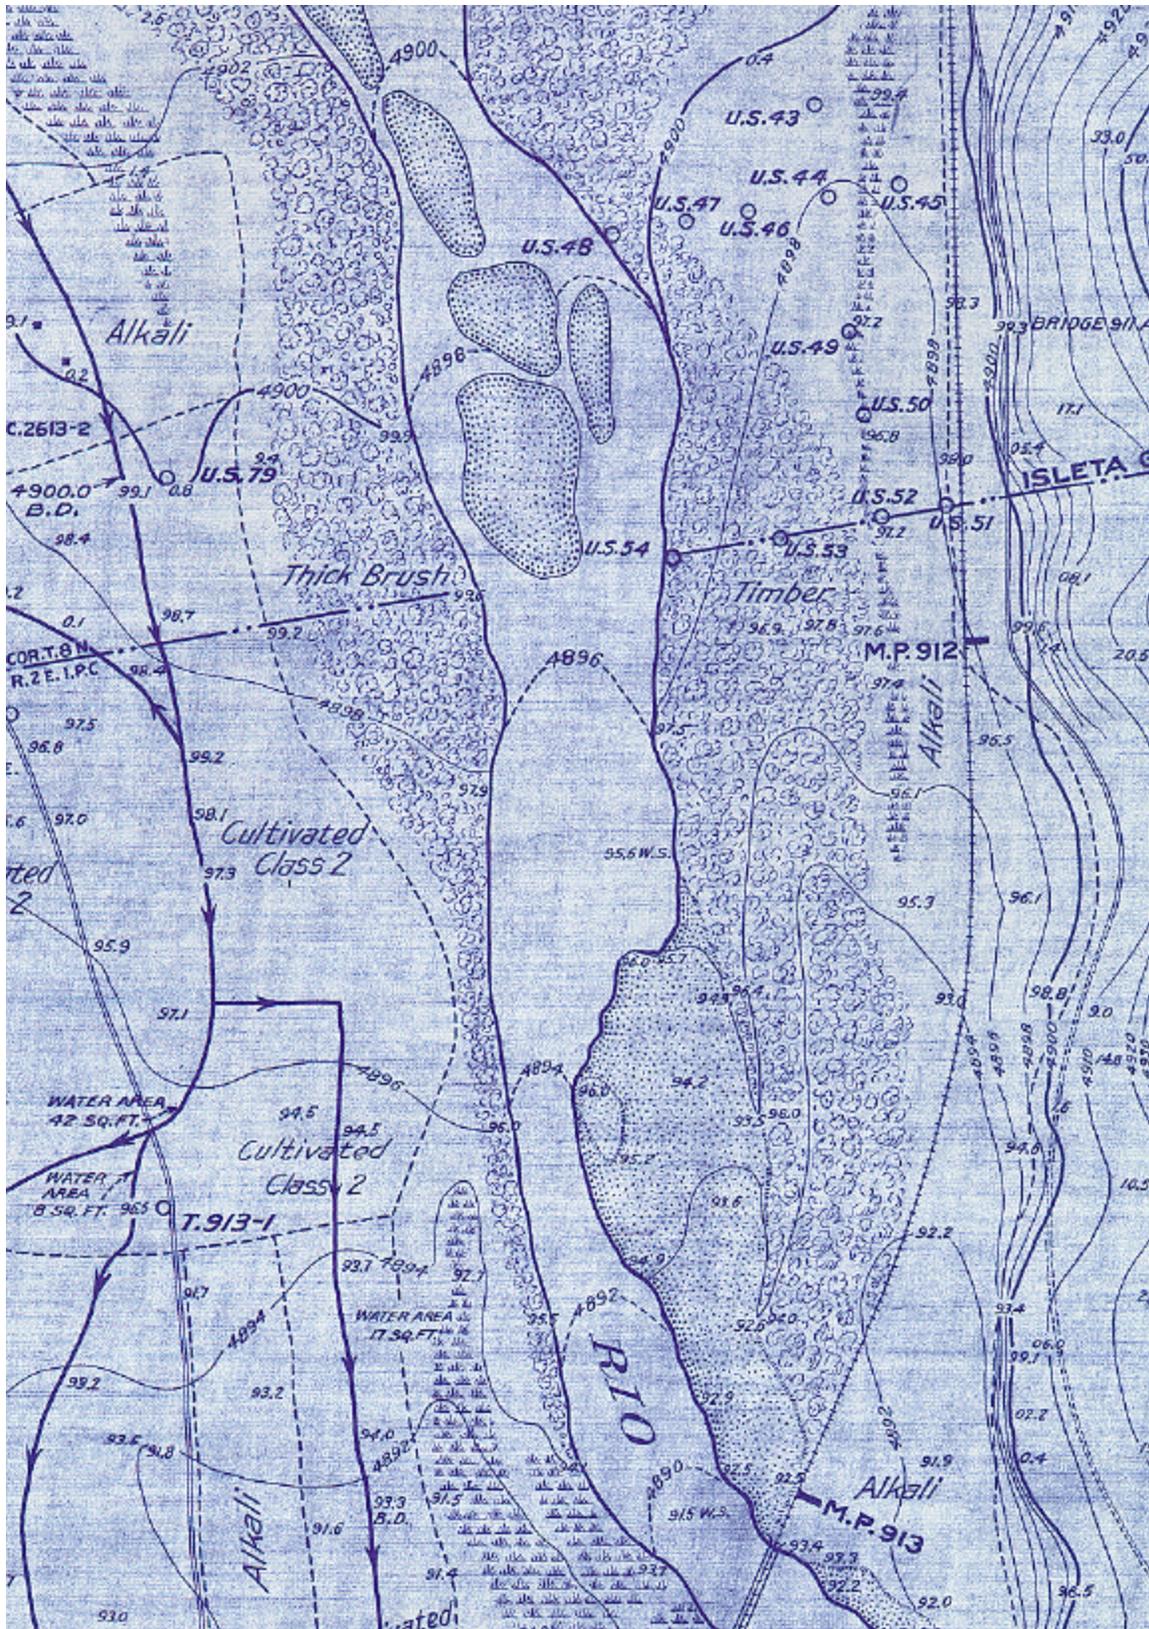
Figure 2.3. A portion of the 1917/1918 map of the Rio Grande showing the braided platform with highly variable channel width and numerous mid-channel bars in Reach 3.

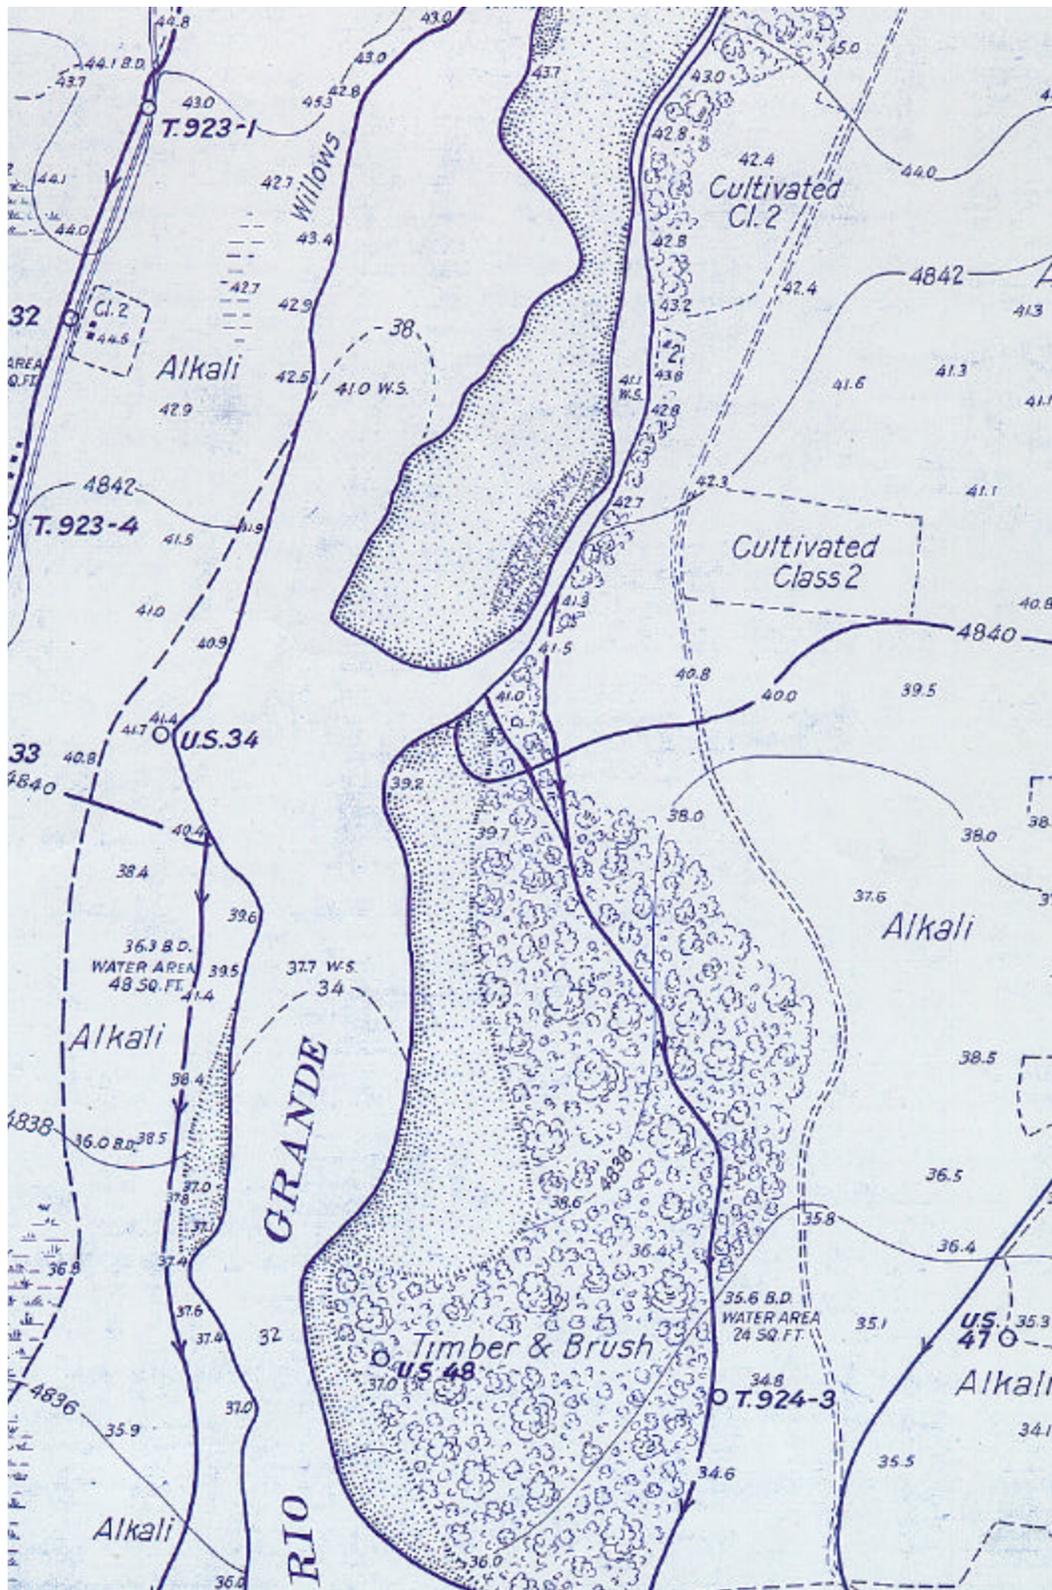
Figure 2.4. A portion of the 1917/1918 map of the Rio Grande showing the braided planform with highly variable channel width in Reach 4a.

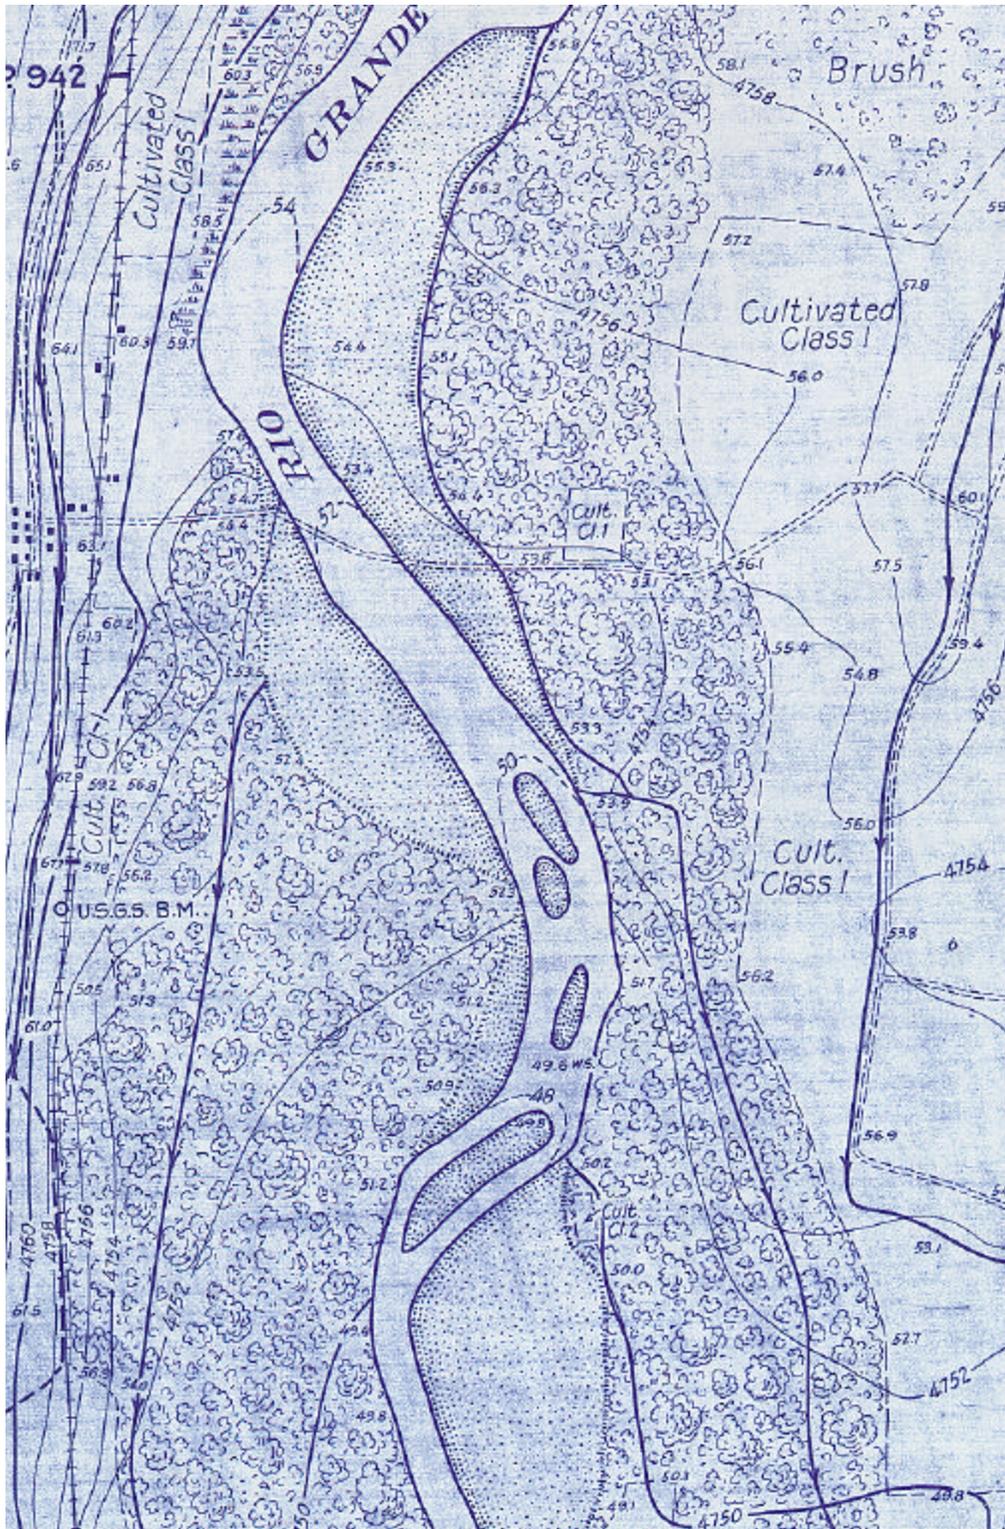
Figure 2.5. A portion of the 1917/1918 map of the Rio Grande showing the braided planform with highly variable channel width and numerous mid-channel and lateral bars in Reach 4b.

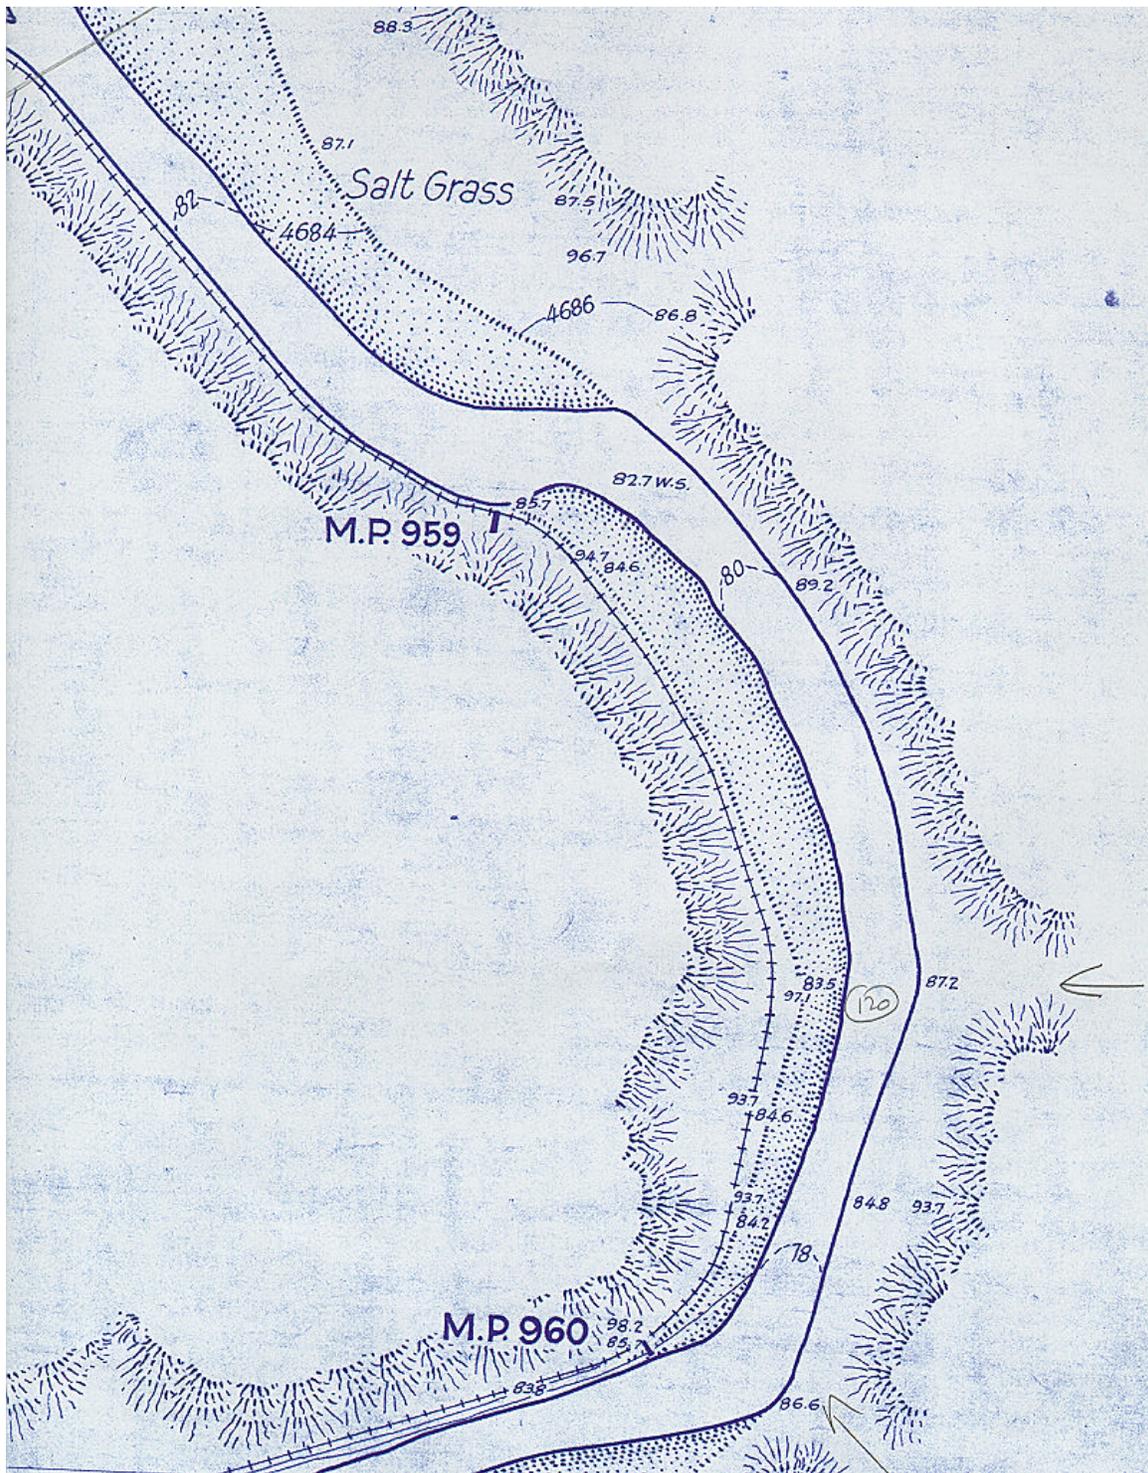
Figure 2.6. A portion of the 1917/1918 map of the Rio Grande showing the narrow, bedrock-controlled channel in the upstream part of Reach 5. Alternate bars characterized this part of the river.

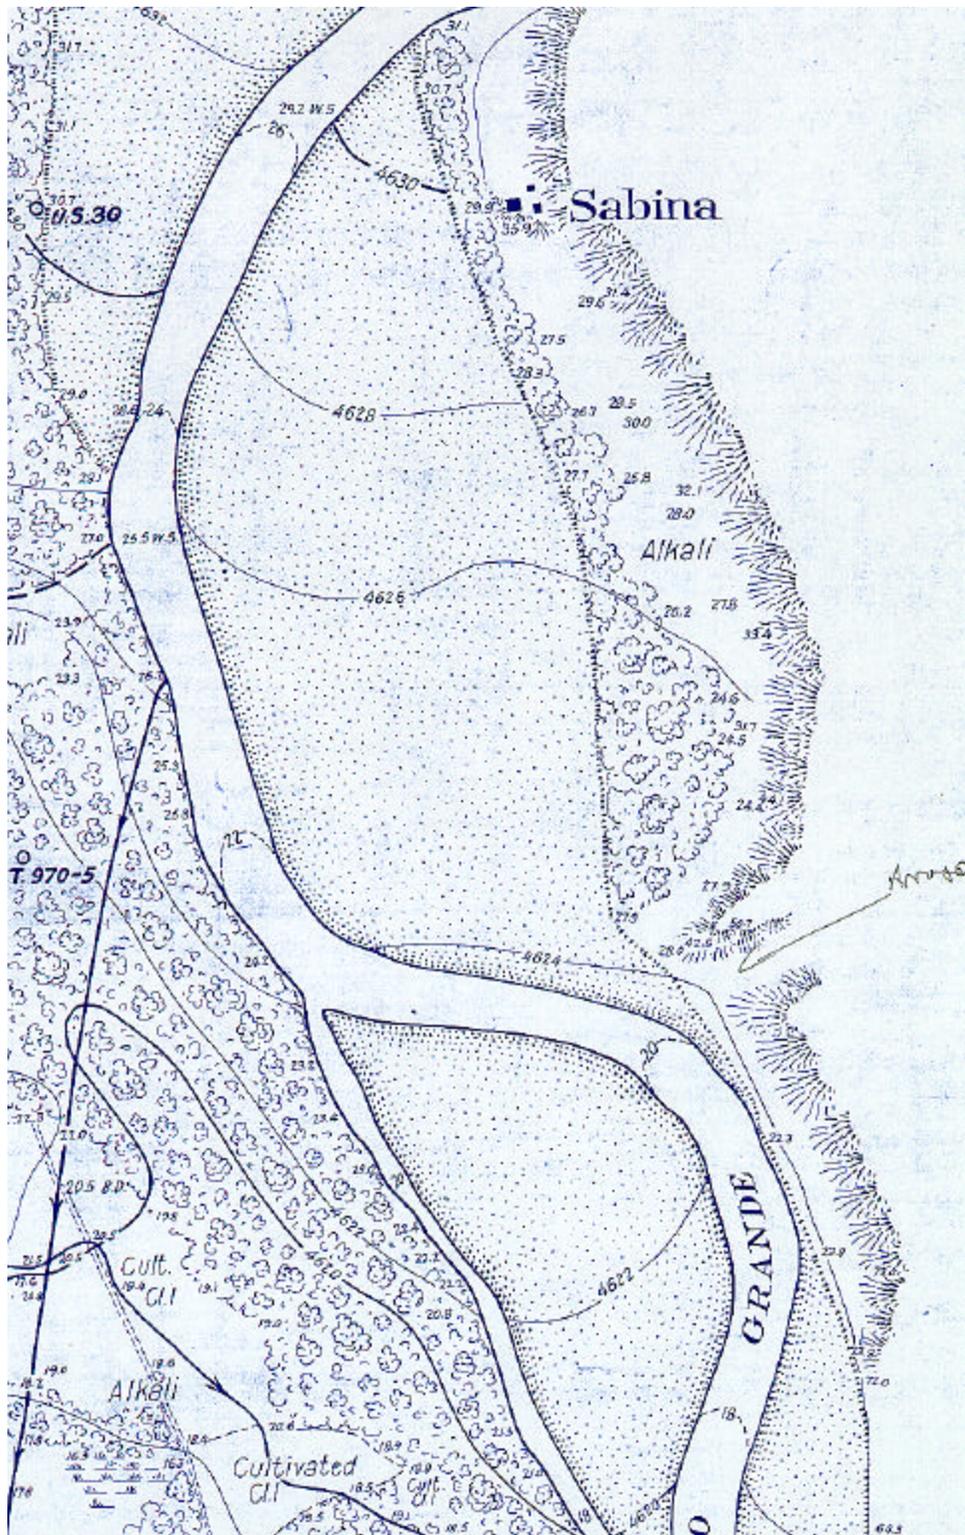
Figure 2.7. A portion of the 1917/1918 map of the Rio Grande showing the braided planform and large mid-channel bars in Reach 6 where numerous east-side arroyos episodically delivered large volumes of sediment to the channel.

- ! Reach 6 (San Acacia to Escondida), in 1917/1918, contained a very wide and braided channel (**Figure 2.7**). The sediment contributions from the Rio Puerco and Rio Salado, as well as the east-side tributary arroyos were responsible for the very wide braided condition of the channel. There was considerable dredging of the channel in this reach before 1962 and up to 1992.

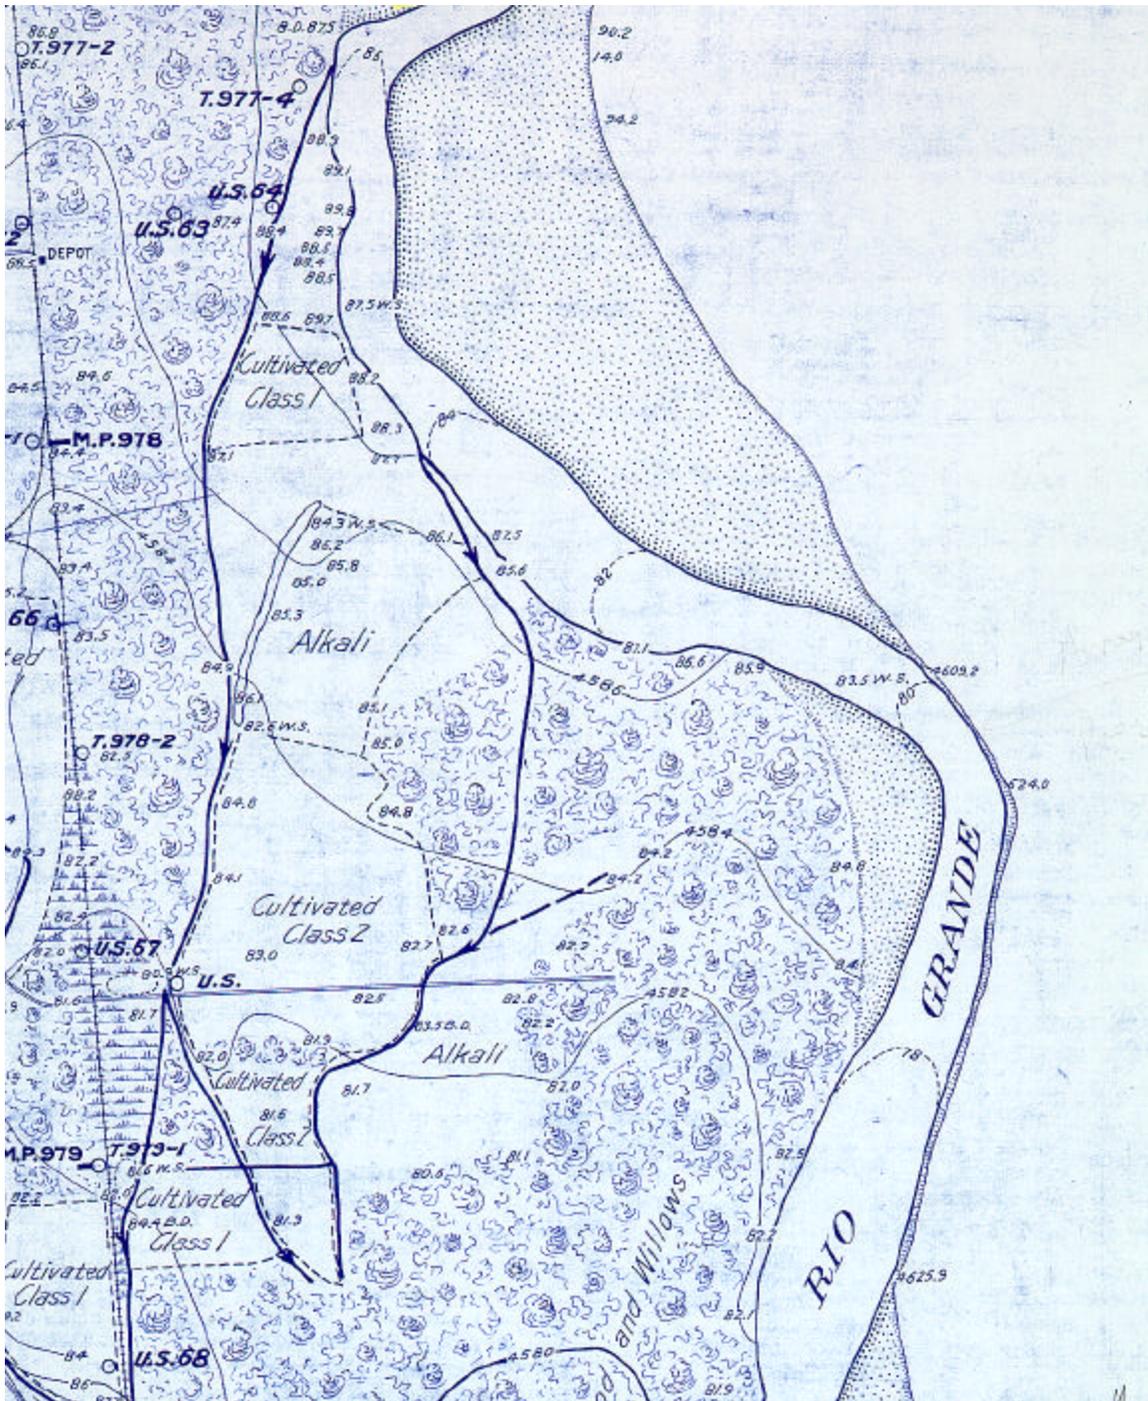
Figure 2.8. A portion of the 1917/1918 map of the Rio Grande showing a low sinuosity planform in Reach 7. The low sinuosity planform is probably related to the higher proportion of fine-grained sediments introduced by the Rio Puerco degradation.

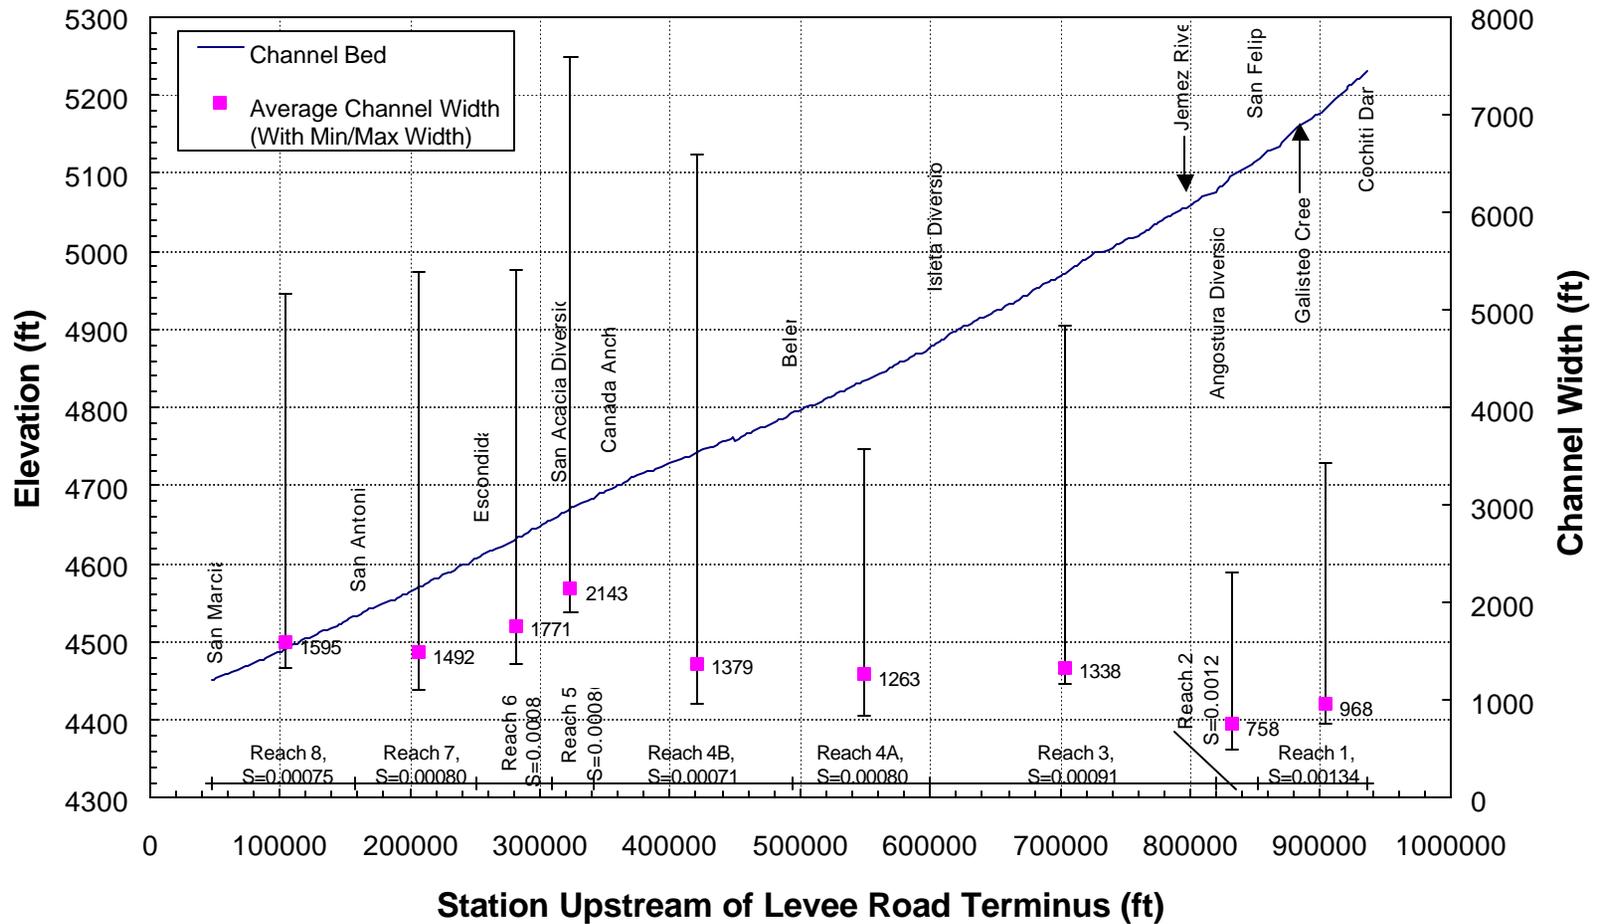
Figure 2.10. Longitudinal profile of the Rio Grande developed from the 1917 -1918 survey of the river. The bed slopes as well as the average active channel width and maximum and minimum widths for each of the identified reaches are also shown.

The longitudinal profile of the Middle Rio Grande shows a large convexity in the uplifted area (Figure 2.10). A more detailed profile showing aggradation and degradation between 1917 and 1972 before Cochiti Dam came into operation clearly illustrates the zone of uplift and the resulting convexity of the Rio Grande profile between Belen and Socorro (**Figure 3.2**).

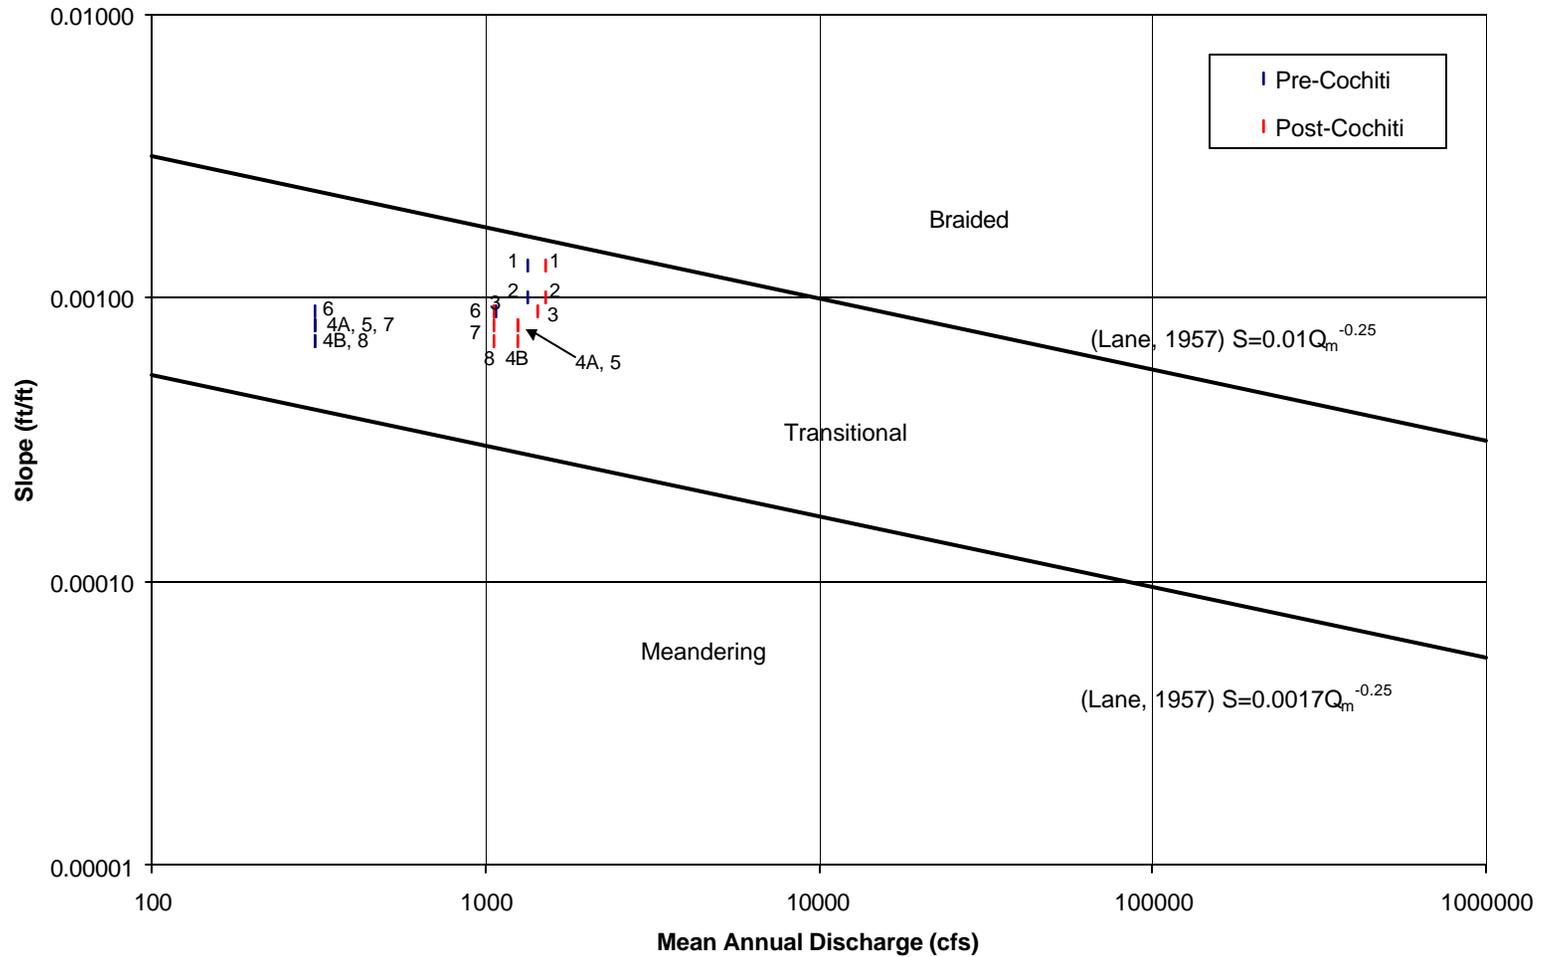
Figure 2.11. Plot of pre- and post-Cochiti mean discharge against channel slope showing the threshold lines for braided and meandering channels developed by Lane (1957). The individual reaches all plots in the transitional category between meandering and braided.
