# 1. INTRODUCTION

## 1.1. Background

The Middle Rio Grande, as defined in this report, is that part of the Rio Grande in New Mexico that extends from Cochiti Dam to Elephant Butte Reservoir, a distance of about 165 miles (**Figure 1.1**). The Rio Grande valley has been a home to the Pueblo people, Spanish colonizers, and Americans (Horgan, 1954; Crawford et al., 1993). The valley has a complex geomorphic and geologic history (Belcher, 1975) and hydrologic conditions are unusual (Graf, 1994). For example, discharge decreases as the river flows from areas of higher to lower precipitation (**Figure 1.2**). However, contributions from Rio Puerco and Rio Salado increase flood peaks between Albuquerque and San Marcial (**Figure 1.3**). Both suspended load and bed load are increased dramatically by contributions from the Rio Puerco and Rio Salado (**Figures 1.4 and 1.5**).

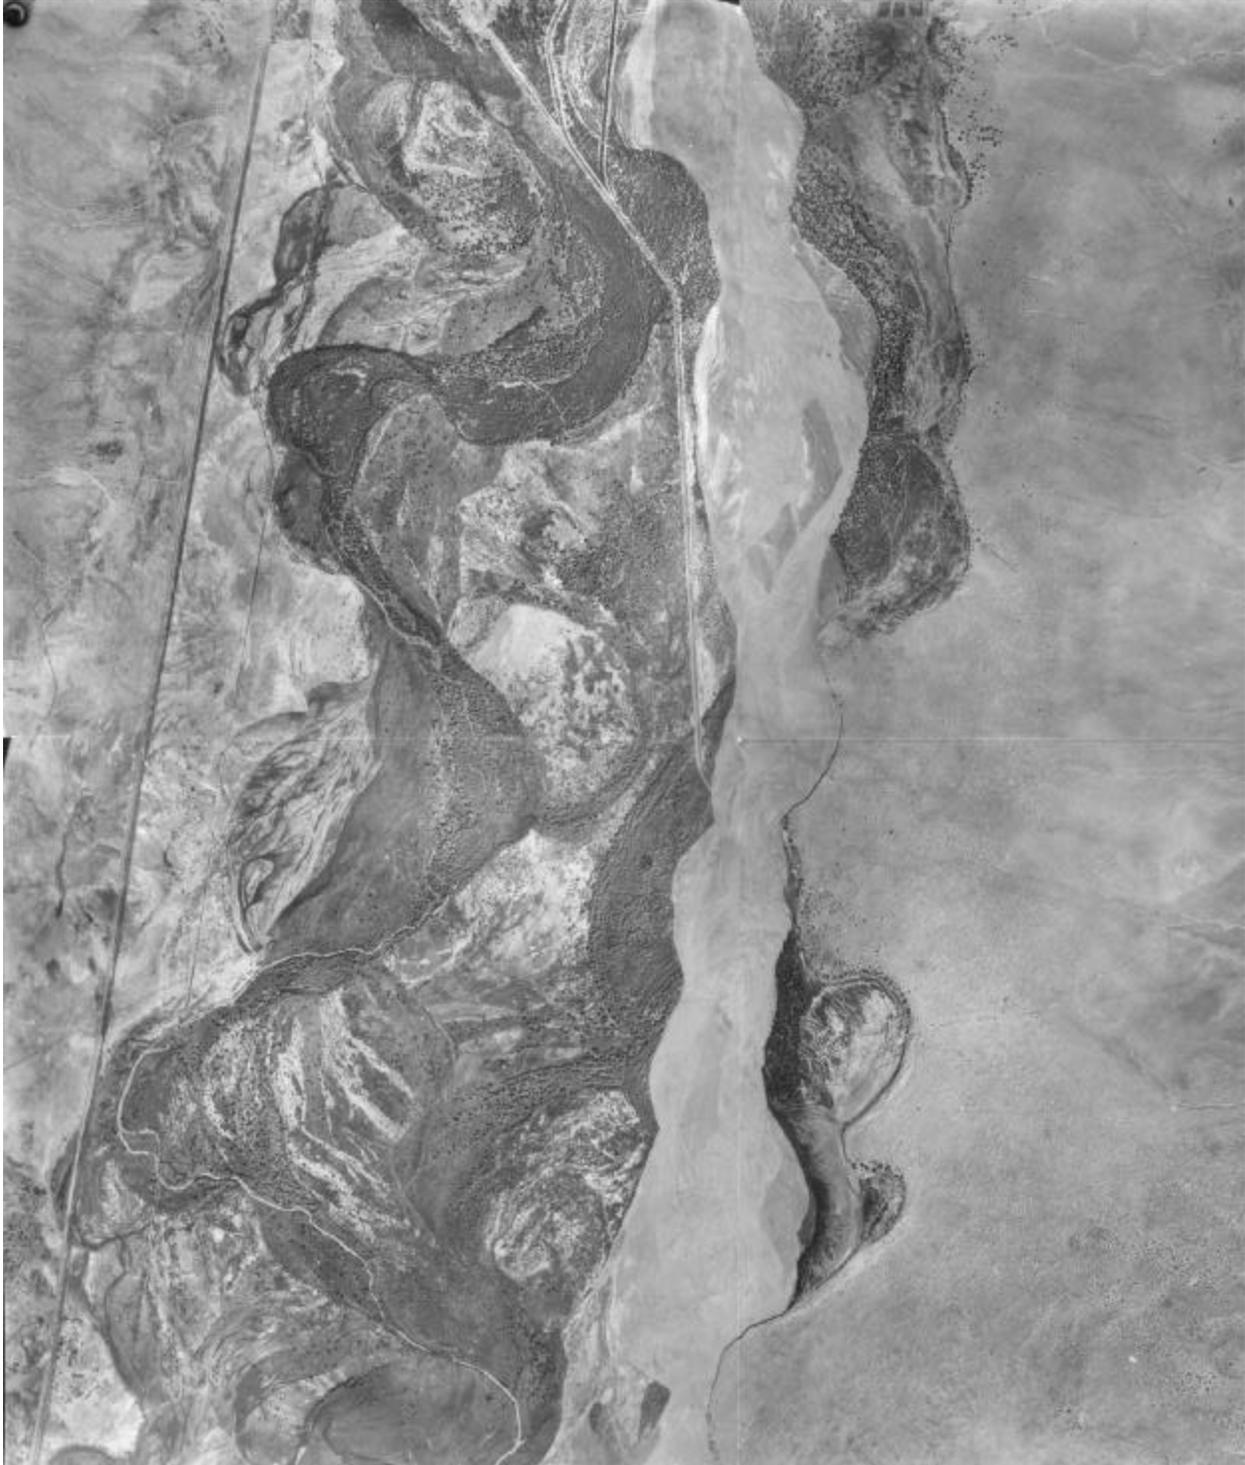
Figure 2.12. 1935 aerial photograph (#5933A) of a reach of the Rio Grande in the vicinity of the Bosque del Apache National Wildlife Refuge (RM 80 – RM 83, Reach 8) showing sections of a moderately sinuous meandering channel (Sinuosity 1.4) that was probably abandoned in the floods of 1929 and early 1933.

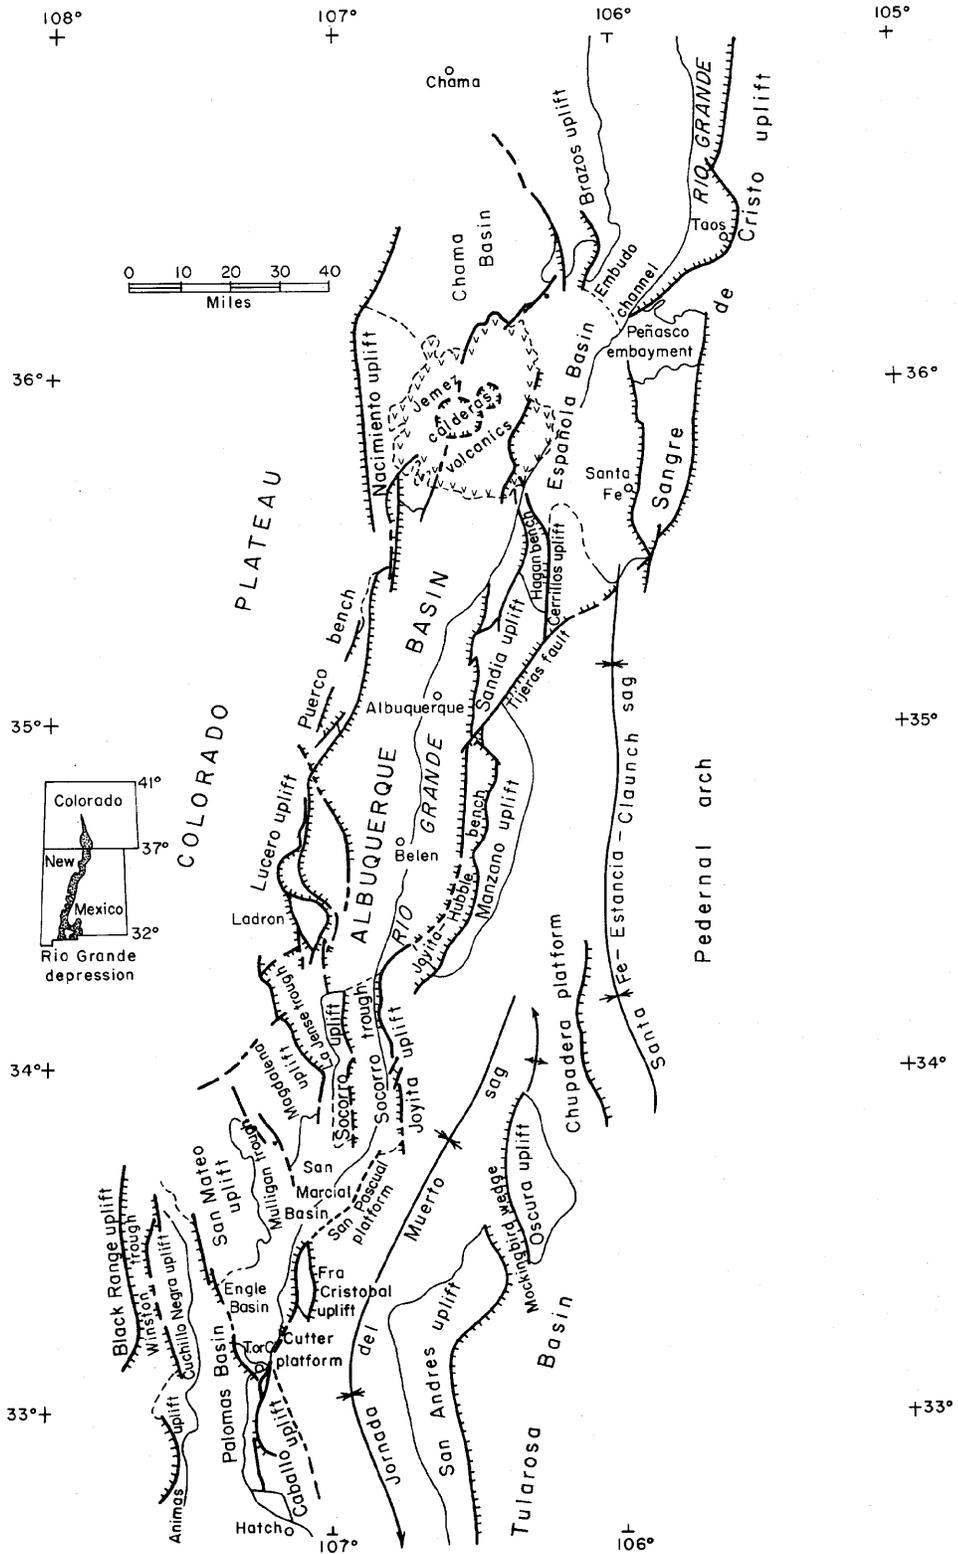
Figure 3.1. Tectonic map of the Rio Grande Rift system in New Mexico showing the locations of the structural basins and associated zones of uplift (Kelley, 1977).

The Joyita Uplift, located on the east side of the Rio Grande (Figure 3.1) affects both the topography and geology of the Rio Grande valley in Reaches 5,6 and 7 (**Figure 3.3**). The uplift, bounded on the west by the West Joyita Fault, causes a higher elevation complex of highly faulted sedimentary, volcanic, metamorphic and igneous rocks to be present on the east side of the river (Kelley, 1977). The exposed rocks are the source of both sediment and runoff that are able to traverse the much-narrowed belt of Santa Fe Formation that exists between the margin of the uplifted rocks and the Rio Grande. The reduced width of the Santa Fe Formation outcrop and the increased slope of the channels permit flood flows in the east-side tributaries to deliver sediment to the river (**Figure 3.4**). This is in contrast to the situation in Reaches 4a and 4b where the width of the Santa Fe Formation outcrop is high and very few tributaries are present because of flow infiltration into the highly permeable Santa Fe sediments (Chronic, 1987). The local geological setting, therefore, is very important with respect to sediment delivery to the Rio Grande in Reaches 5, 6 and 7.

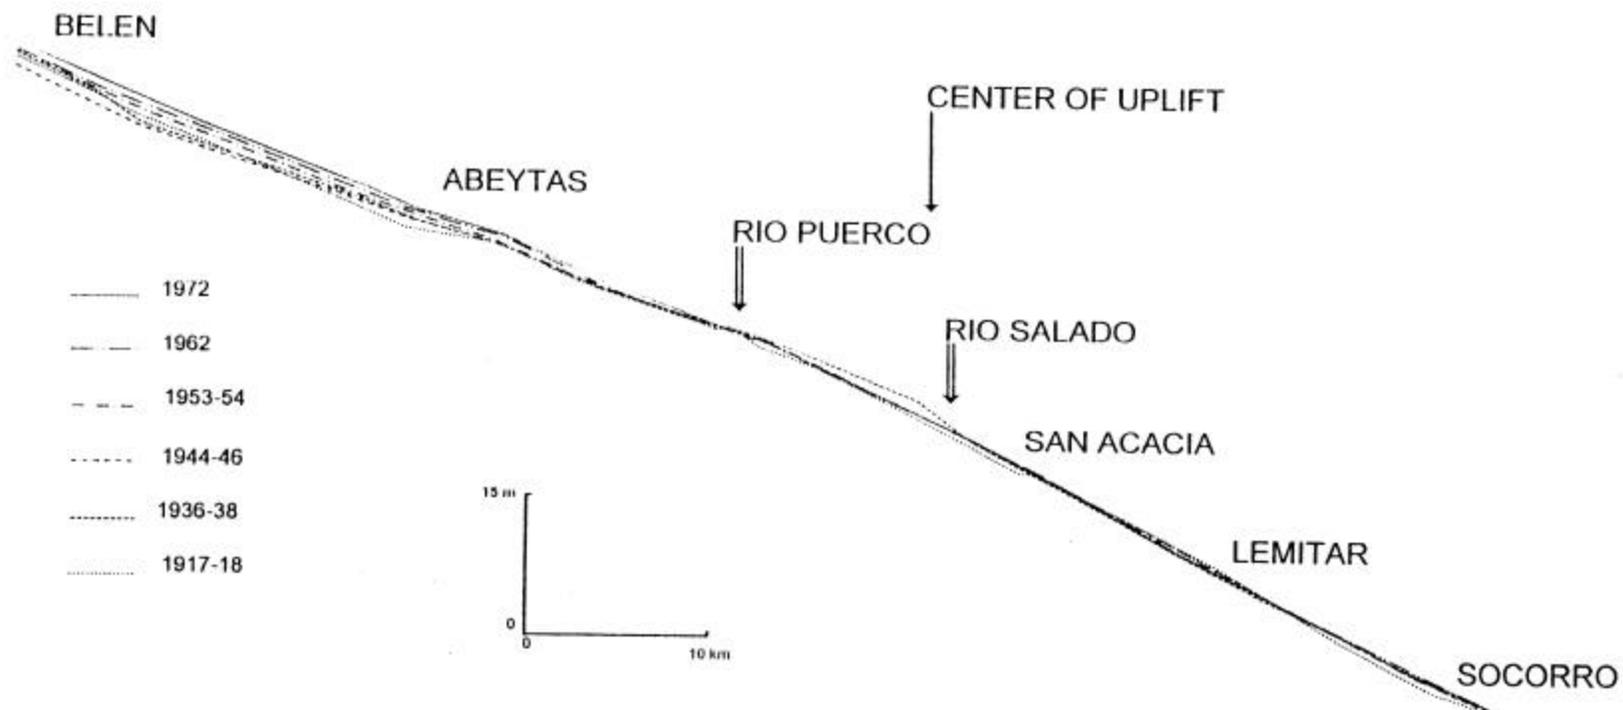
Figure 3.2. Longitudinal profiles of the Rio Grande from Belen to Socorro (Ouchi, 1983).

The longitudinal profile of the Middle Rio Grande shows a large convexity in the uplifted area (Figure 2.10). A more detailed profile showing aggradation and degradation between 1917 and 1972 before Cochiti Dam came into operation clearly illustrates the zone of uplift and the resulting convexity of the Rio Grande profile between Belen and Socorro (**Figure 3.2**).

Major deposition by the 1929 flood from Rio Puerco and Rio Salado appears on the 1936-1938 profile as a small convexity on the larger convexity from the mouth of the Rio Puerco to San Acacia (Figure 3.2). This convexity was removed by 1944, probably by Rio Grande floods in 1937 and 1941. Therefore, local deposition is not the cause of the convexity in the Rio Grande thalweg profile. The fact that the center and areal expanse of the convexity almost perfectly coincides with the uplift indicates that it is caused by the uplift (Ouchi, 1985). In addition, there are terraces in the central area of uplift that display marked upward convexity.

Aggradation, which has been a problem in the Middle Rio Grande, is affected by the uplift. There was aggradation between 1917 and 1972 upstream of the Rio Puerco. Aggradation can be explained by the slope reduction of the upstream side of the uplift (Figure 3.2). The reduced discharge of the Rio Grande and increased sediment supply from tributaries since the late 19<sup>th</sup> century probably accelerated this aggradation (Happ, 1948). In the reach from Lemitar to the downstream limit of the uplift, sediment derived from the uplift has caused aggradation (Figure 3.2).

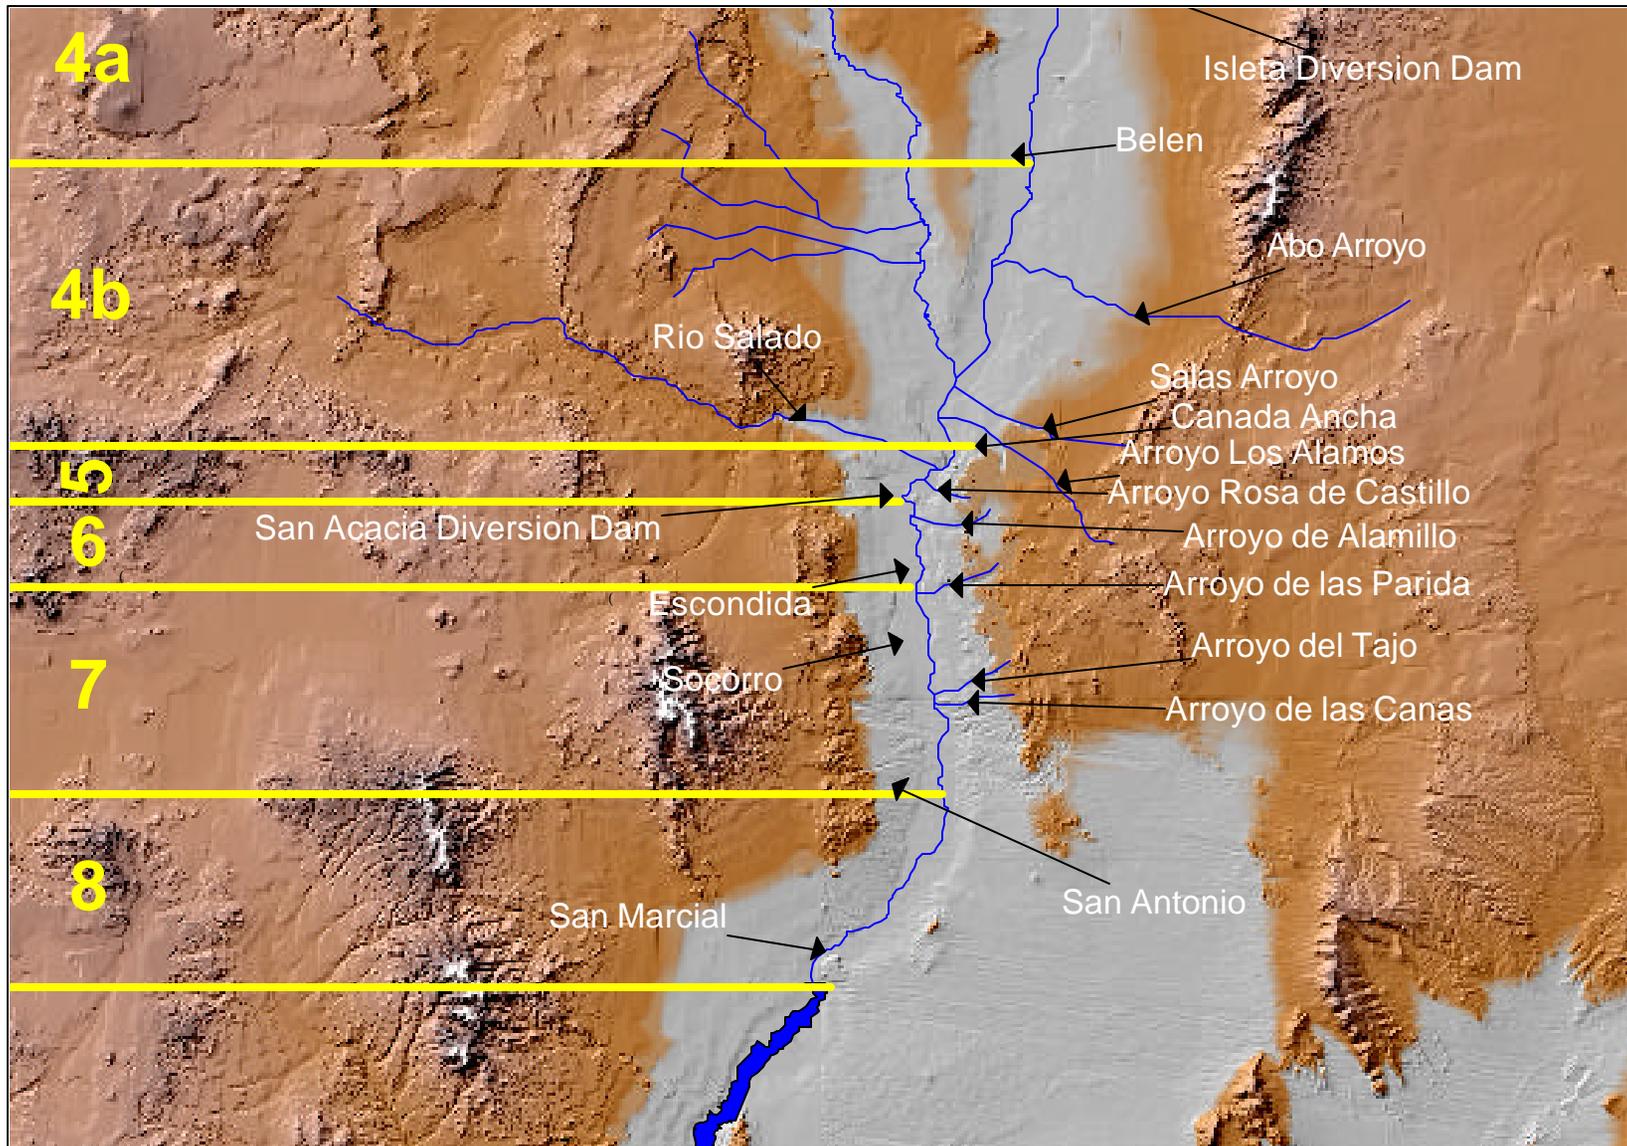
Figure 3.3. Map of the Rio Grande valley centered on Socorro showing the effects of the Joyita Uplift on the local geology and topography, as well as the frequency of the east-side tributaries.

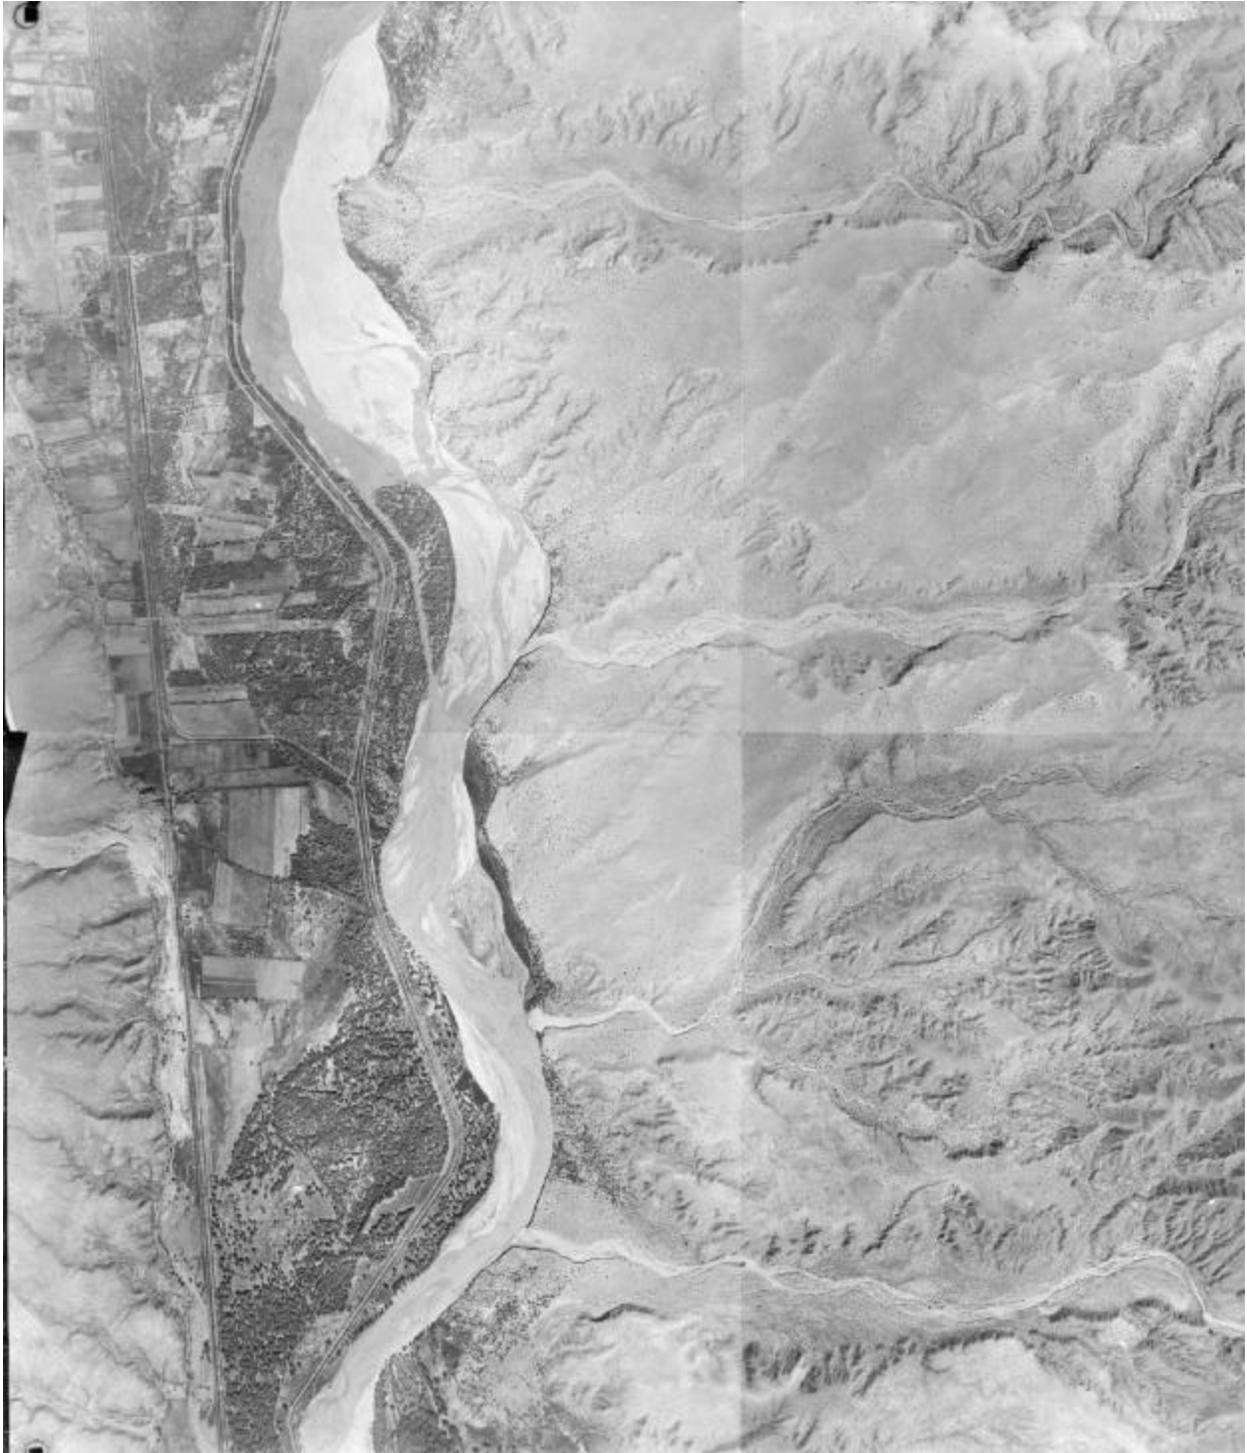
Figure 3.4. 1935 aerial photograph (#5925A) showing the high frequency of east-side tributary arroyos draining the Joyita Uplift in Reach 6, and delivering sediment to the Rio Grande. The reach of the river is located near Socorro, between RM 96 and RM 102.

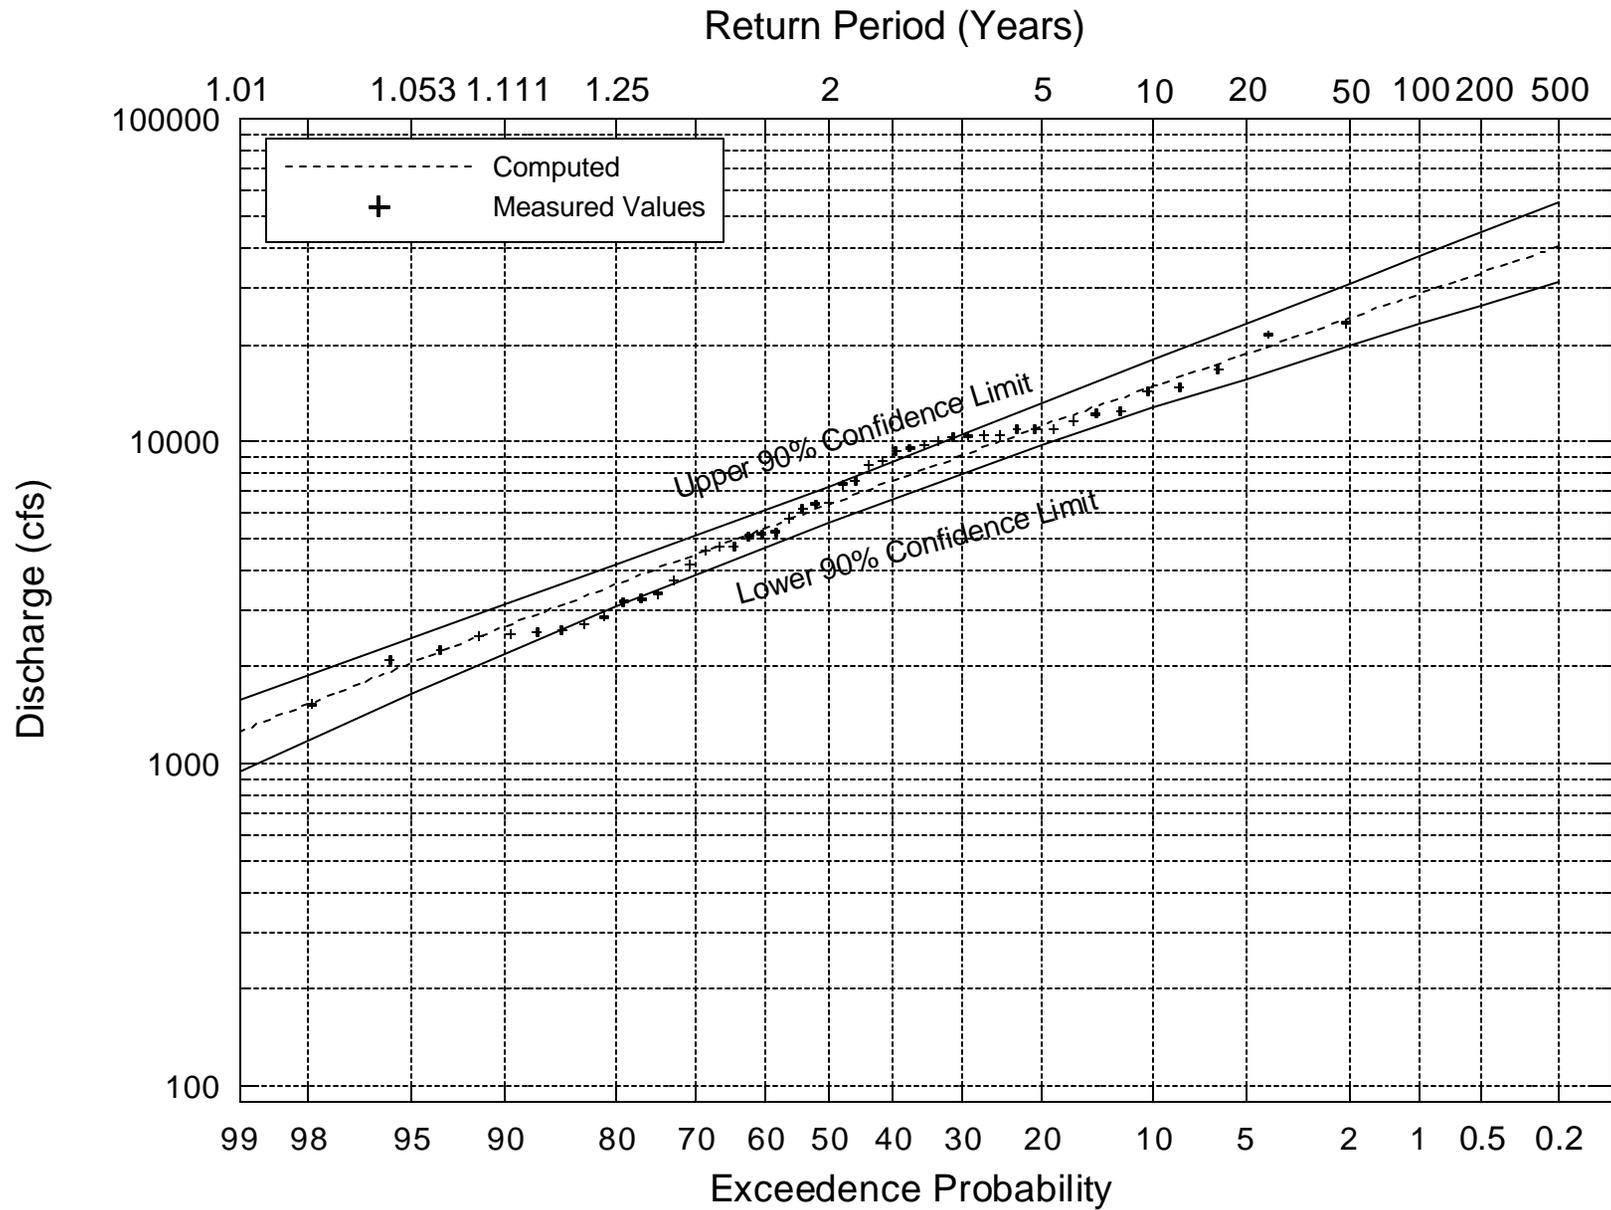
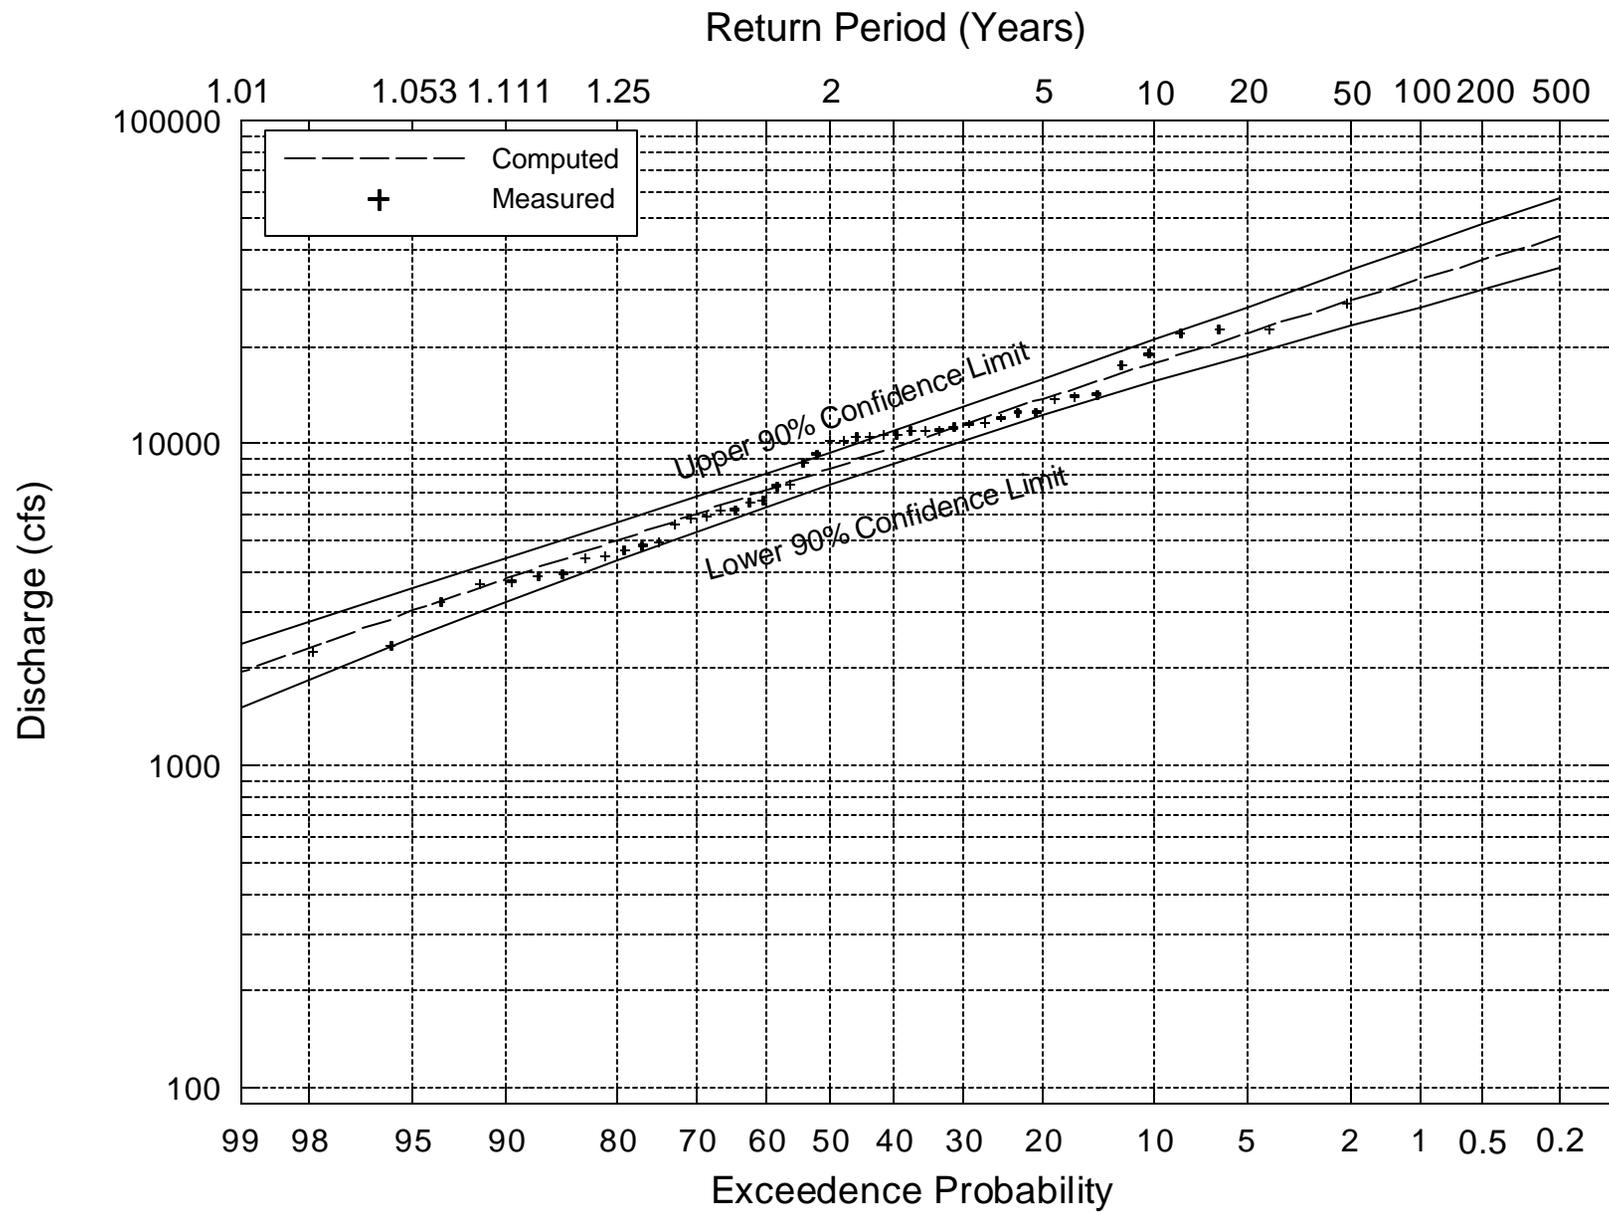
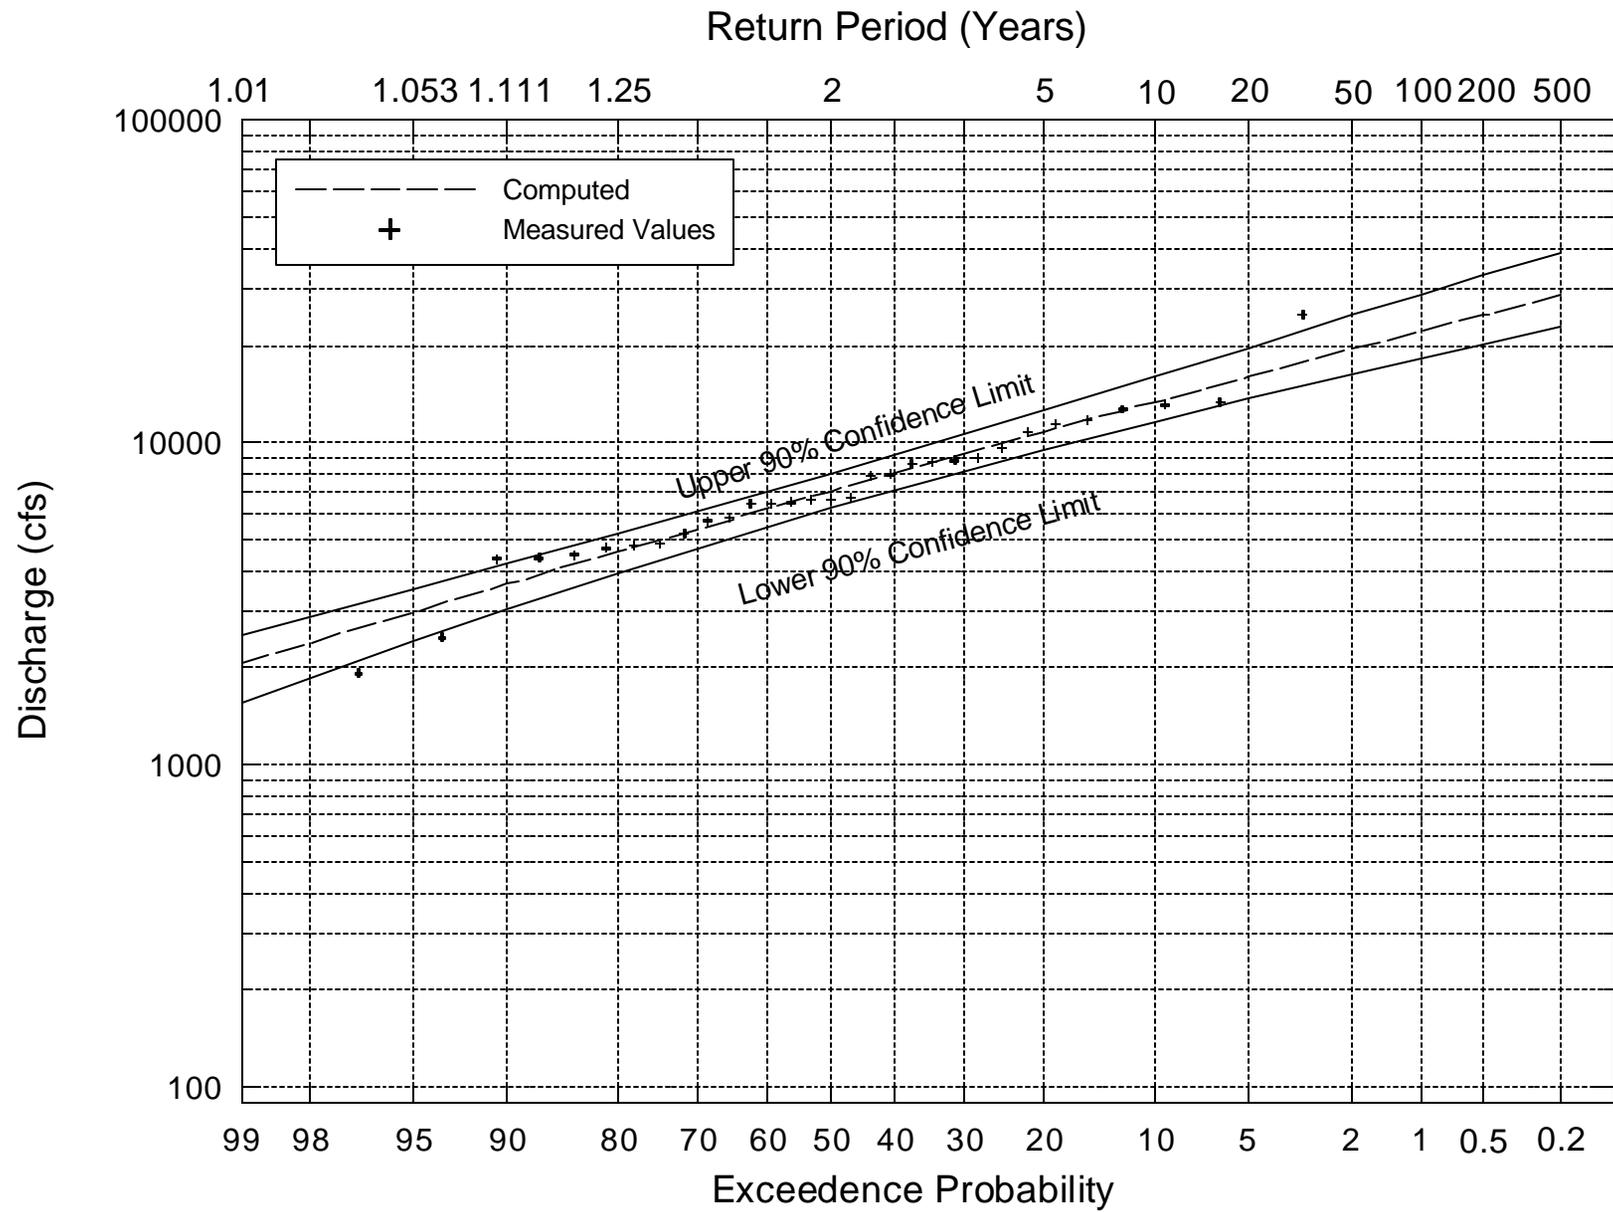
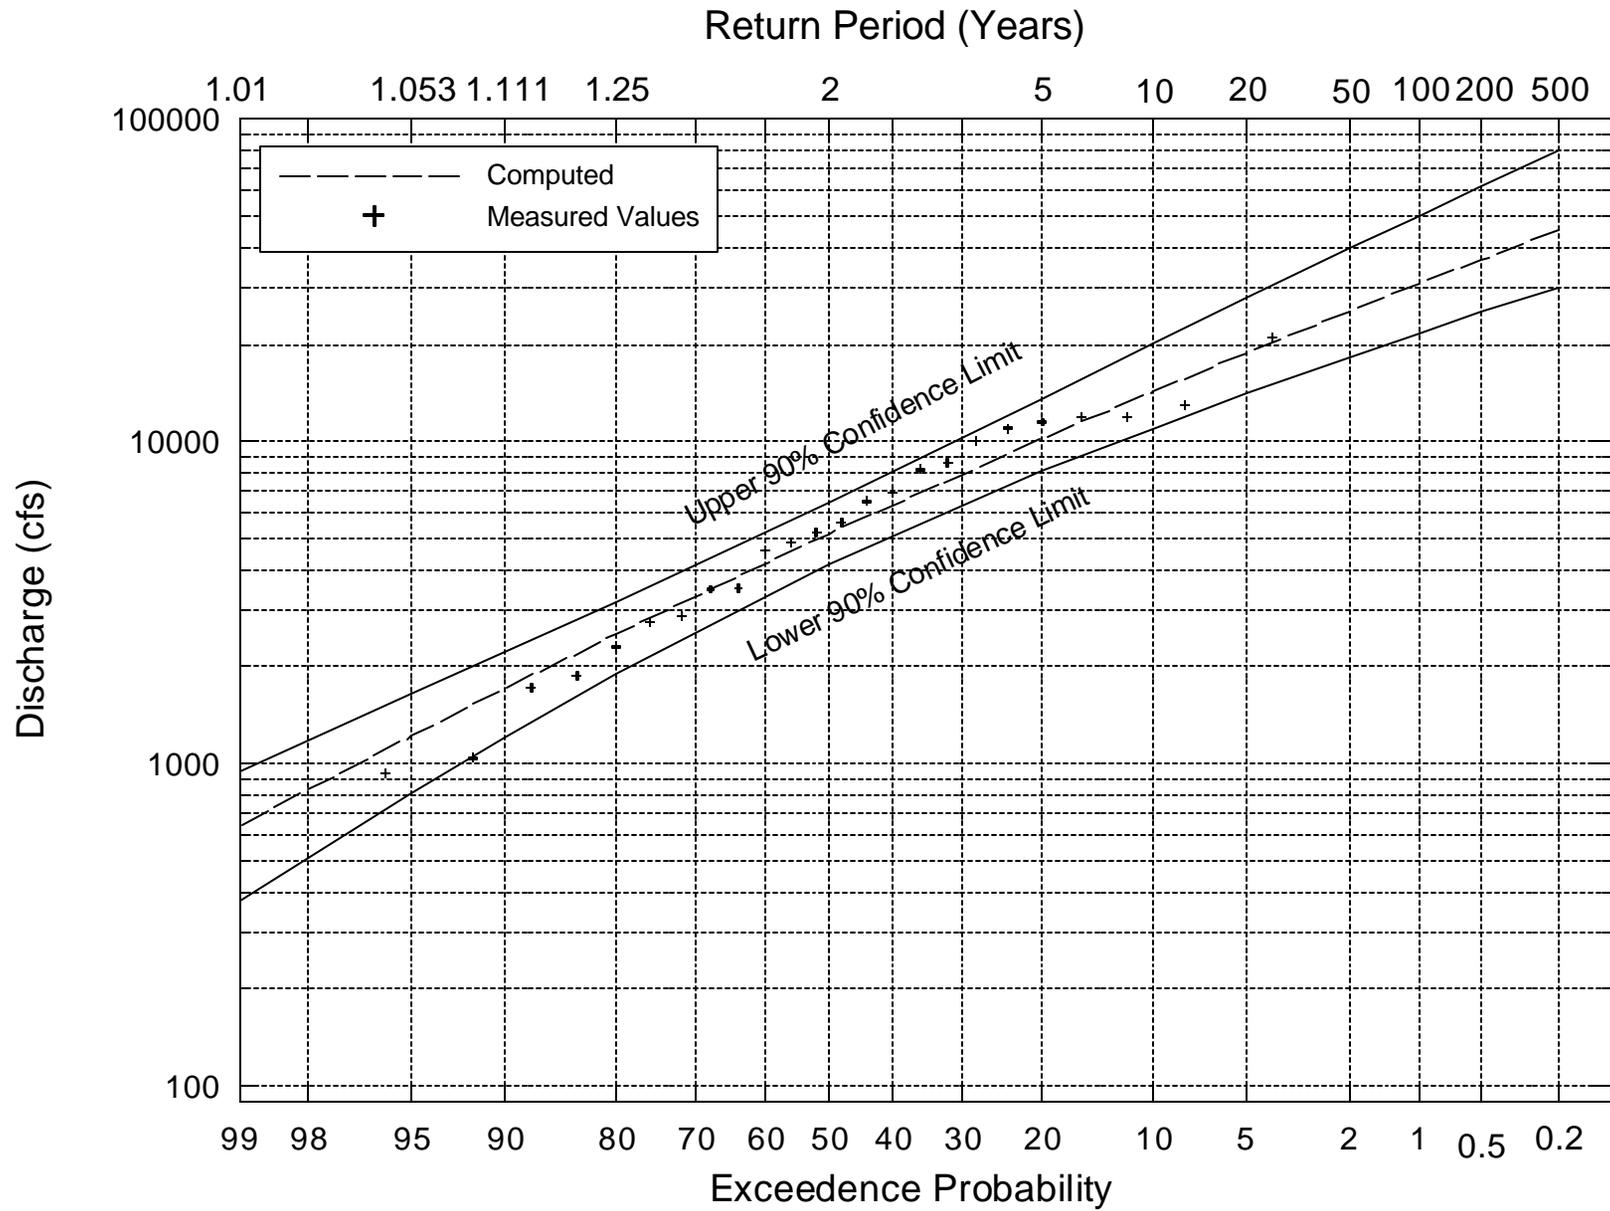
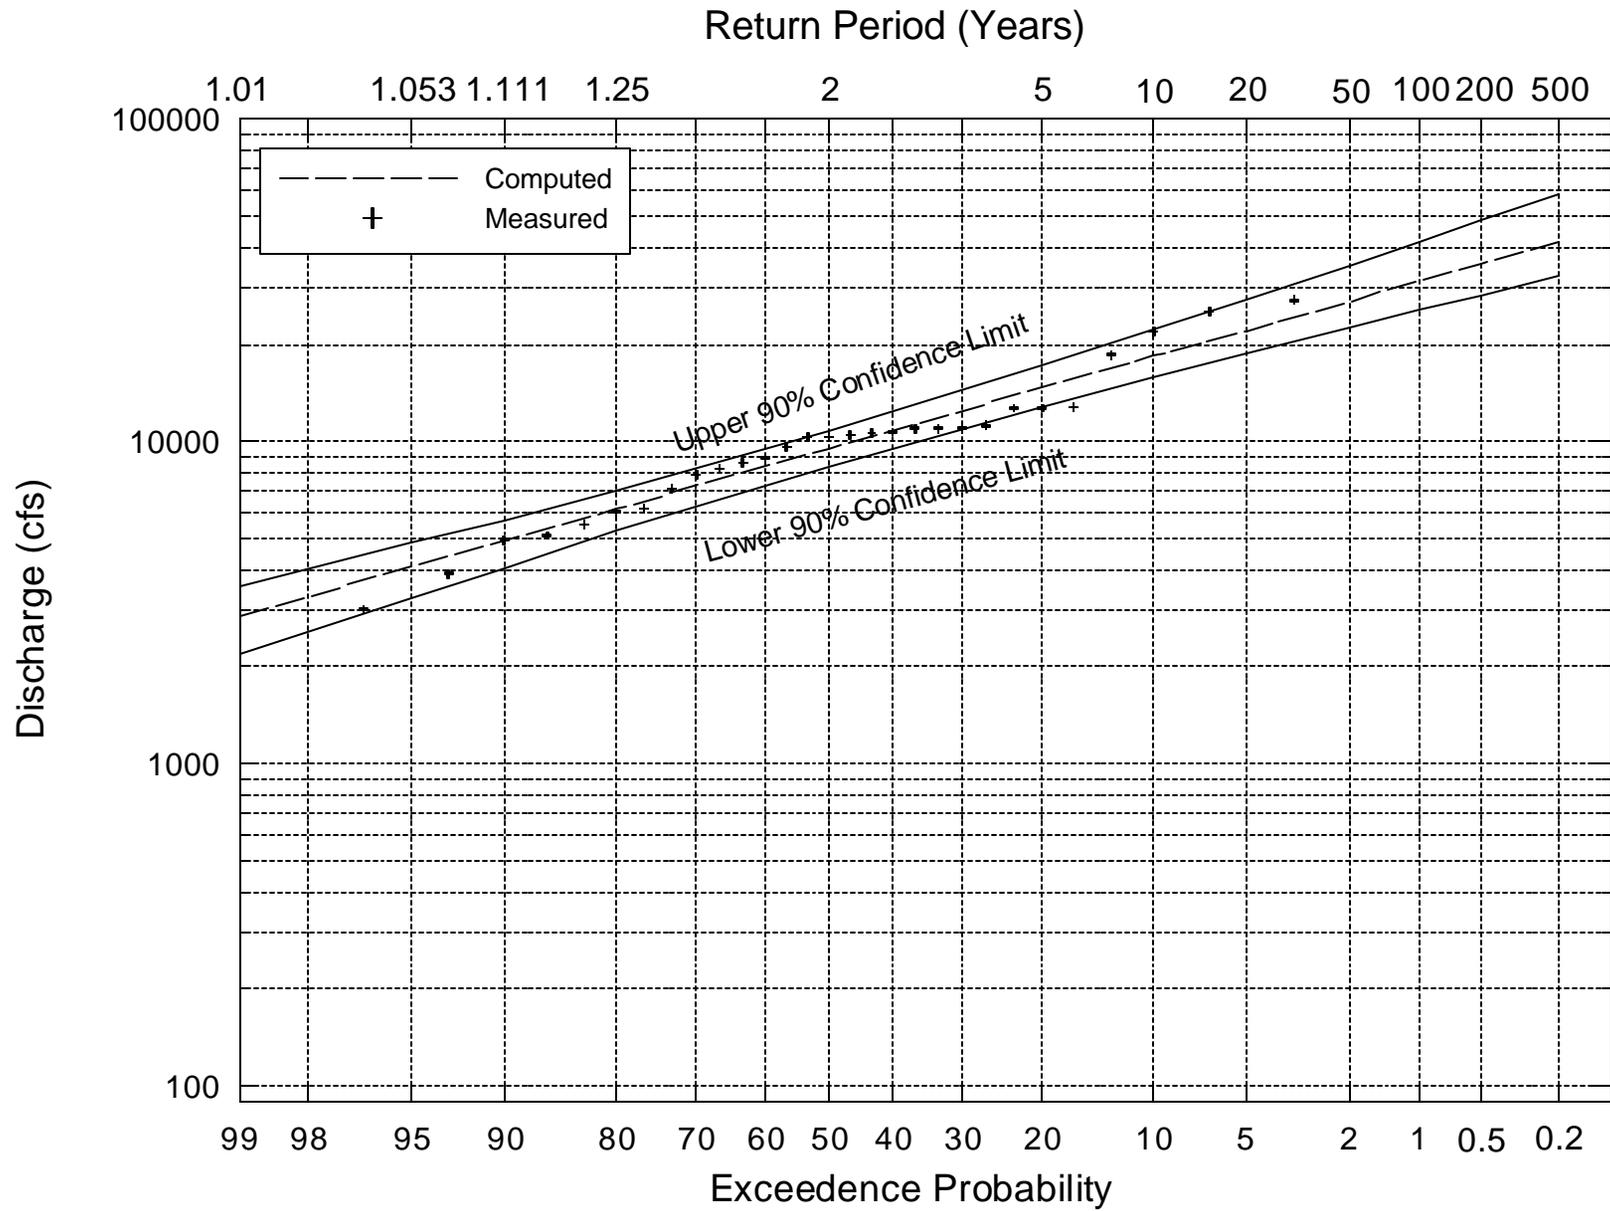
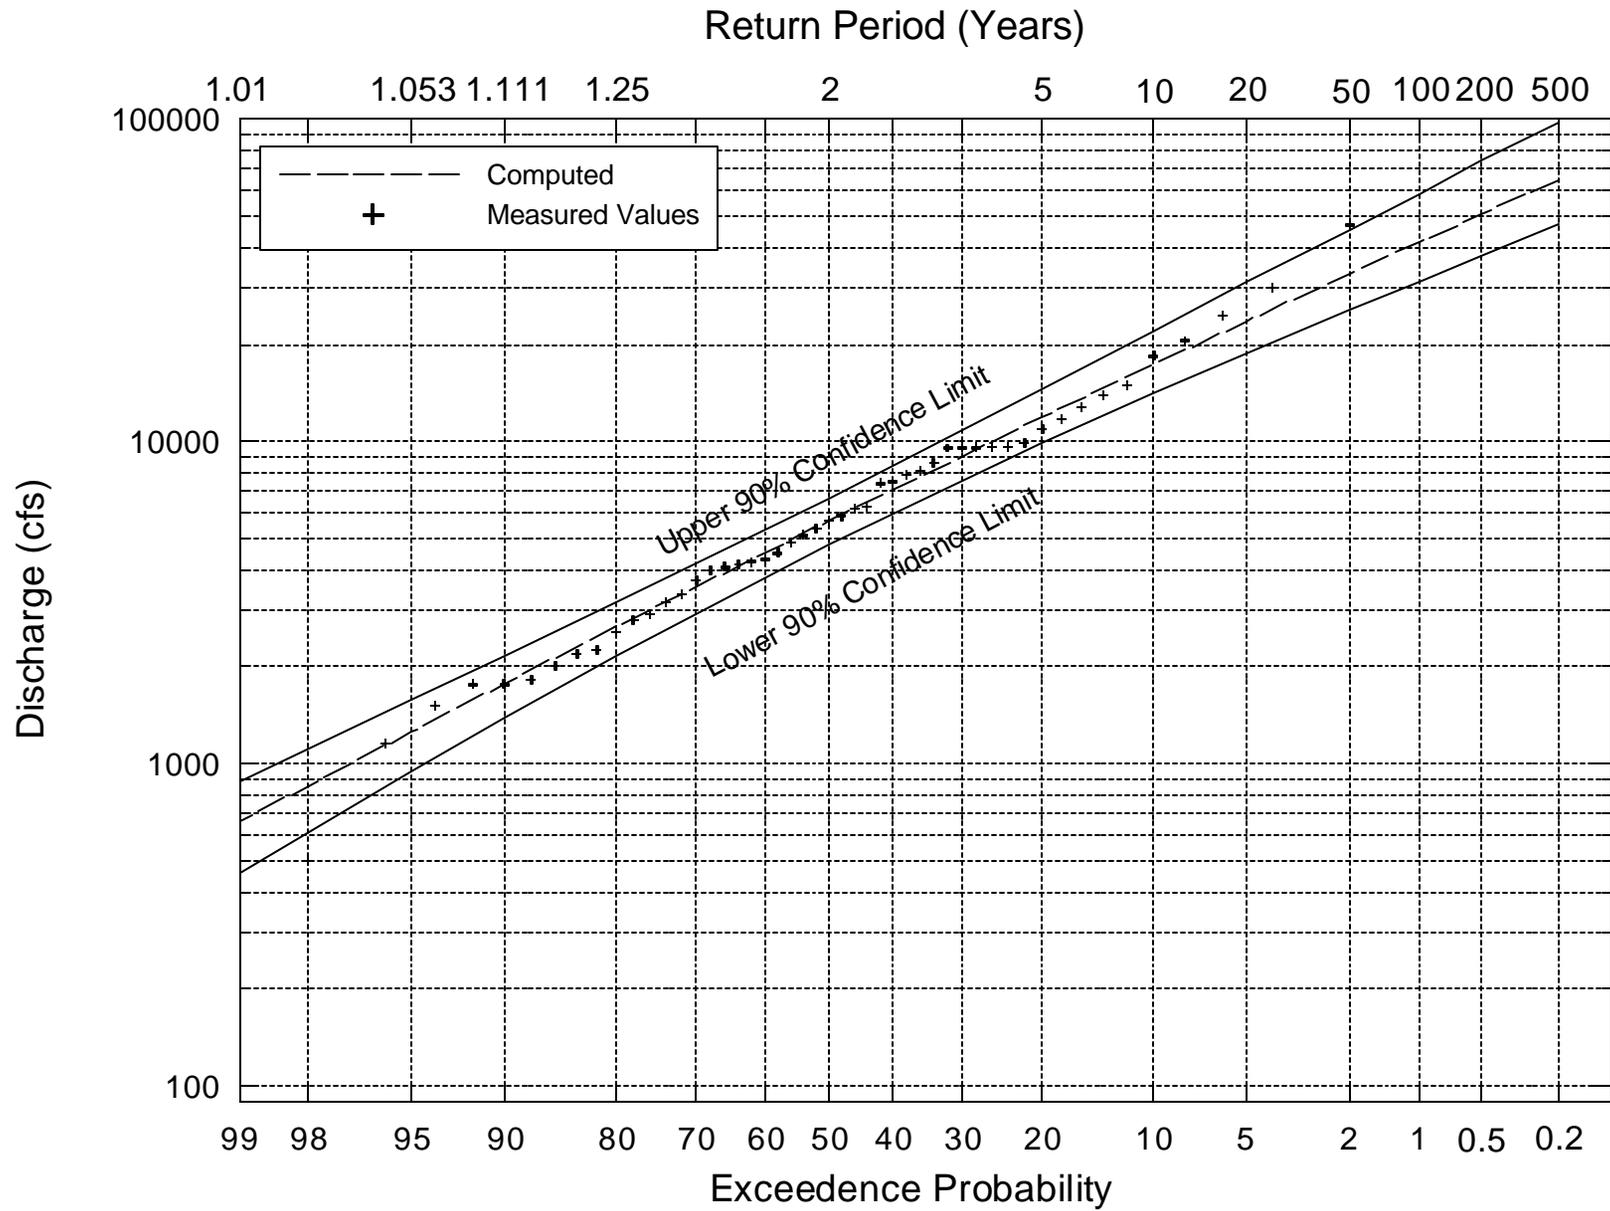
Figure 3.5. Pre-Cochiti flood-frequency curve for the Cochiti gage, based on the period of record between 1927 and 1973.

Figure 3.6. Pre-Cochiti flood-frequency curve for the San Felipe gage, based on the period of record between 1927 and 1973.

Figure 3.7. Pre-Cochiti flood-frequency curve for the Albuquerque gage, based on the period of record between 1942 and 1973.

Figure 3.8. Pre-Cochiti flood-frequency curve for the Bernardo gage, based on the period of record between 1929 and 1973.

Figure 3.9. Pre-Cochiti flood-frequency curve for the San Acacia gage, based on the period of record between 1936 and 1973.

Figure 3.10. Pre-Cochiti flood-frequency curve for the San Marcial gage, based on the period of record between 1925 and 1973.
