# 1. INTRODUCTION

## 1.1. Background

The Middle Rio Grande, as defined in this report, is that part of the Rio Grande in New Mexico that extends from Cochiti Dam to Elephant Butte Reservoir, a distance of about 165 miles (**Figure 1.1**). The Rio Grande valley has been a home to the Pueblo people, Spanish colonizers, and Americans (Horgan, 1954; Crawford et al., 1993). The valley has a complex geomorphic and geologic history (Belcher, 1975) and hydrologic conditions are unusual (Graf, 1994). For example, discharge decreases as the river flows from areas of higher to lower precipitation (**Figure 1.2**). However, contributions from Rio Puerco and Rio Salado increase flood peaks between Albuquerque and San Marcial (**Figure 1.3**). Both suspended load and bed load are increased dramatically by contributions from the Rio Puerco and Rio Salado (**Figures 1.4 and 1.5**).

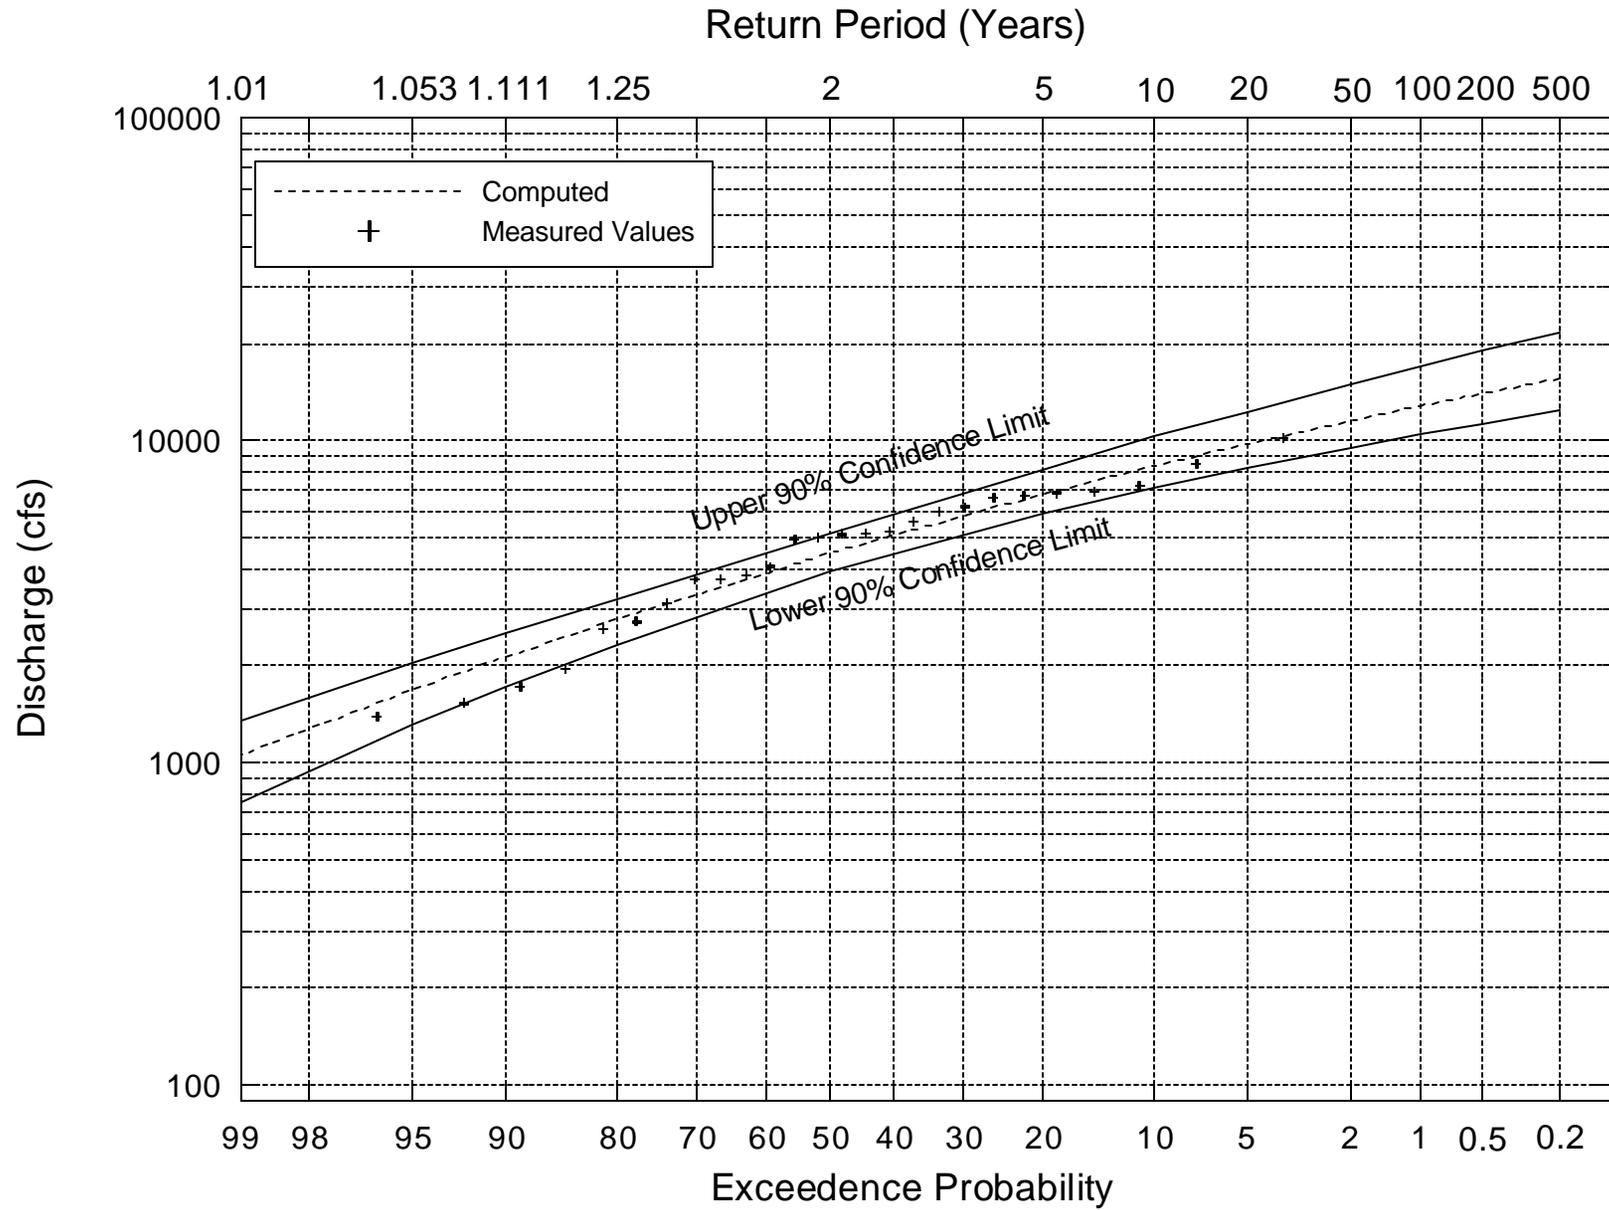
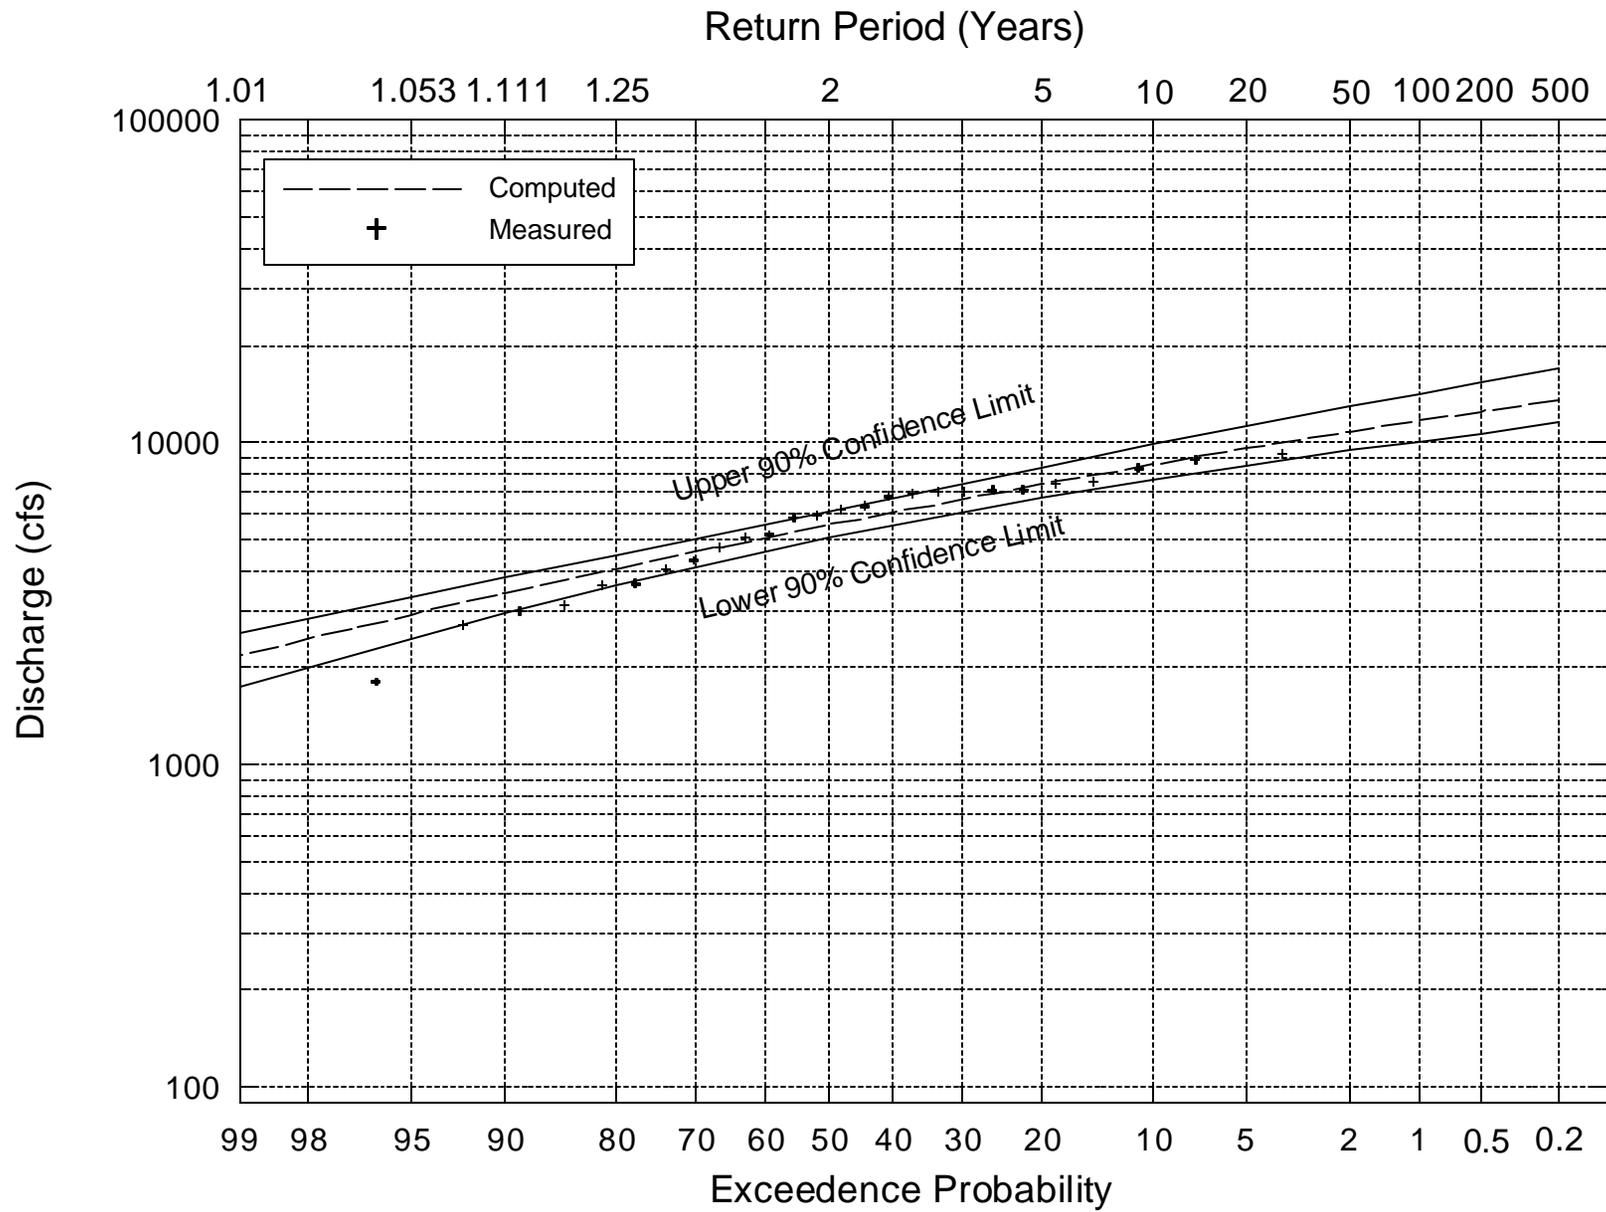
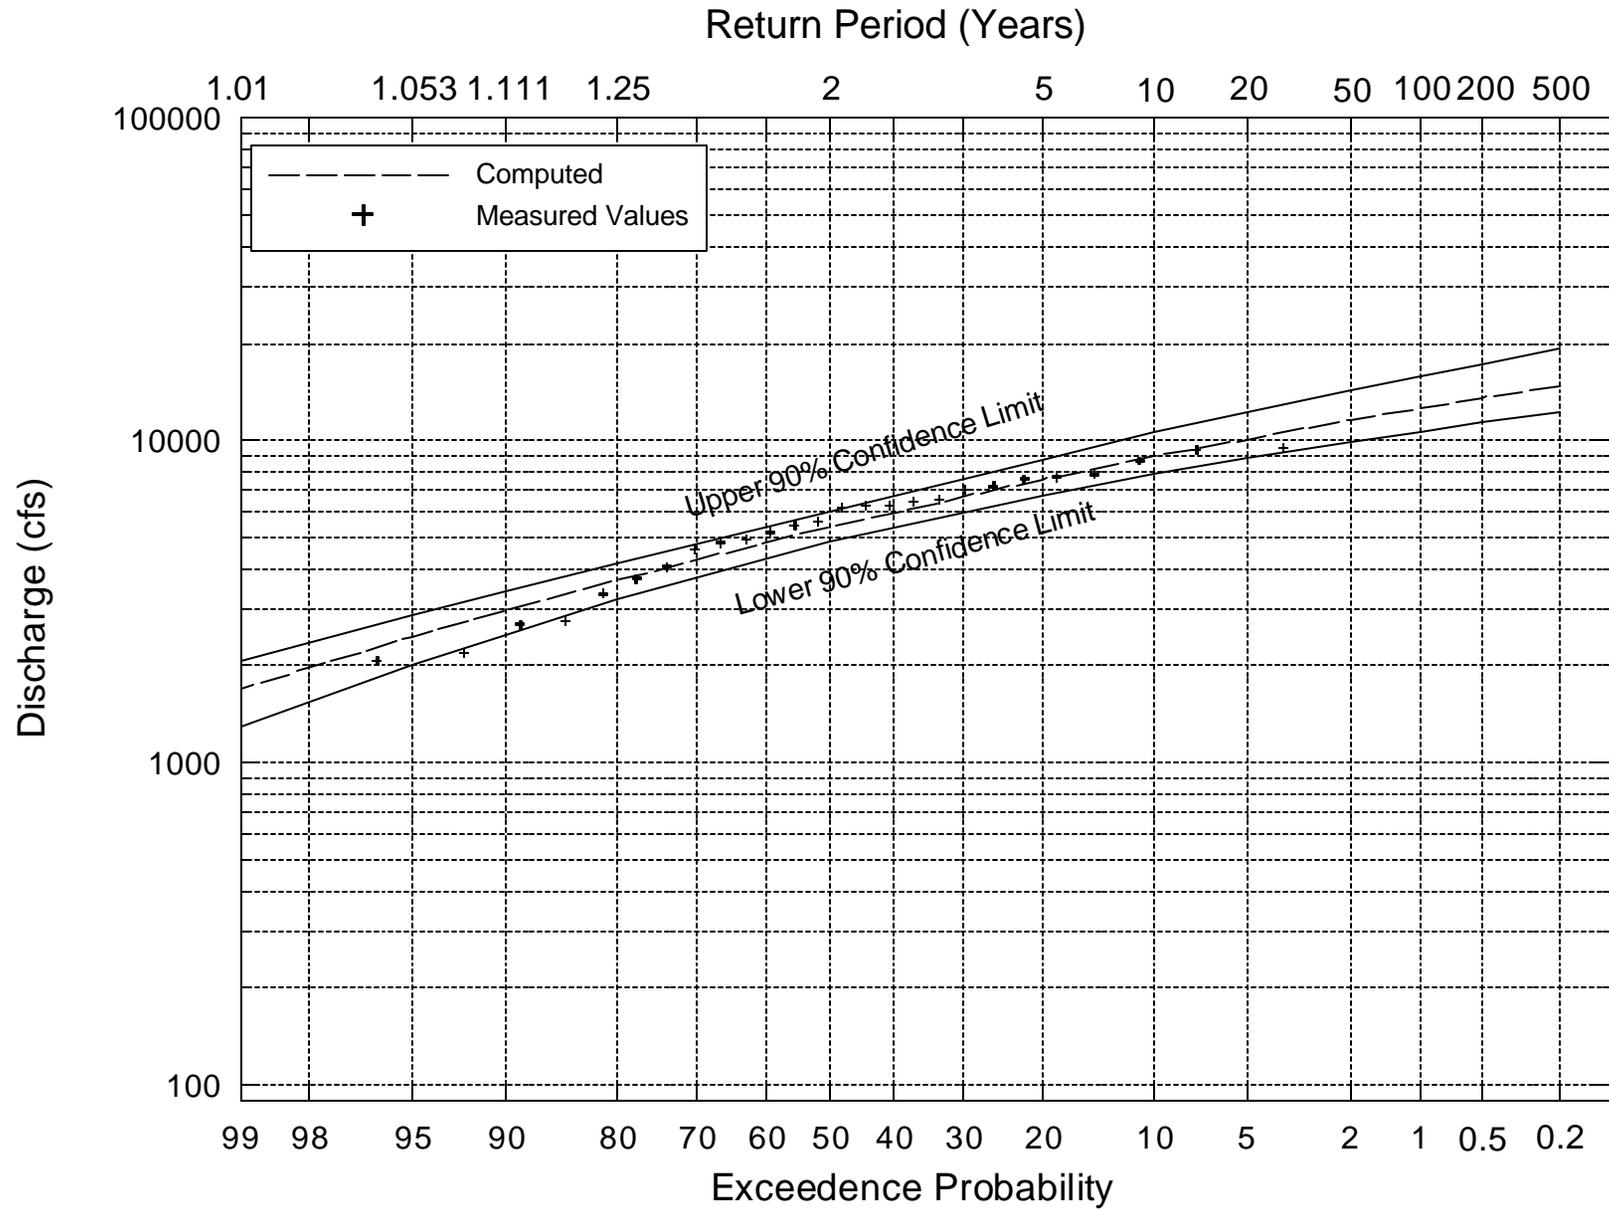
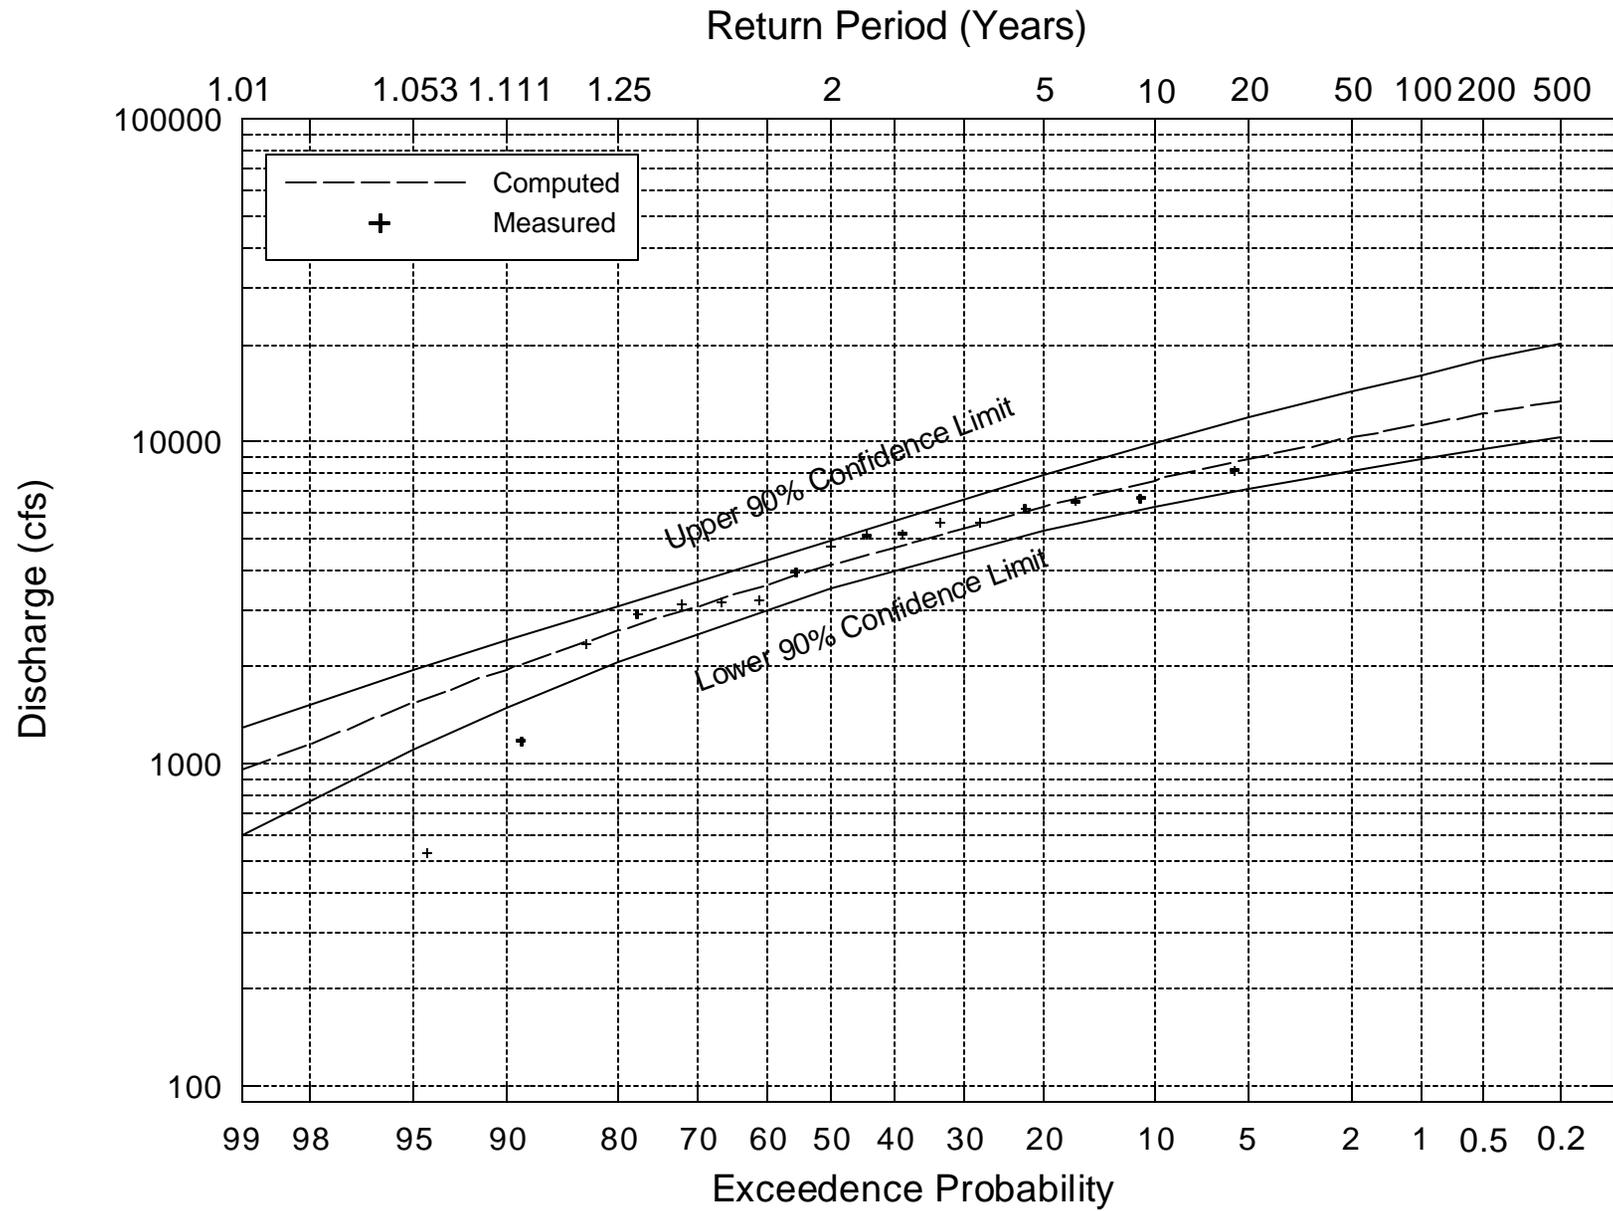
Figure 3.11. Post-Cochiti flood-frequency curve for the Cochiti gage, based on the period of record between 1974 and 1999.

Figure 3.12. Post-Cochiti flood-frequency curve for the San Felipe gage, based on the period of record between 1974 and 1999.

Figure 3.13. Post-Cochiti flood-frequency curve for the Albuquerque gage, based on the period of record between 1974 and 1999.

Figure 3.14. Post-Cochiti flood-frequency curve for the San Marcial gage, based on the period of record between 1974 and 1999.

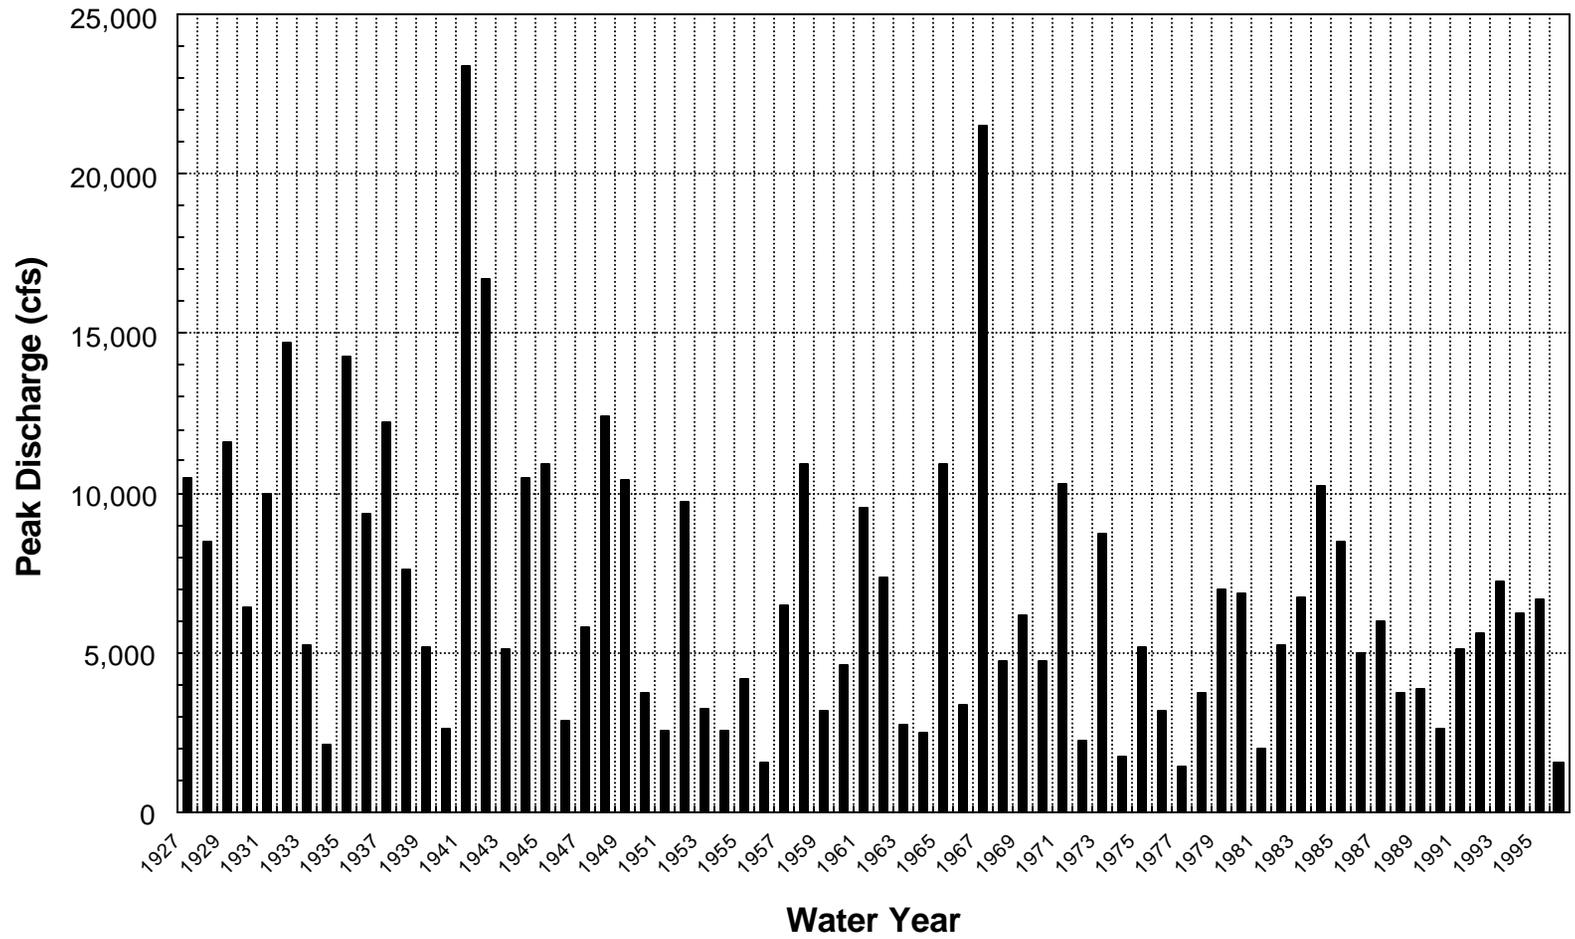
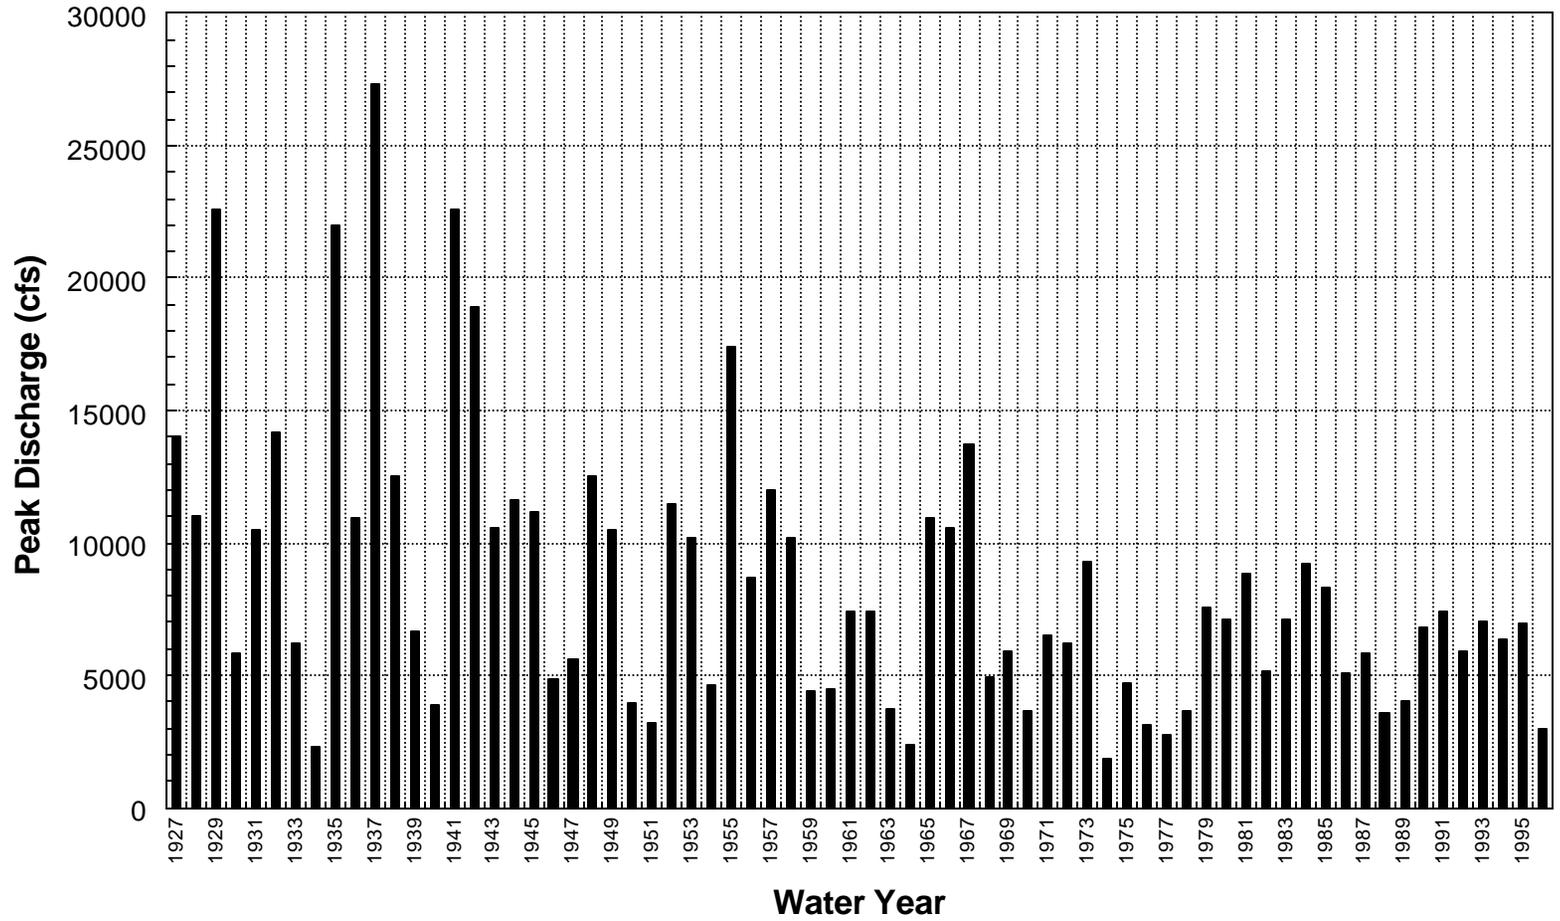
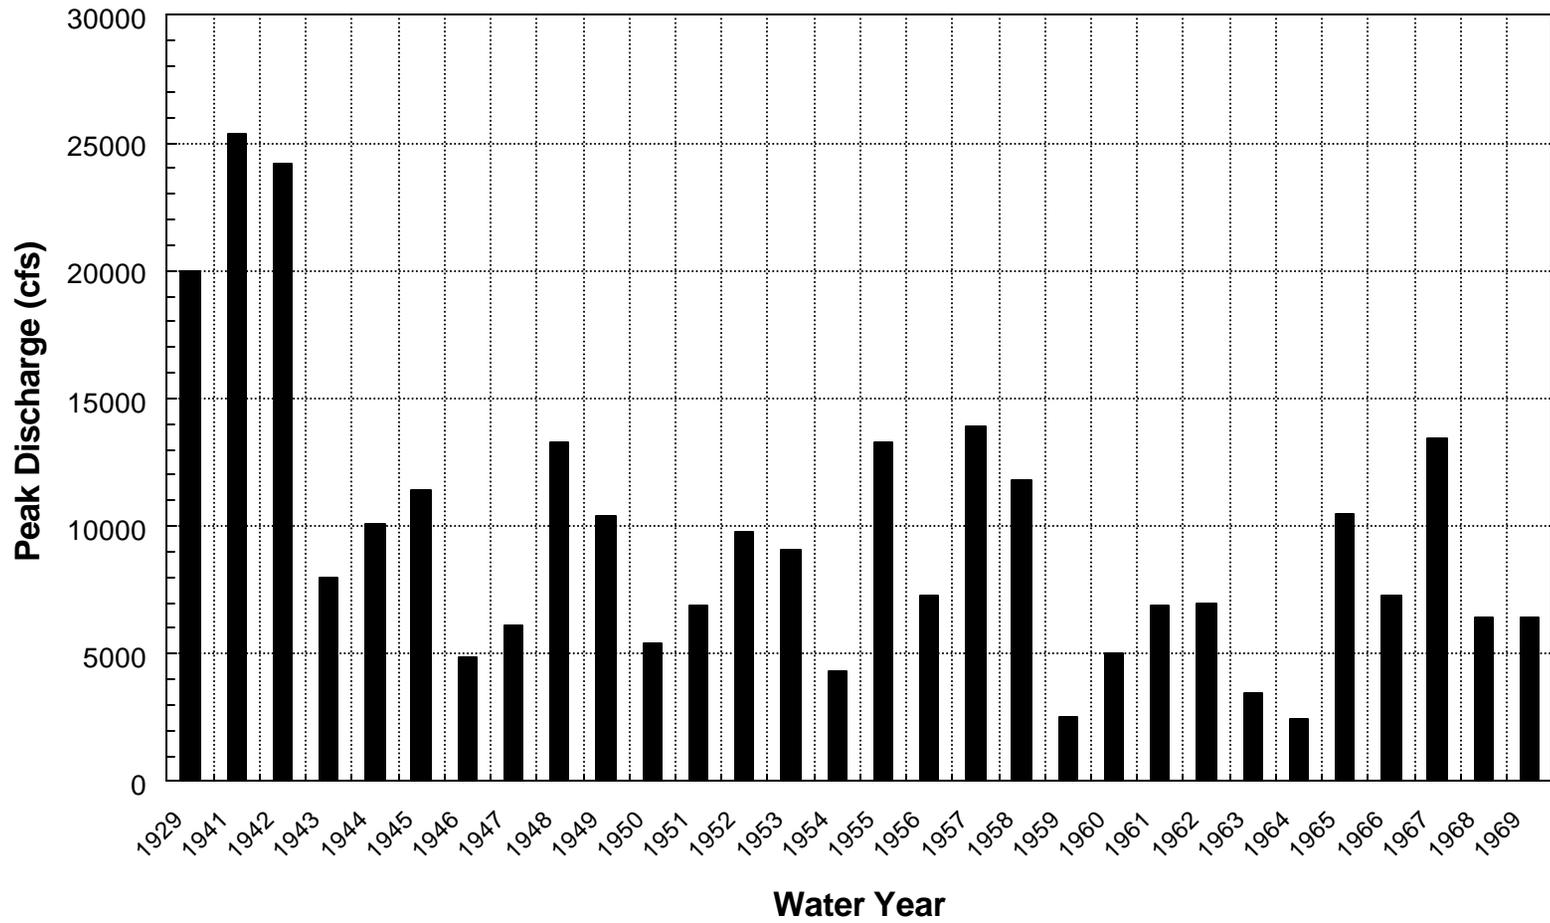
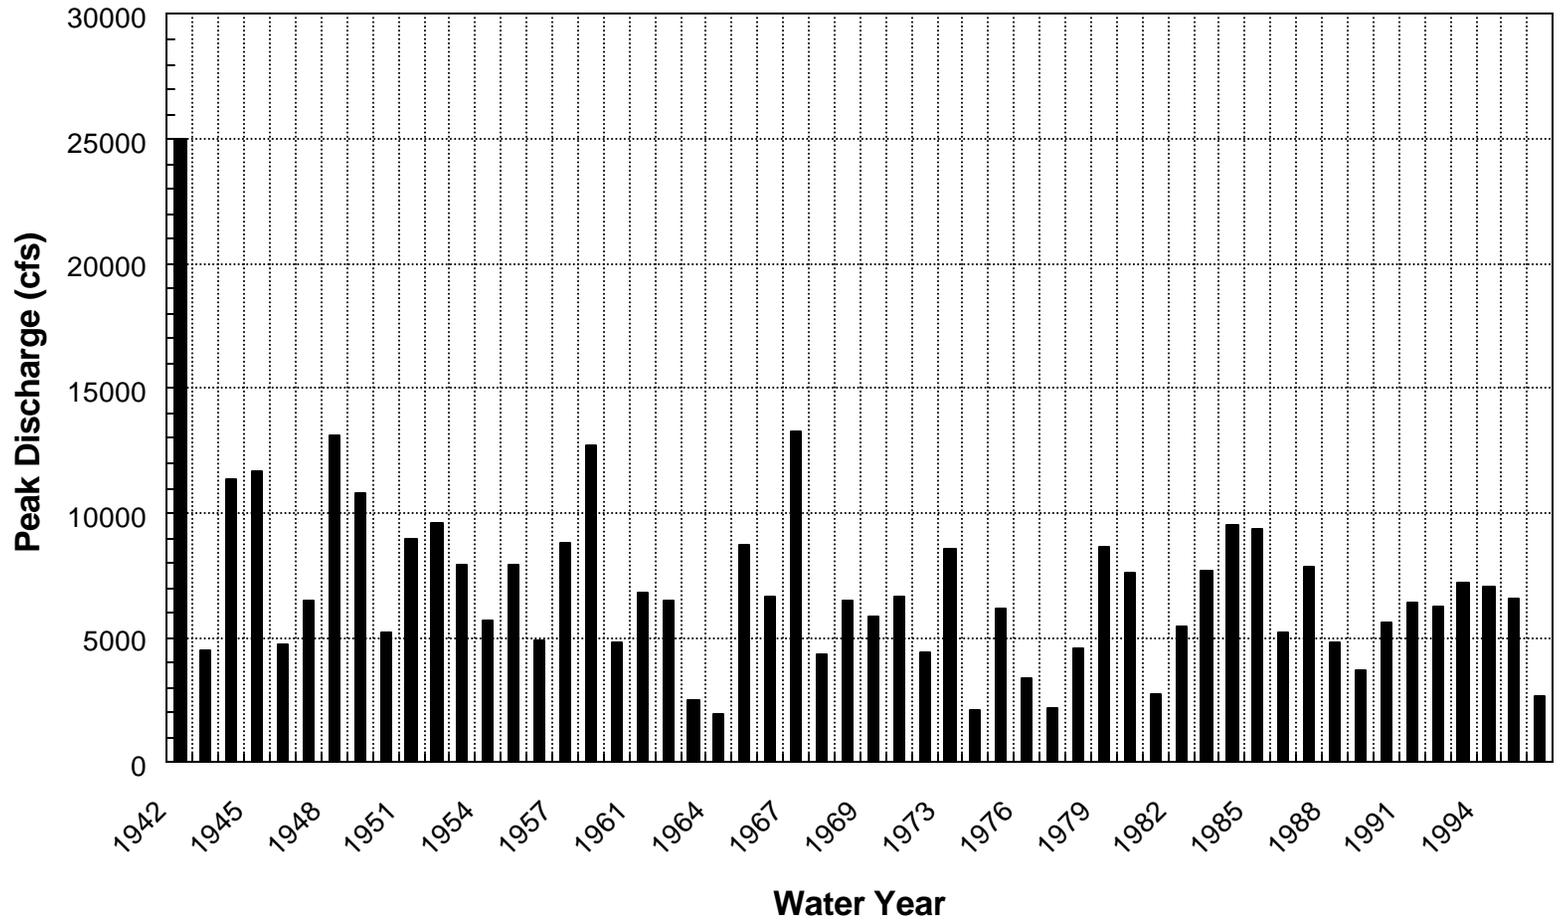
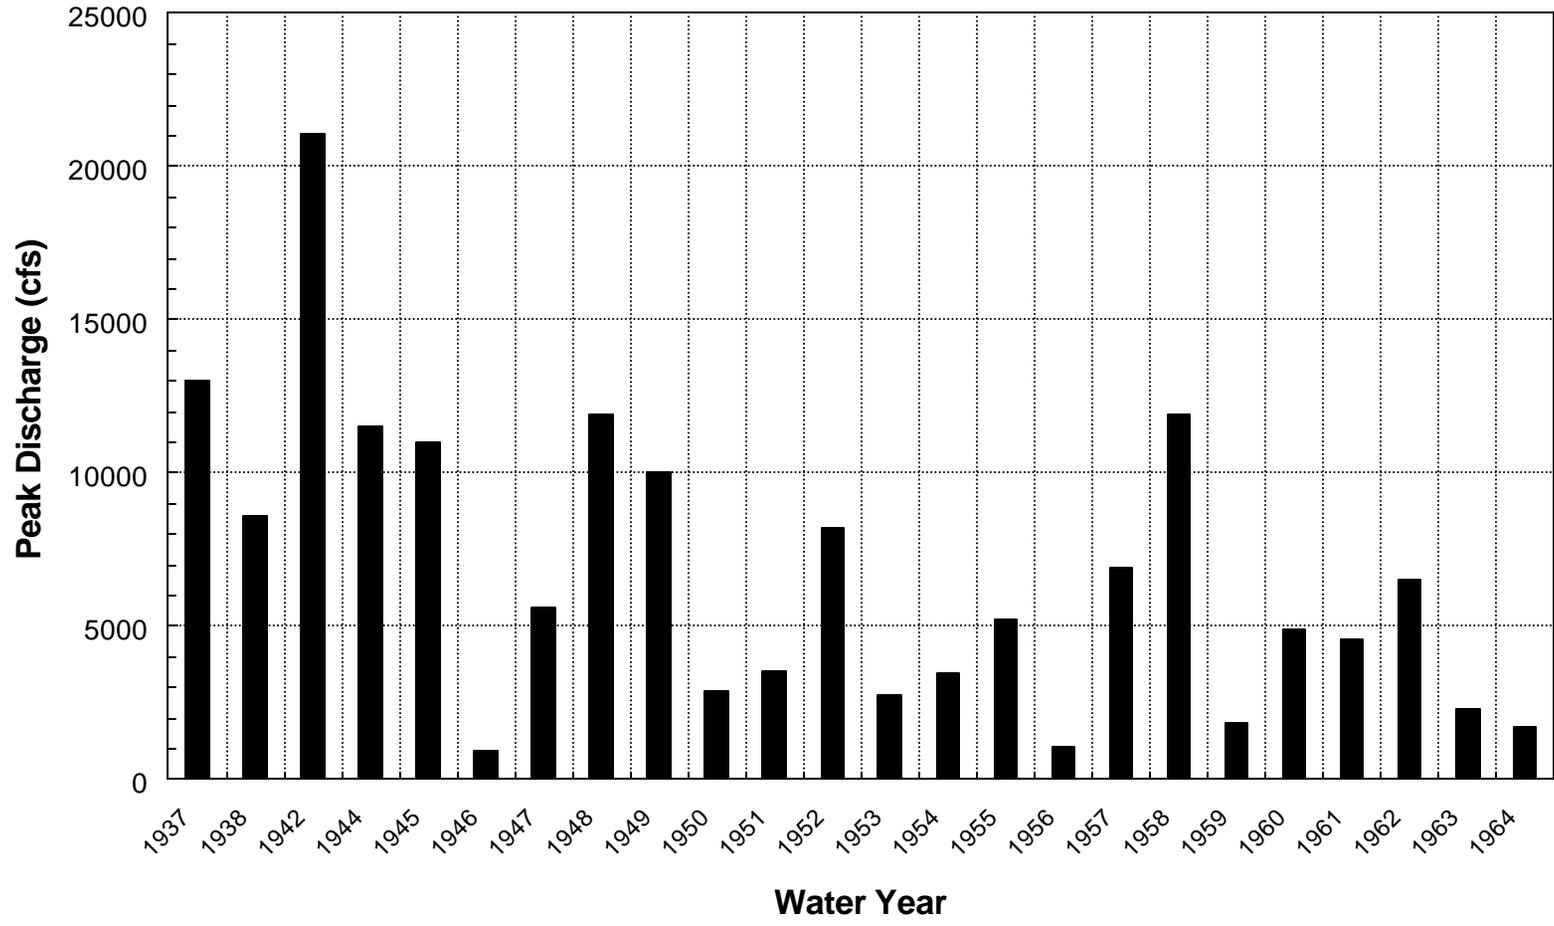
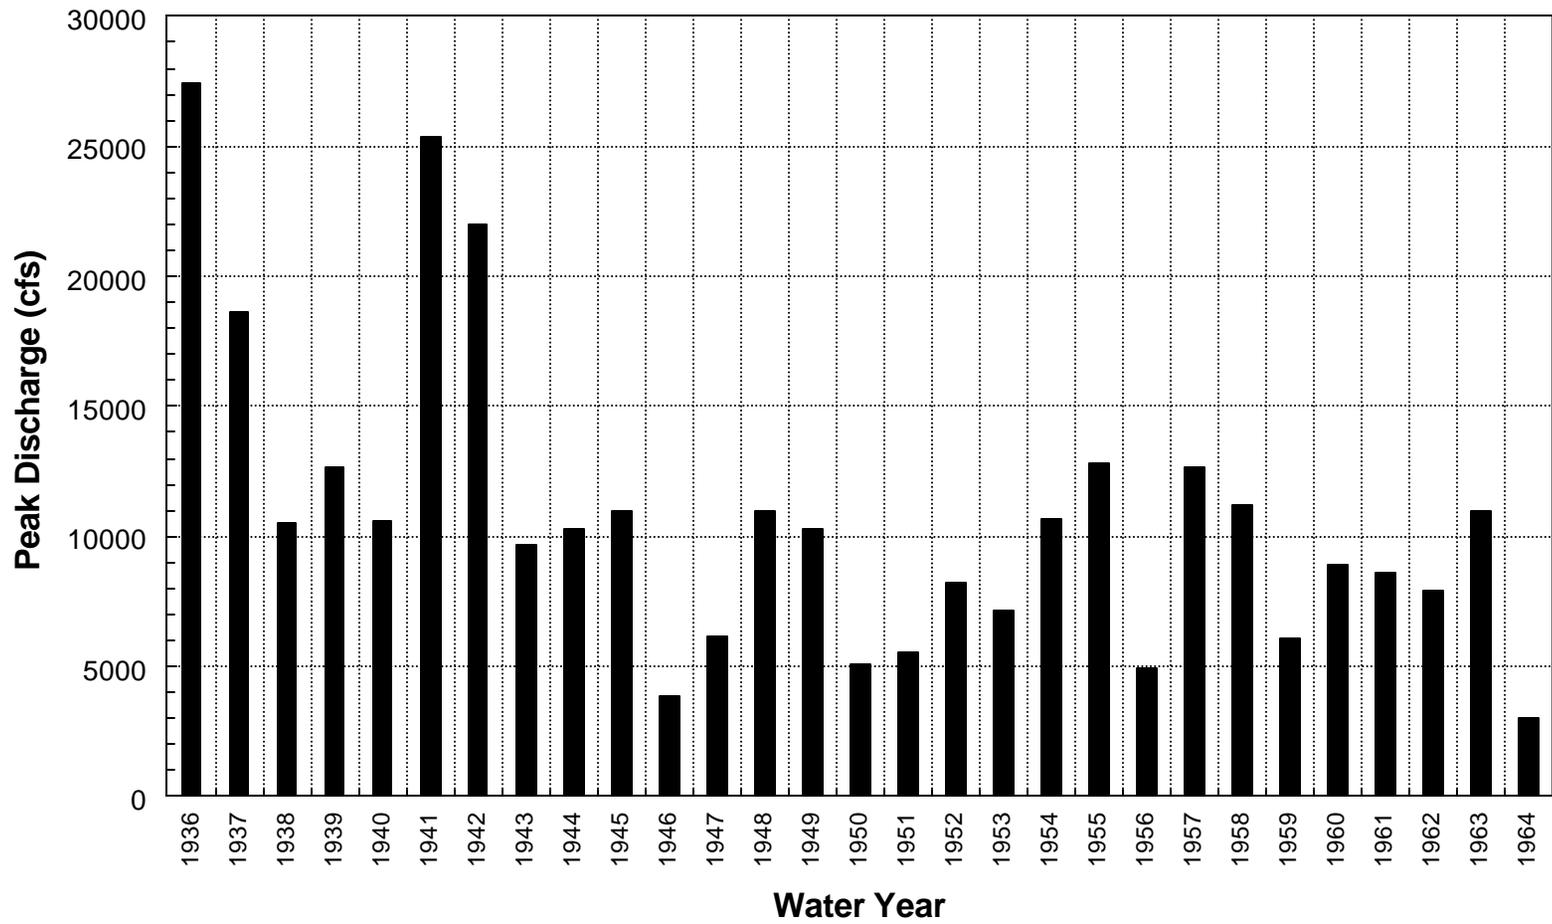
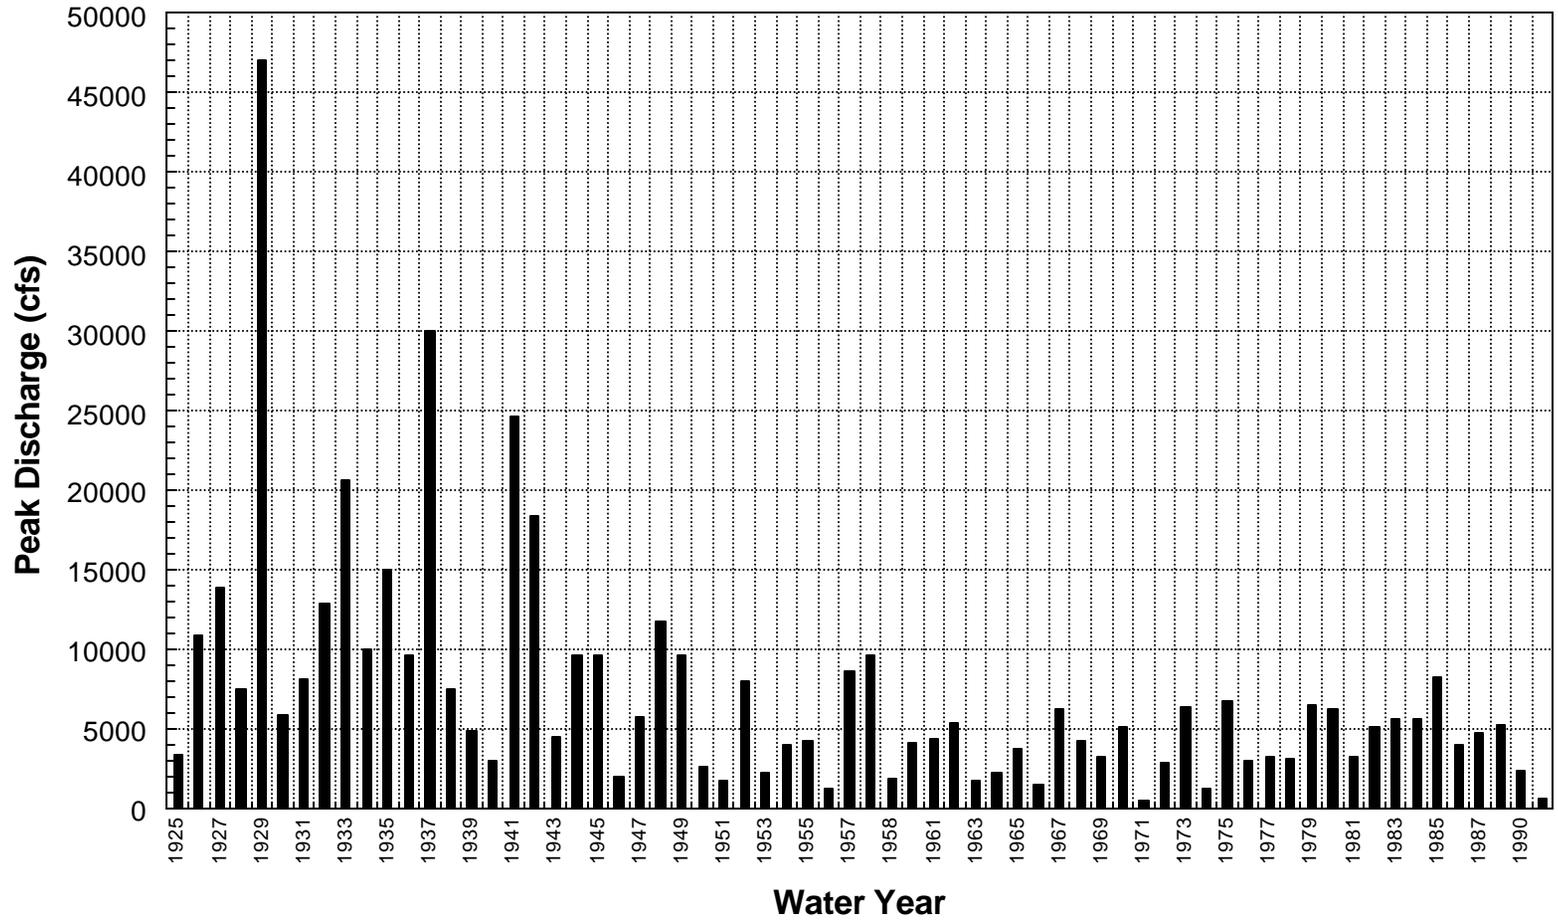
Figure 3.15. Annual maximum flood peaks for the period of record for the Cochiti gage. The data represent two separate gage locations that were necessitated by construction of Cochiti Dam.

Figure 3.16. Annual maximum flood peaks for the period of record for the San Felipe gage.

Figure 3.17. Annual maximum flood peaks for the period of record for the Bernalillo gage.

Figure 3.18. Annual maximum flood peaks for the period of record for Albuquerque gage.

Figure 3.19. Annual maximum flood peaks for the period of record for Bernardo gage.

Figure 3.20. Annual maximum flood peaks for the period of record for San Acacia gage.

Figure 3.21. Annual maximum flood peaks for the period of record for San Marcial gage.

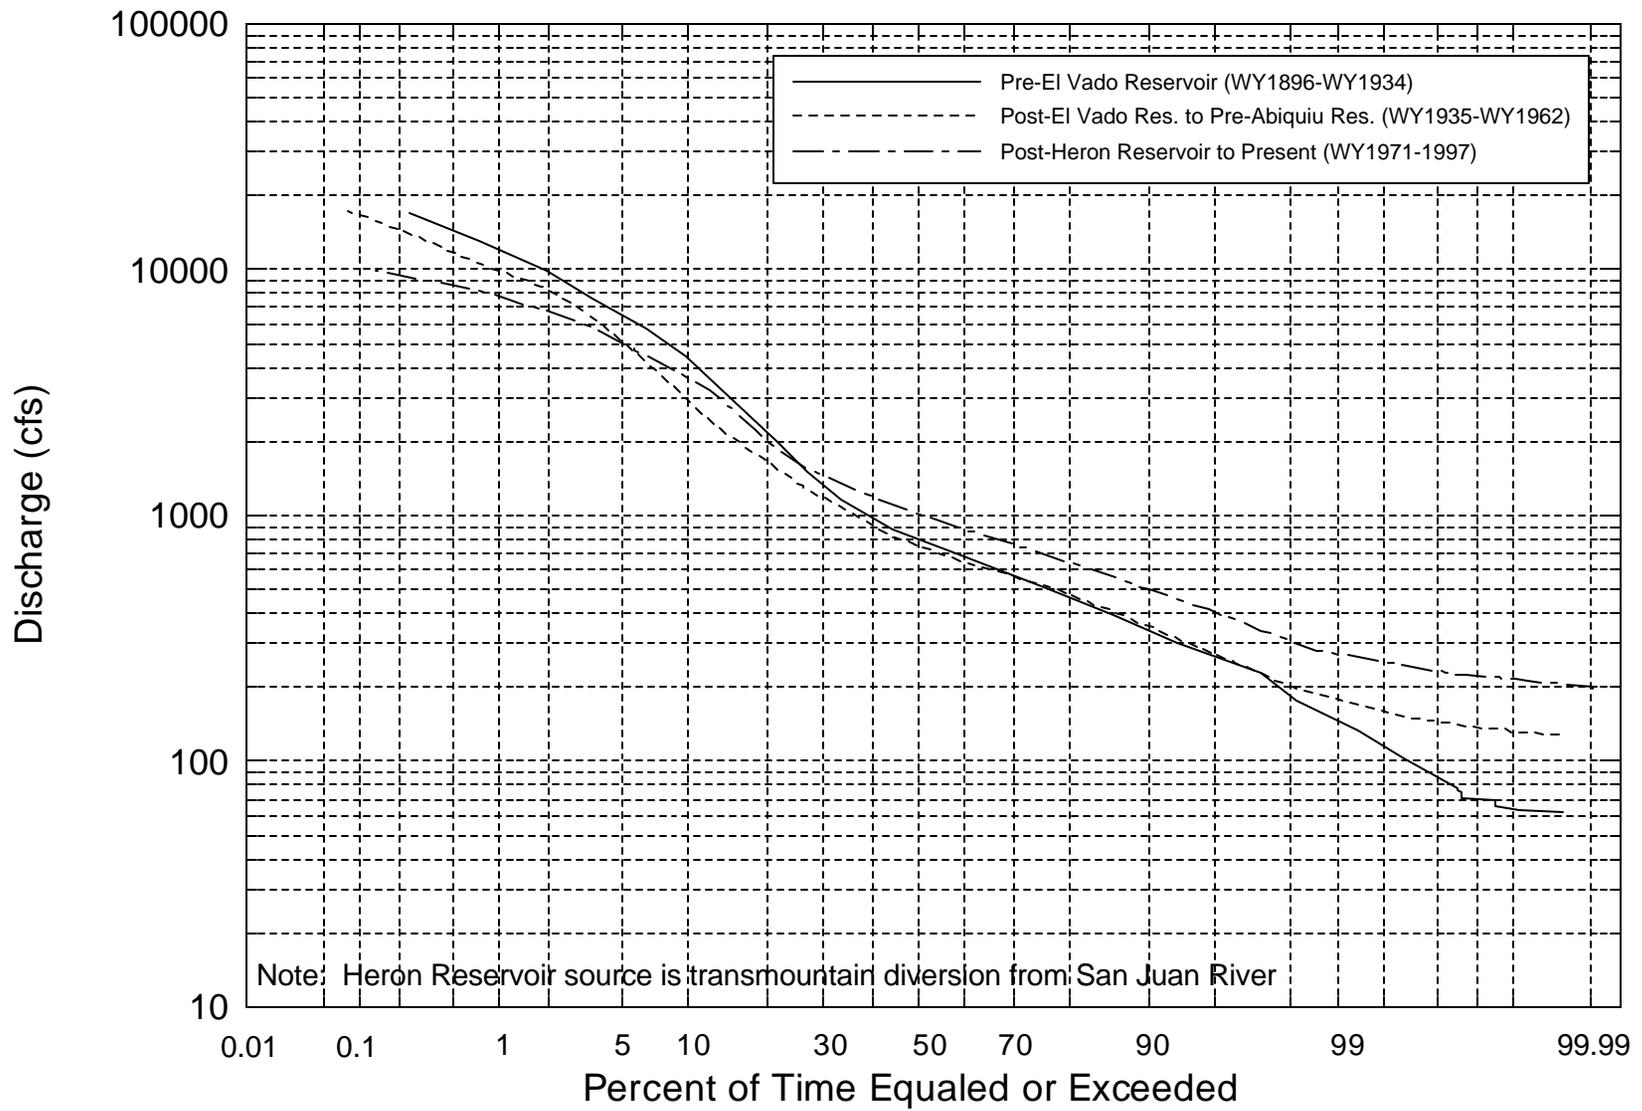
Figure 3.22. Flow-duration curves for the Otowi gage based on mean daily flow data for four different time periods.
