# 1. INTRODUCTION

## 1.1. Background

The Middle Rio Grande, as defined in this report, is that part of the Rio Grande in New Mexico that extends from Cochiti Dam to Elephant Butte Reservoir, a distance of about 165 miles (**Figure 1.1**). The Rio Grande valley has been a home to the Pueblo people, Spanish colonizers, and Americans (Horgan, 1954; Crawford et al., 1993). The valley has a complex geomorphic and geologic history (Belcher, 1975) and hydrologic conditions are unusual (Graf, 1994). For example, discharge decreases as the river flows from areas of higher to lower precipitation (**Figure 1.2**). However, contributions from Rio Puerco and Rio Salado increase flood peaks between Albuquerque and San Marcial (**Figure 1.3**). Both suspended load and bed load are increased dramatically by contributions from the Rio Puerco and Rio Salado (**Figures 1.4 and 1.5**).

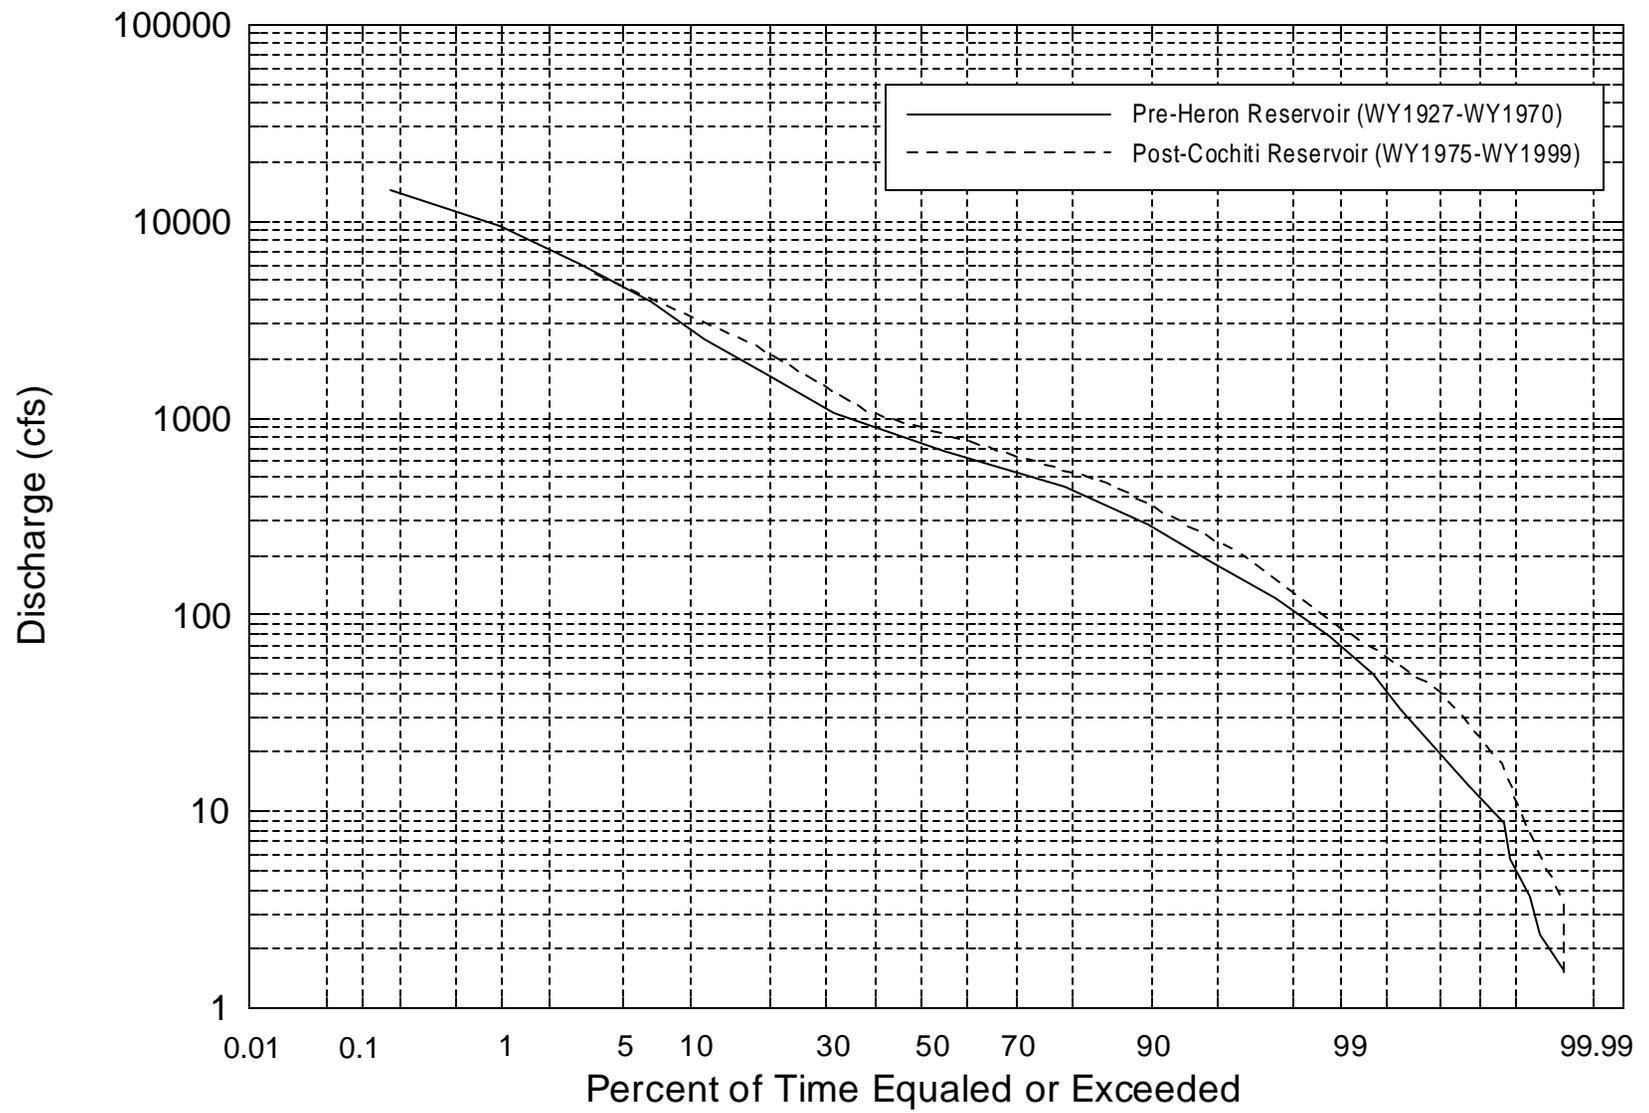
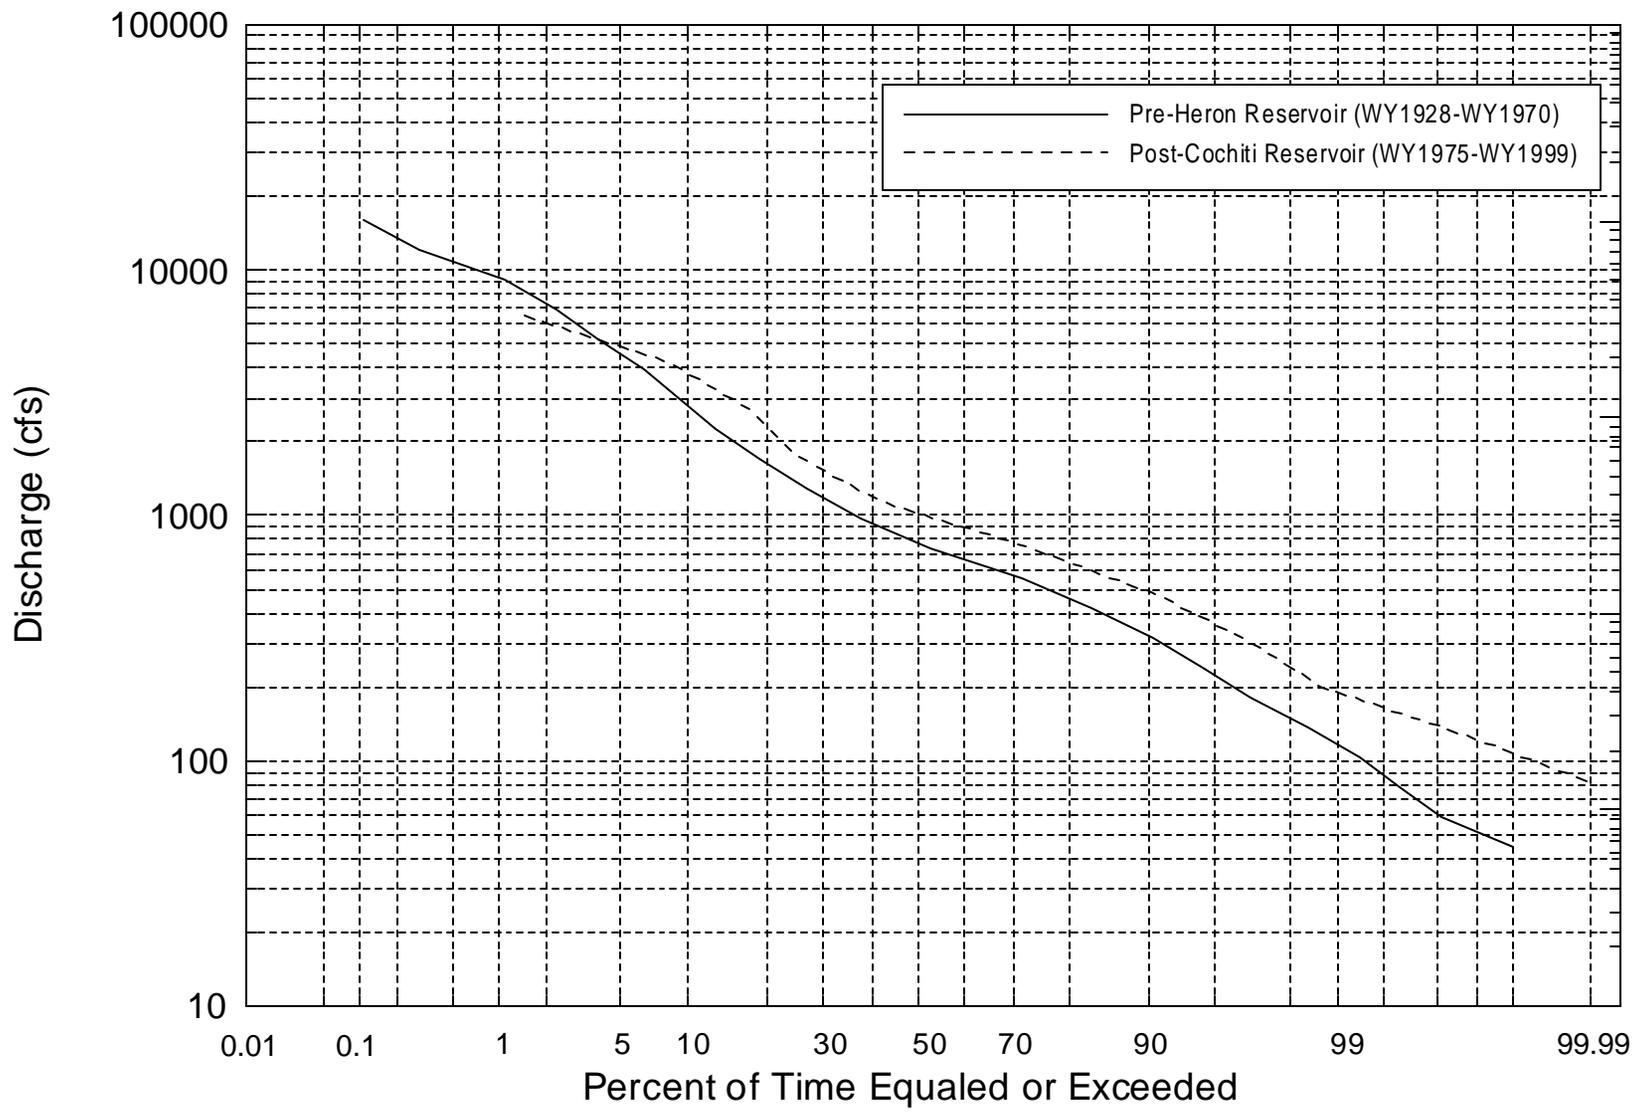
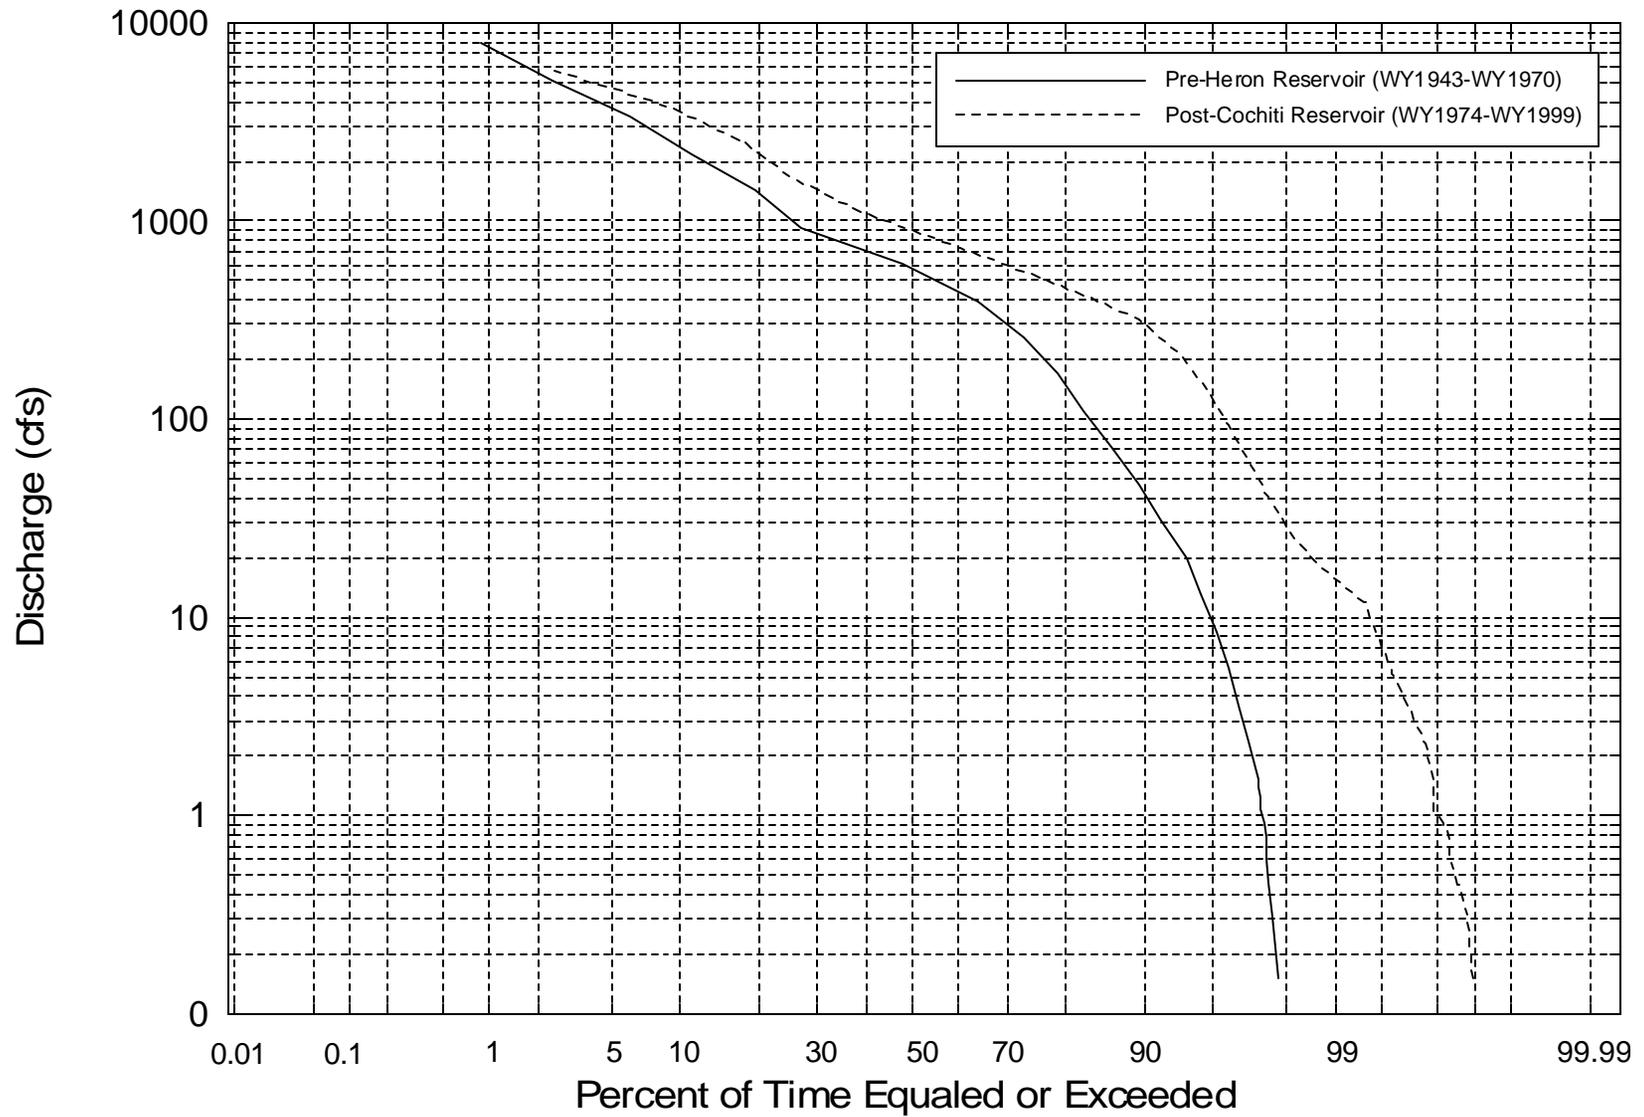
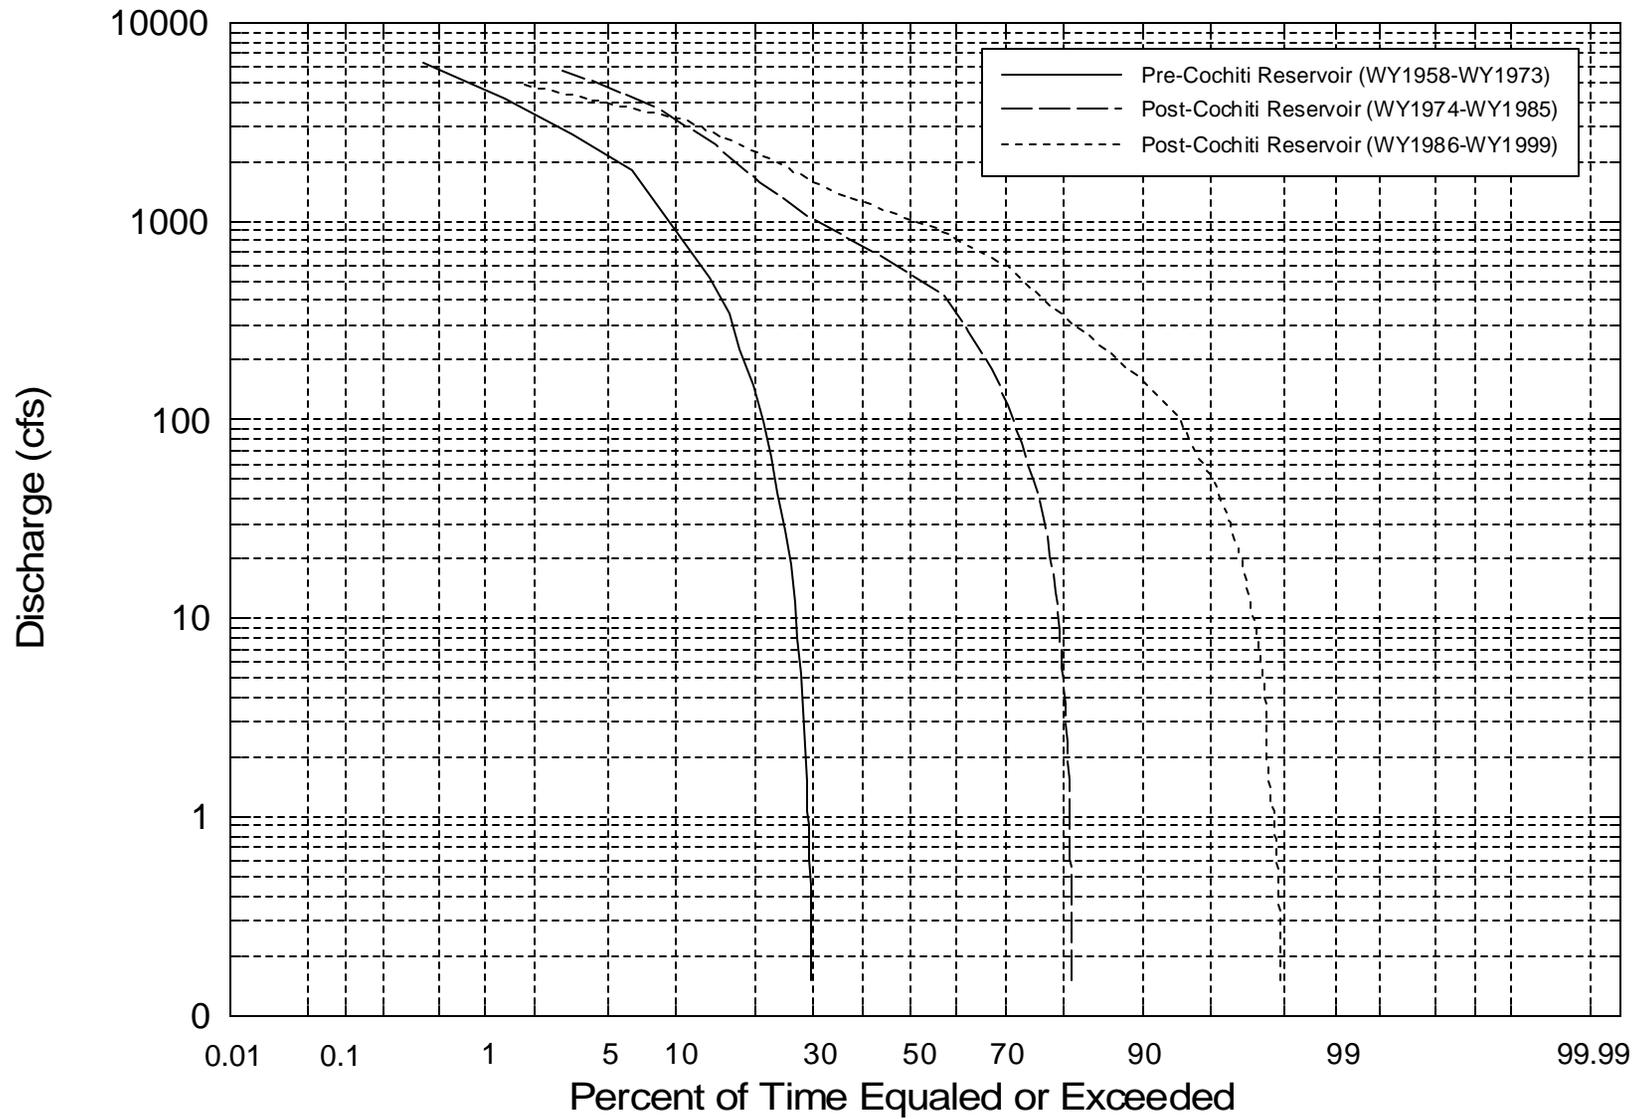
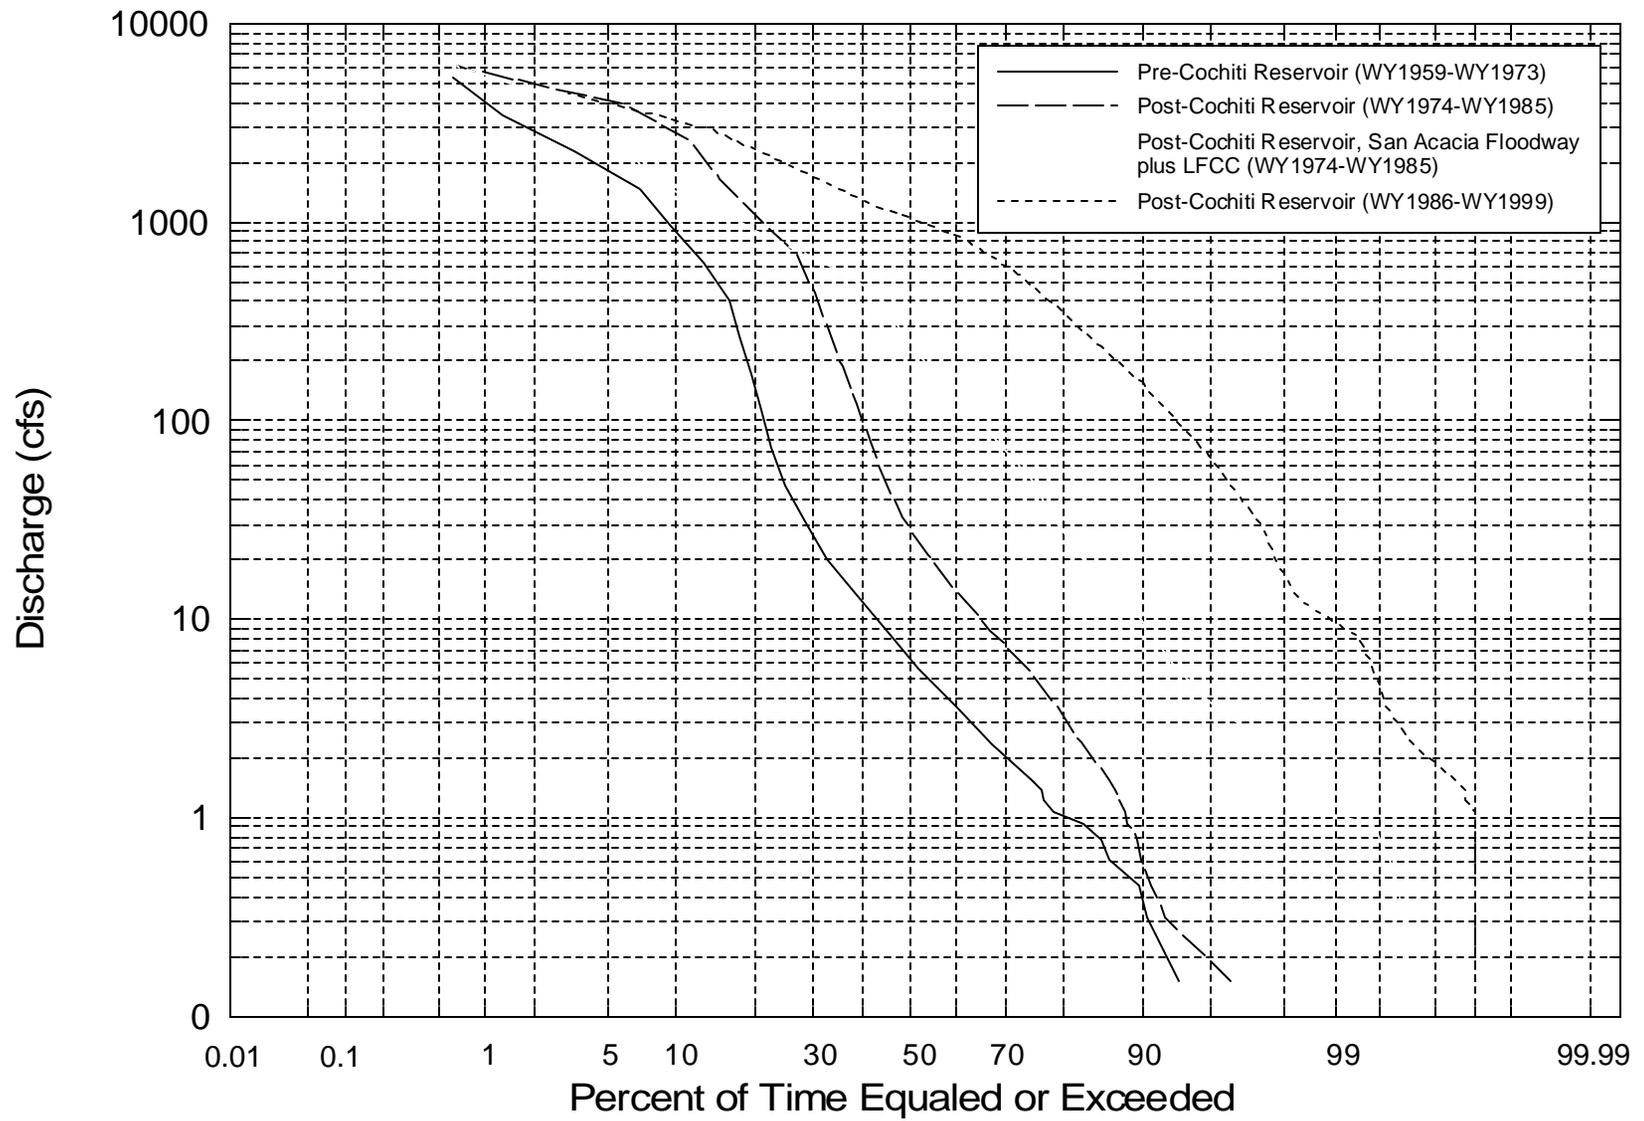
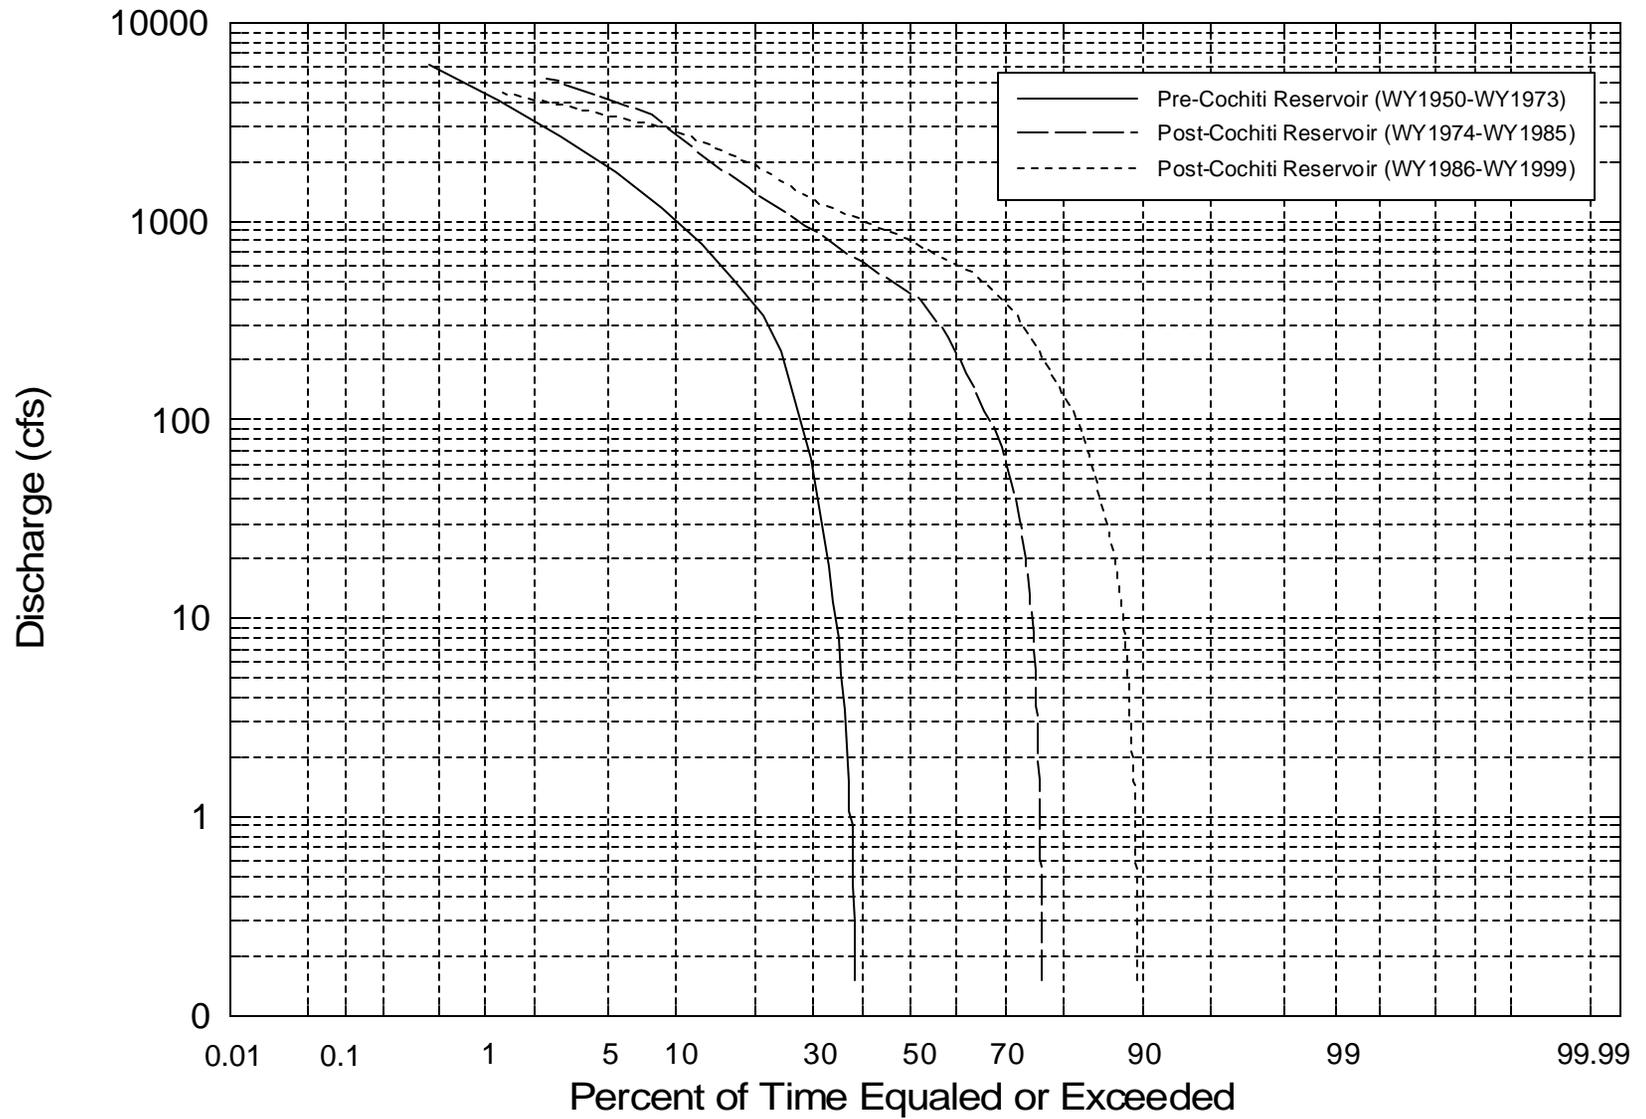
Figure 3.23. Flow-duration curves for the Cochiti gage based on mean daily flow data for pre-Heron Reservoir and post-Cochiti Reservoir periods.

Figure 3.24. Flow-duration curves for the San Felipe gage based on mean daily flow data for pre-Heron Reservoir and post-Cochiti Reservoir periods.

Figure 3.25. Flow-duration curves for the Albuquerque gage based on mean daily flow data for pre-Heron Reservoir and post-Cochiti Reservoir periods.

Figure 3.26. Flow-duration curves for the Rio Grande Floodway near Bernardo gage based on mean daily flow data for pre-Heron Reservoir and post-Cochiti Reservoir periods.

Figure 3.27. Flow-duration curves for the Rio Grande Floodway at San Acacia gage based on mean daily flow data for pre-Heron Reservoir and post-Cochiti Reservoir periods.

Figure 3.28. Flow-duration curves for the San Marcial gage based on mean daily flow data for pre-Heron Reservoir and post-Cochiti Reservoir periods.

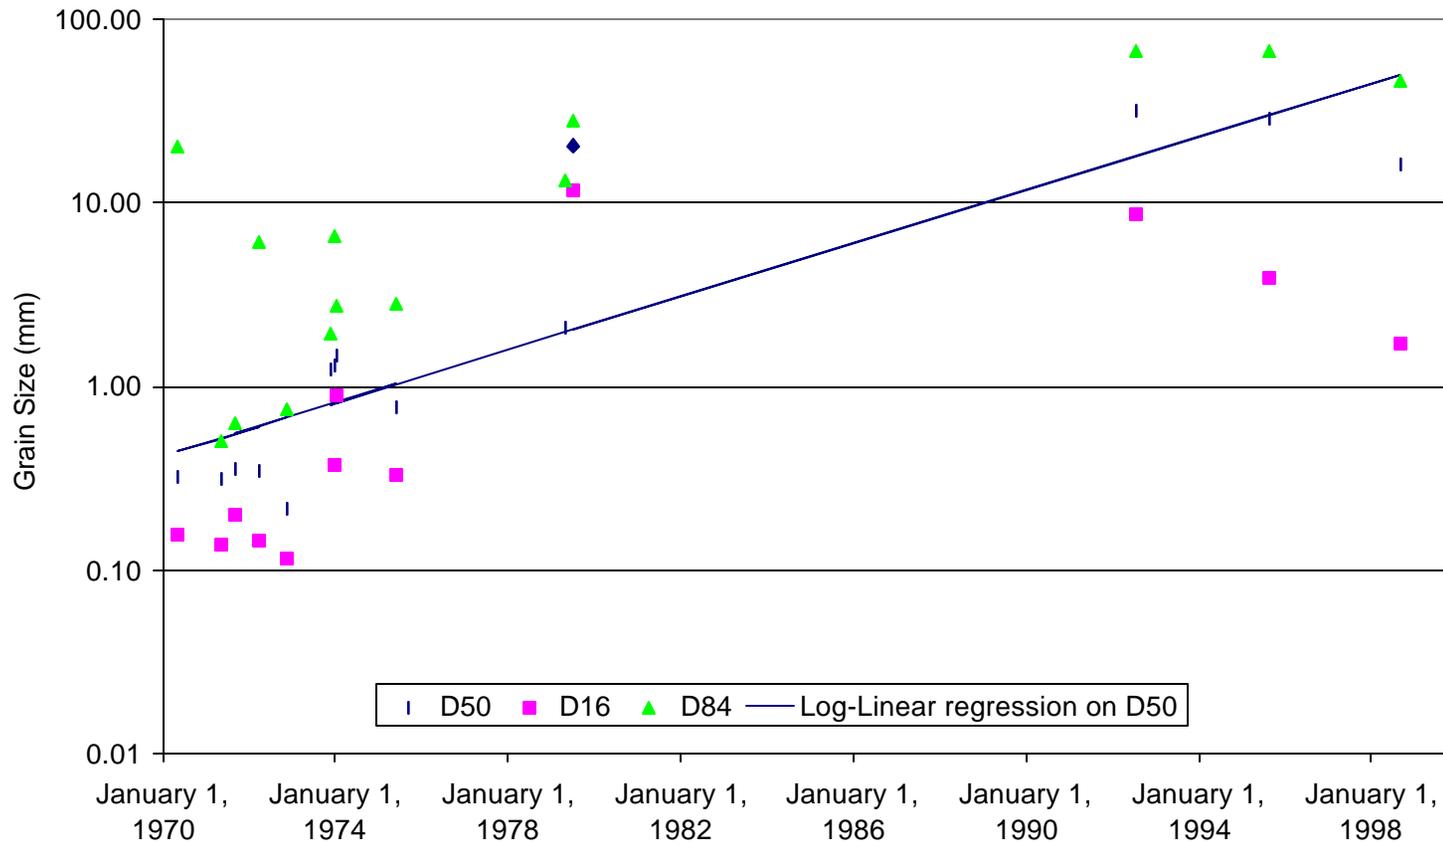
Figure 3.29. Bed-material gradation parameters ( $D_{16}$ ,  $D_{50}$ ,  $D_{84}$ ) plotted against time at Range CO-3, located 3.3 miles downstream of Cochiti Dam. The best-fit regression line for the  $D_{50}$  values is also shown.

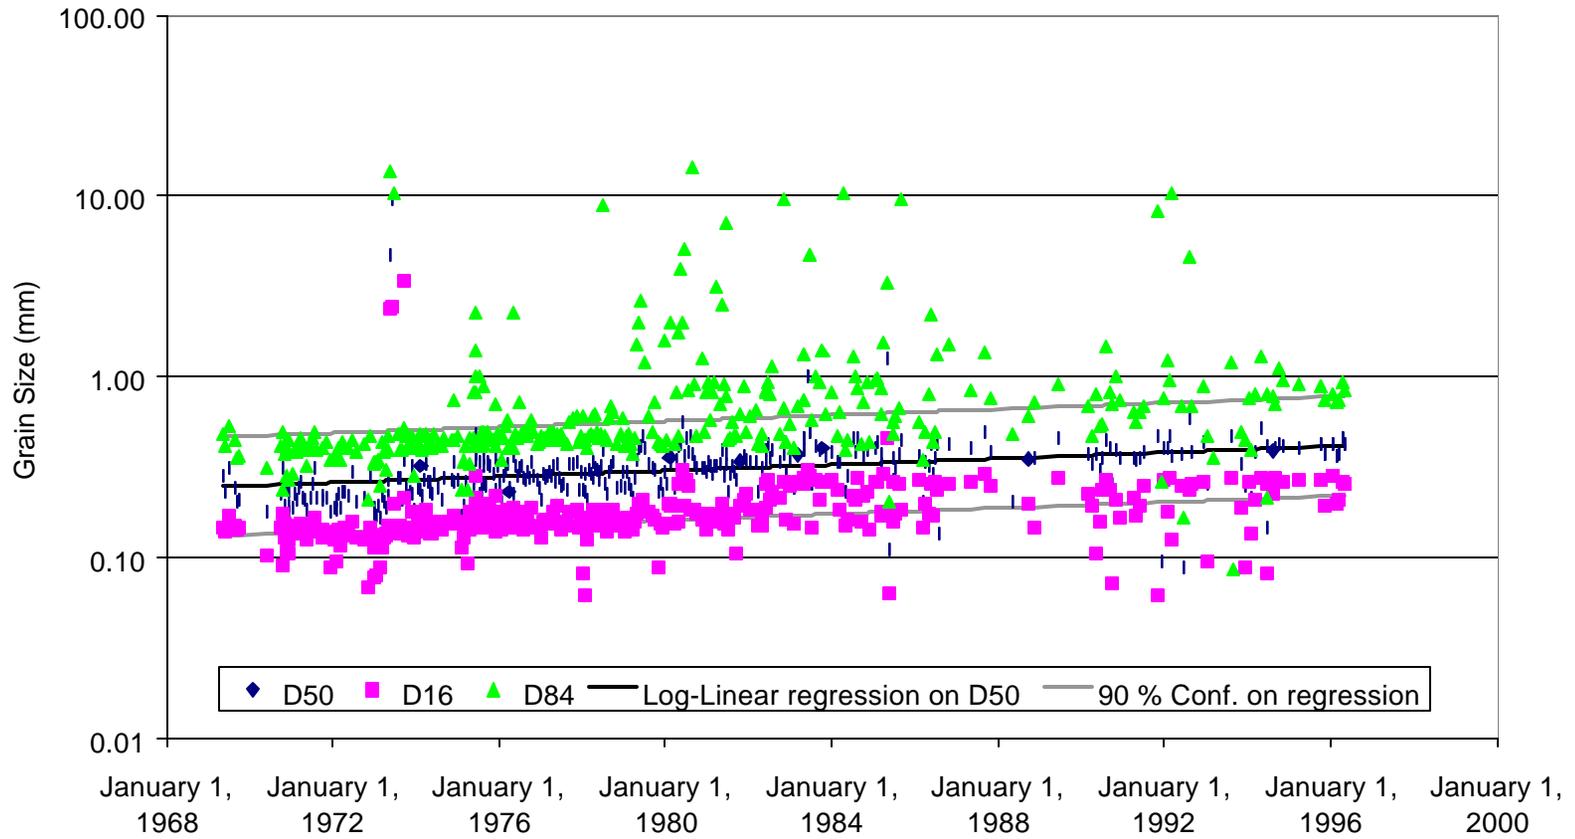
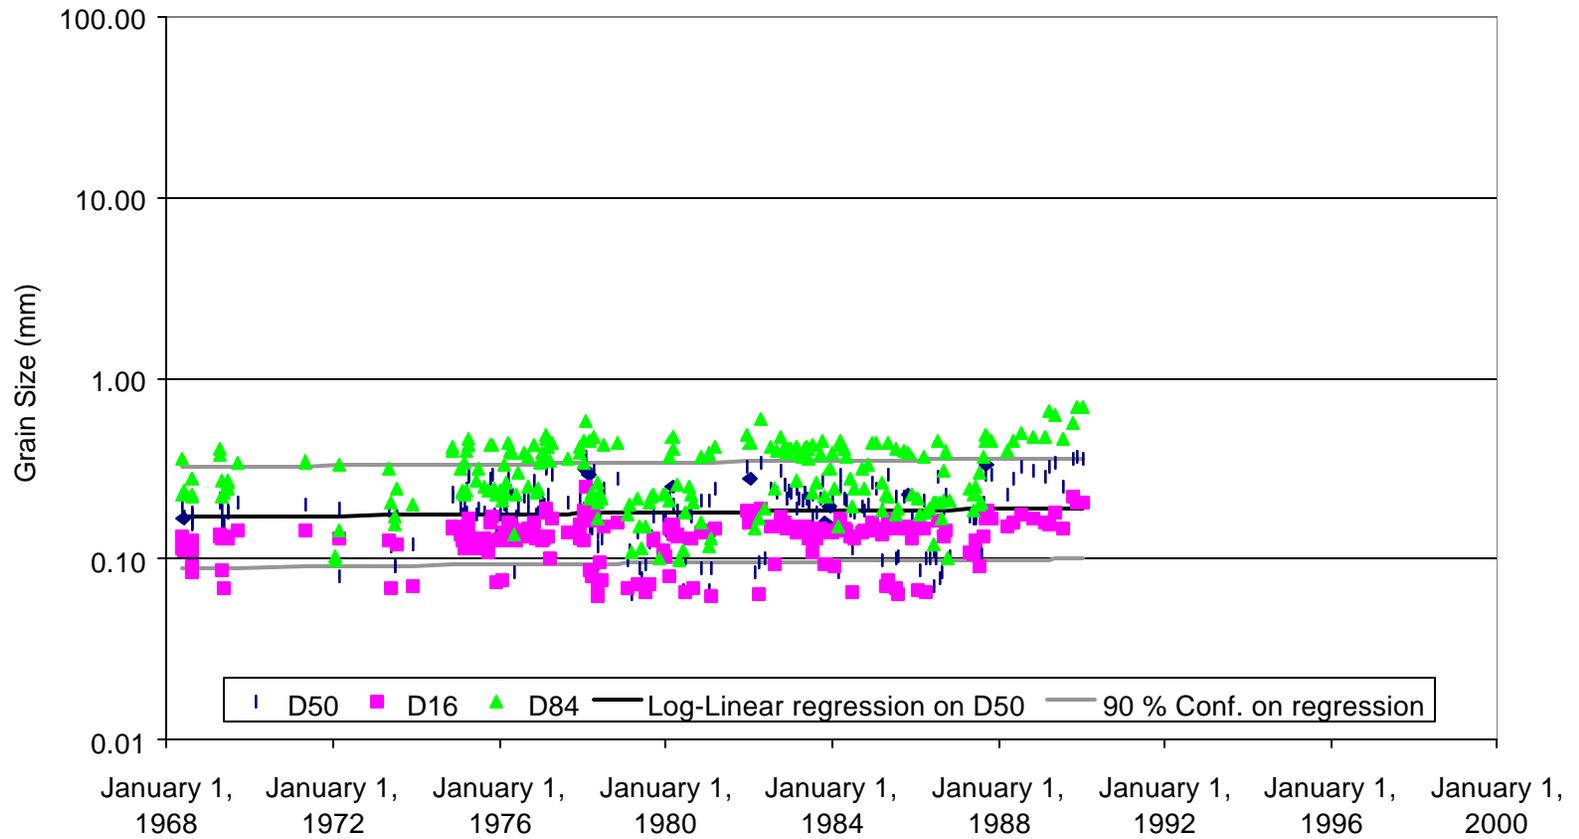
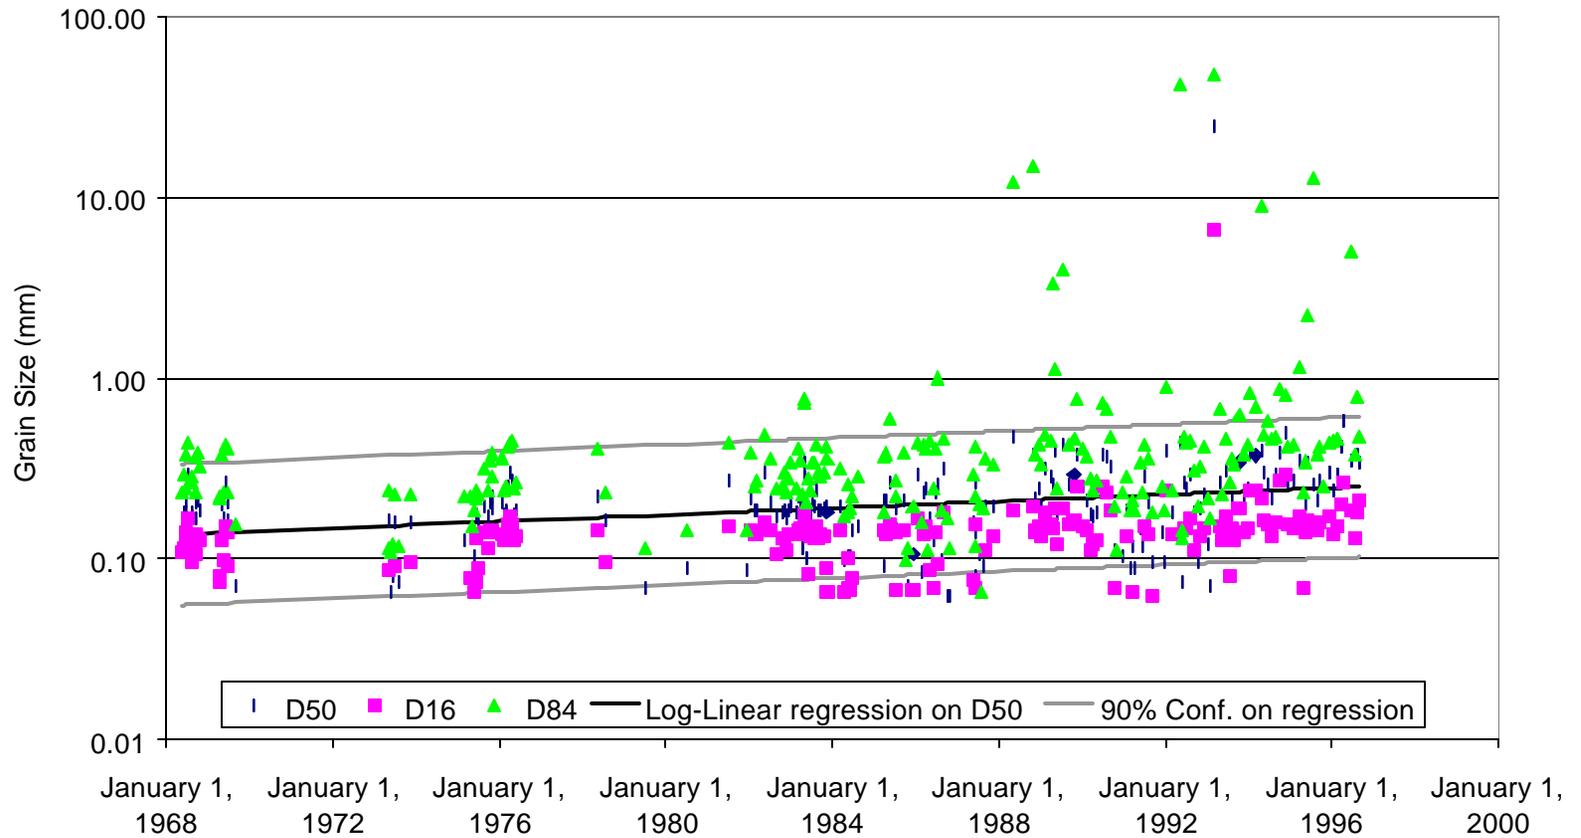
Figure 3.37. Bed-material gradation parameters ( $D_{16}$ ,  $D_{50}$ ,  $D_{84}$ ) plotted against time at the Albuquerque gage. Ninety percent confidence bands on the  $D_{50}$  regression are also shown.

Figure 3.38. Bed-material gradation parameters ( $D_{16}$ ,  $D_{50}$ ,  $D_{84}$ ) plotted against time at the Bernardo gage. Ninety percent confidence bands on the  $D_{50}$  regression are also shown.

Figure 3.39. Bed-material gradation parameters ( $D_{16}$ ,  $D_{50}$ ,  $D_{84}$ ) plotted against time at the San Acacia gage. Ninety percent confidence bands on the  $D_{50}$  regression are also shown.

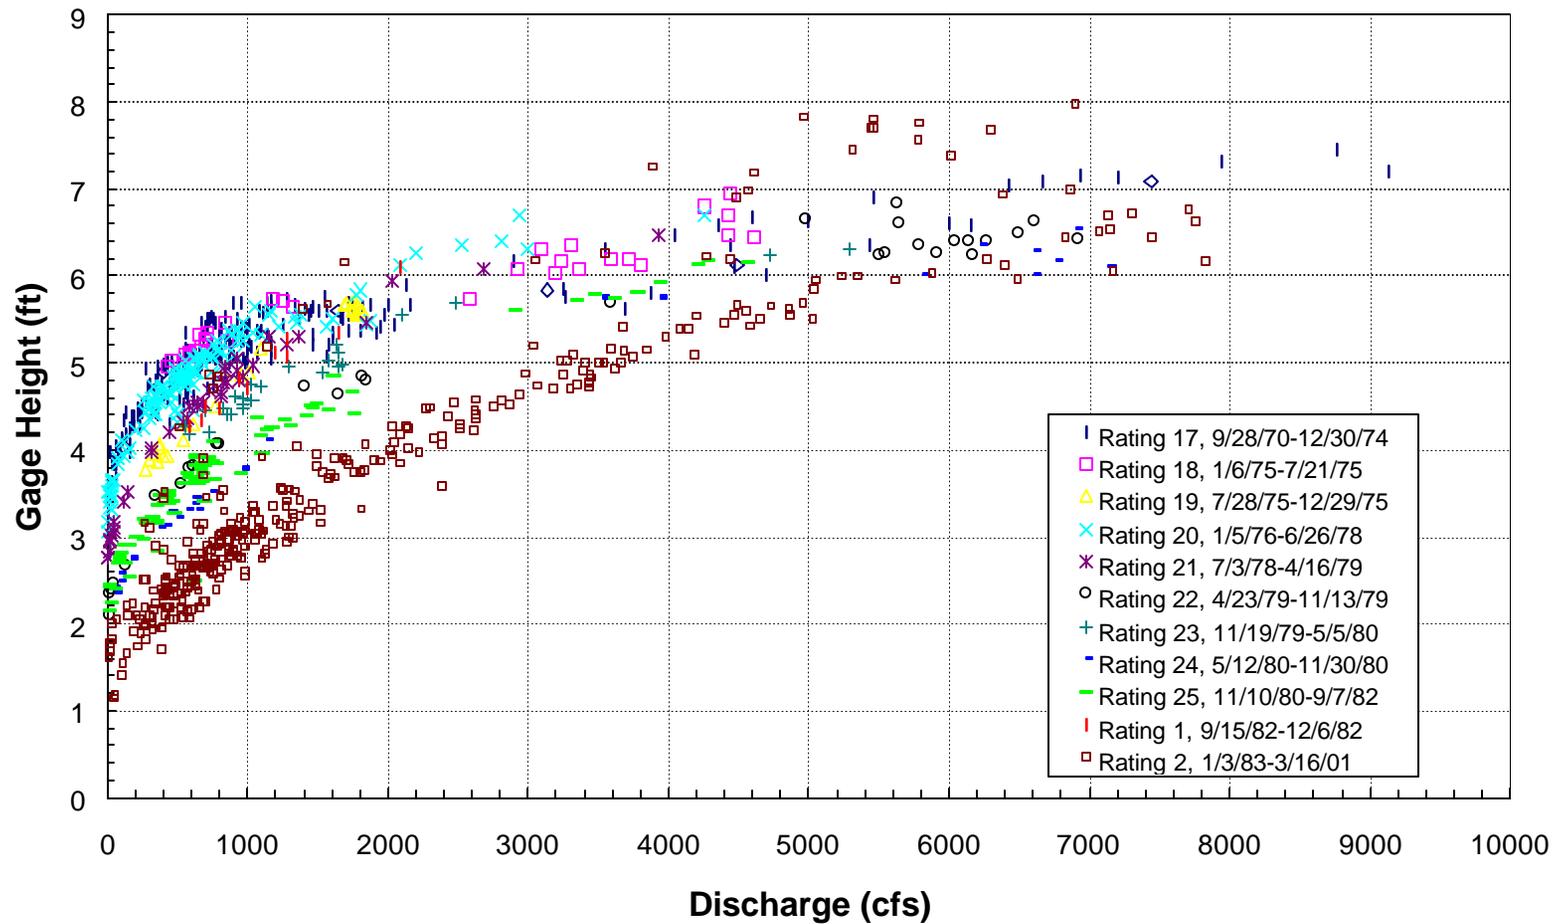
Figure 3.40. Discharge rating curves for the Albuquerque gage between 1974 and 2001, showing the downward shift of the rating through time.

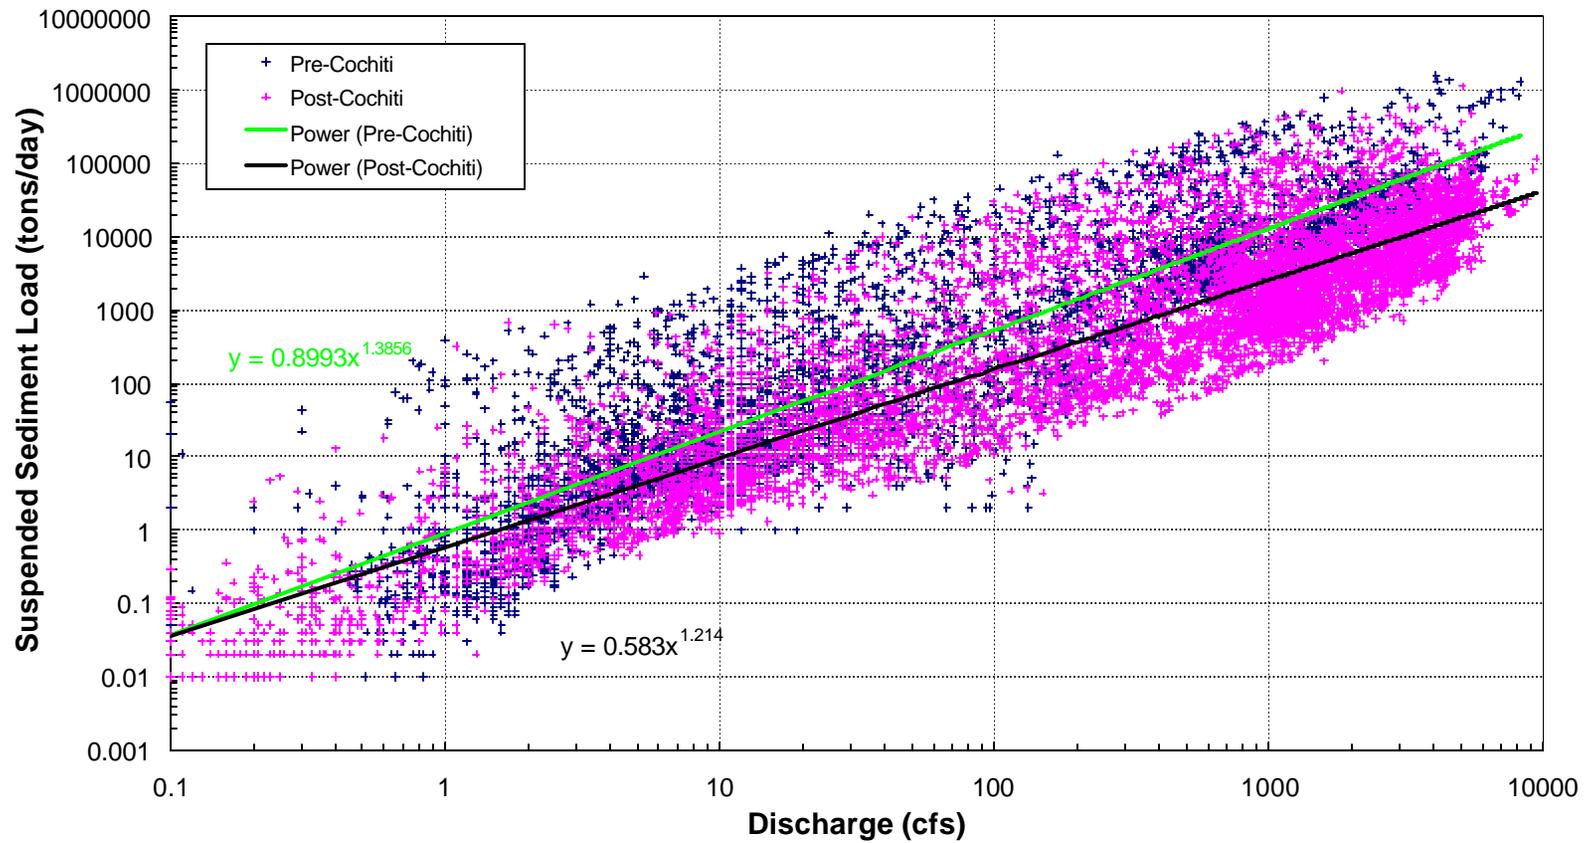
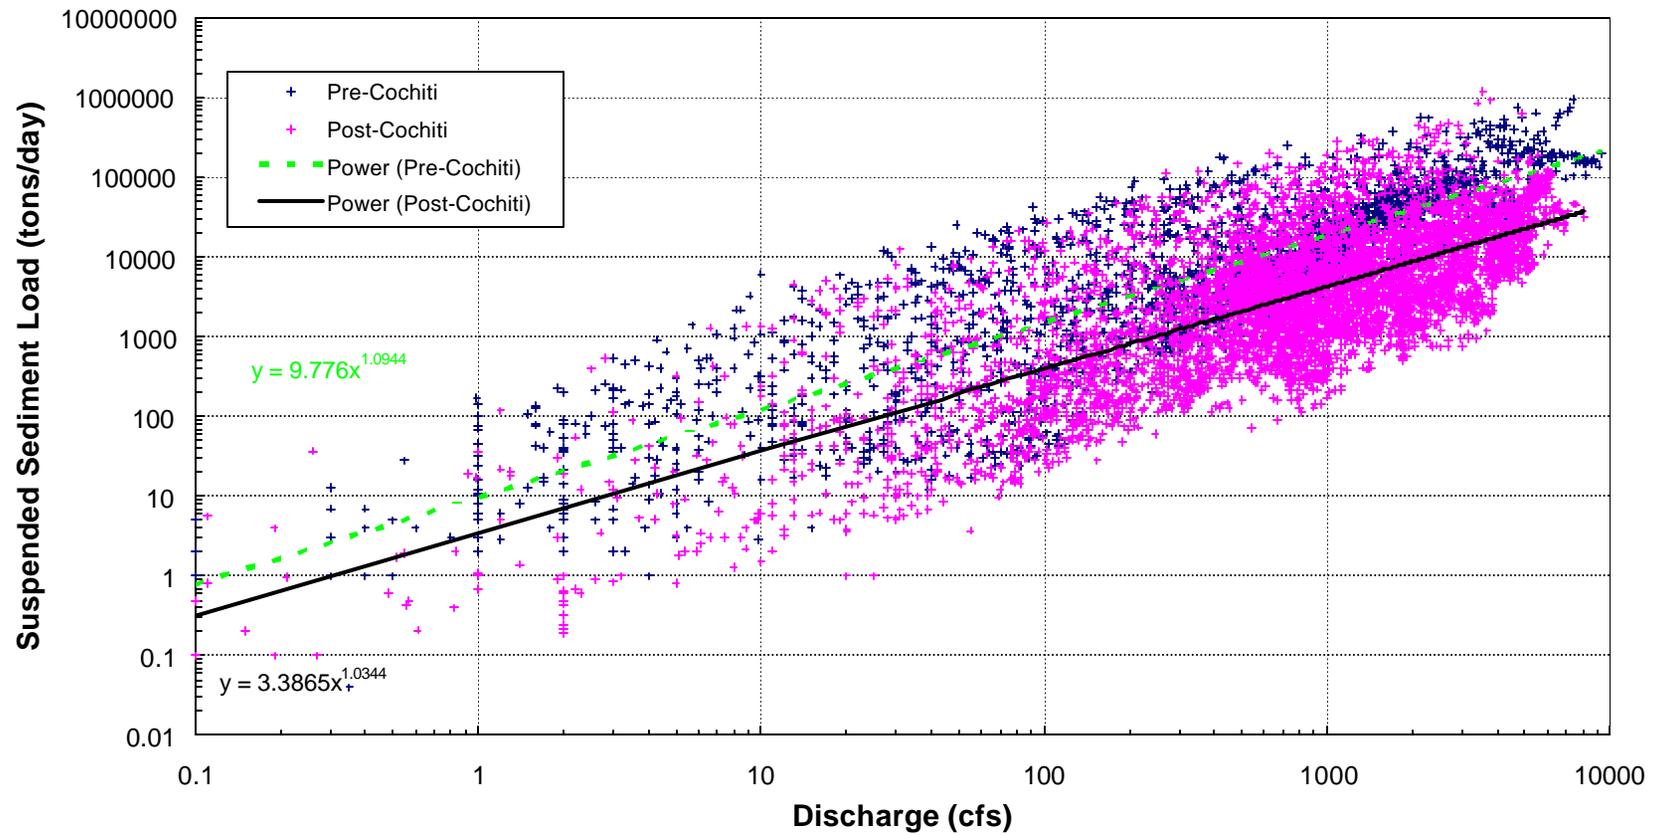
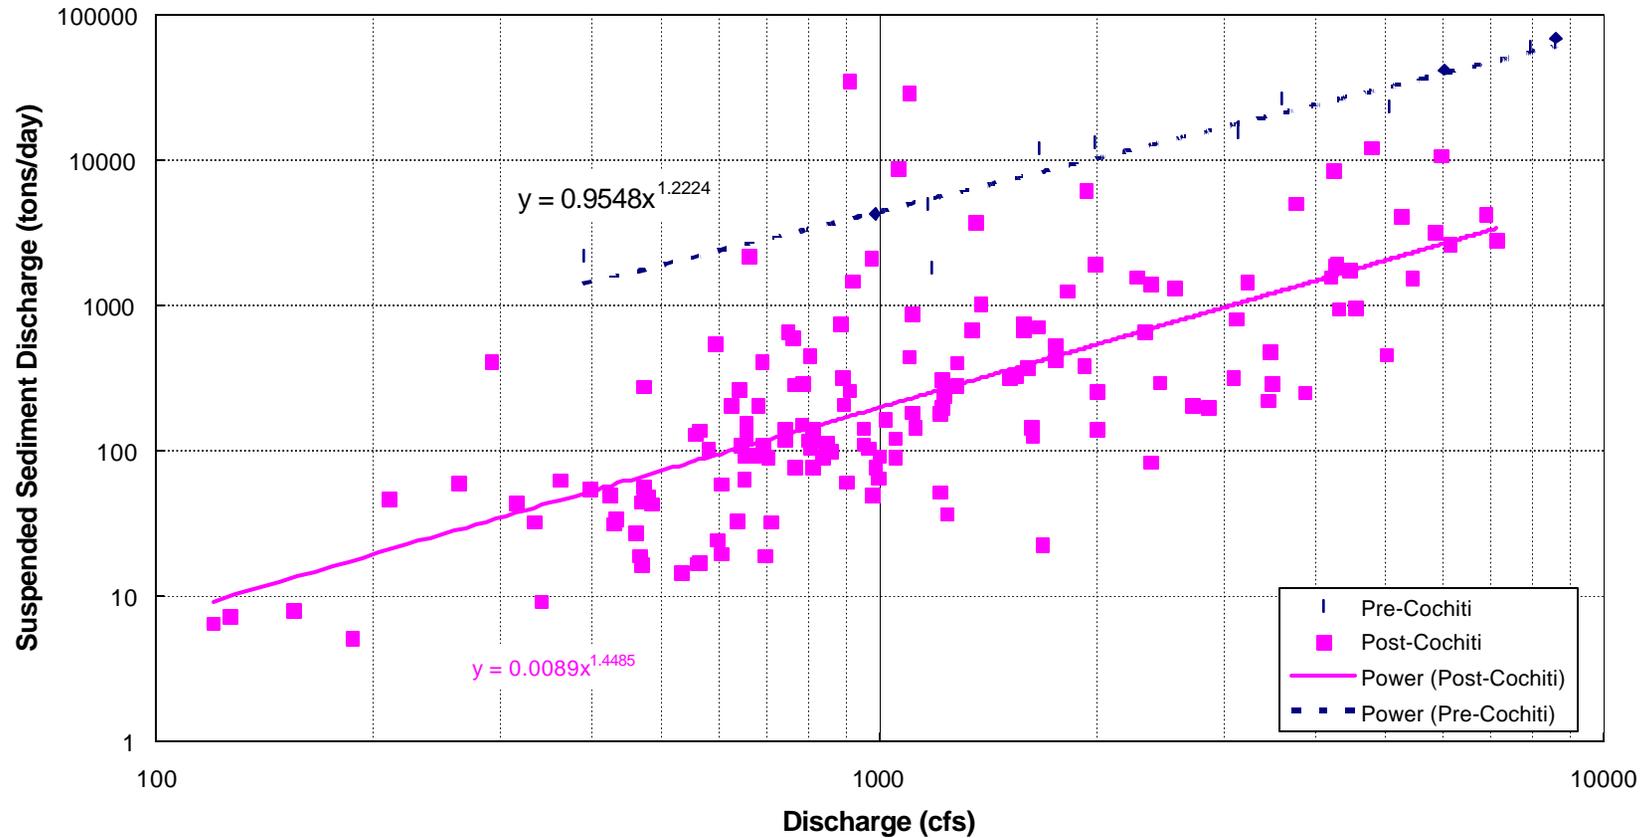
Figure 3.47. Suspended-sediment rating curves for the pre- and post-Cochiti Dam periods at the San Acacia gage (USGS daily values, July 1946-October 1973; November 1973-1996).

Figure 3.48. Suspended-sediment rating curves for the pre- and post-Cochiti Dam periods at the San Marcial gage (USGS daily values, July 1946-October 1973; November 1973-1995).

Figure 3.49. Suspended-sediment rating curves for the pre- and post-Cochiti Dam periods at San Felipe (USGS point measurements, May 1970-October 1973; November 1973-November 1975).
