# 1. INTRODUCTION

## 1.1. Background

The Middle Rio Grande, as defined in this report, is that part of the Rio Grande in New Mexico that extends from Cochiti Dam to Elephant Butte Reservoir, a distance of about 165 miles (**Figure 1.1**). The Rio Grande valley has been a home to the Pueblo people, Spanish colonizers, and Americans (Horgan, 1954; Crawford et al., 1993). The valley has a complex geomorphic and geologic history (Belcher, 1975) and hydrologic conditions are unusual (Graf, 1994). For example, discharge decreases as the river flows from areas of higher to lower precipitation (**Figure 1.2**). However, contributions from Rio Puerco and Rio Salado increase flood peaks between Albuquerque and San Marcial (**Figure 1.3**). Both suspended load and bed load are increased dramatically by contributions from the Rio Puerco and Rio Salado (**Figures 1.4 and 1.5**).

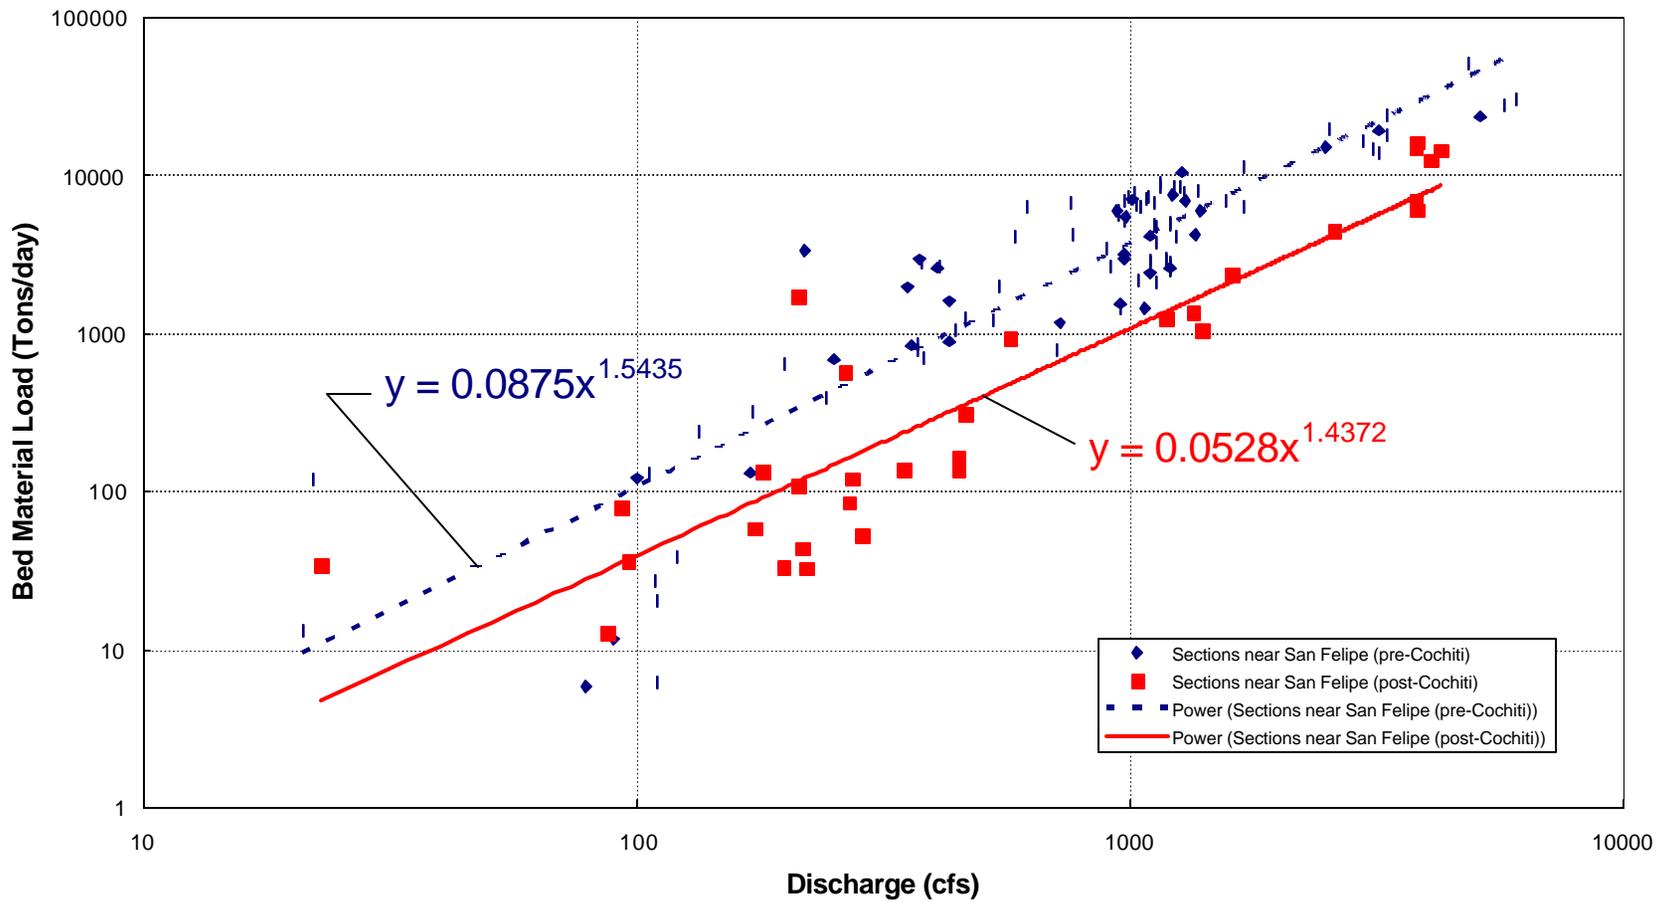
Figure 3.50. Bed-material rating curves for the pre- and post-Cochiti Dam periods at the USGS Channel Adjustment Cross Sections near San Felipe.

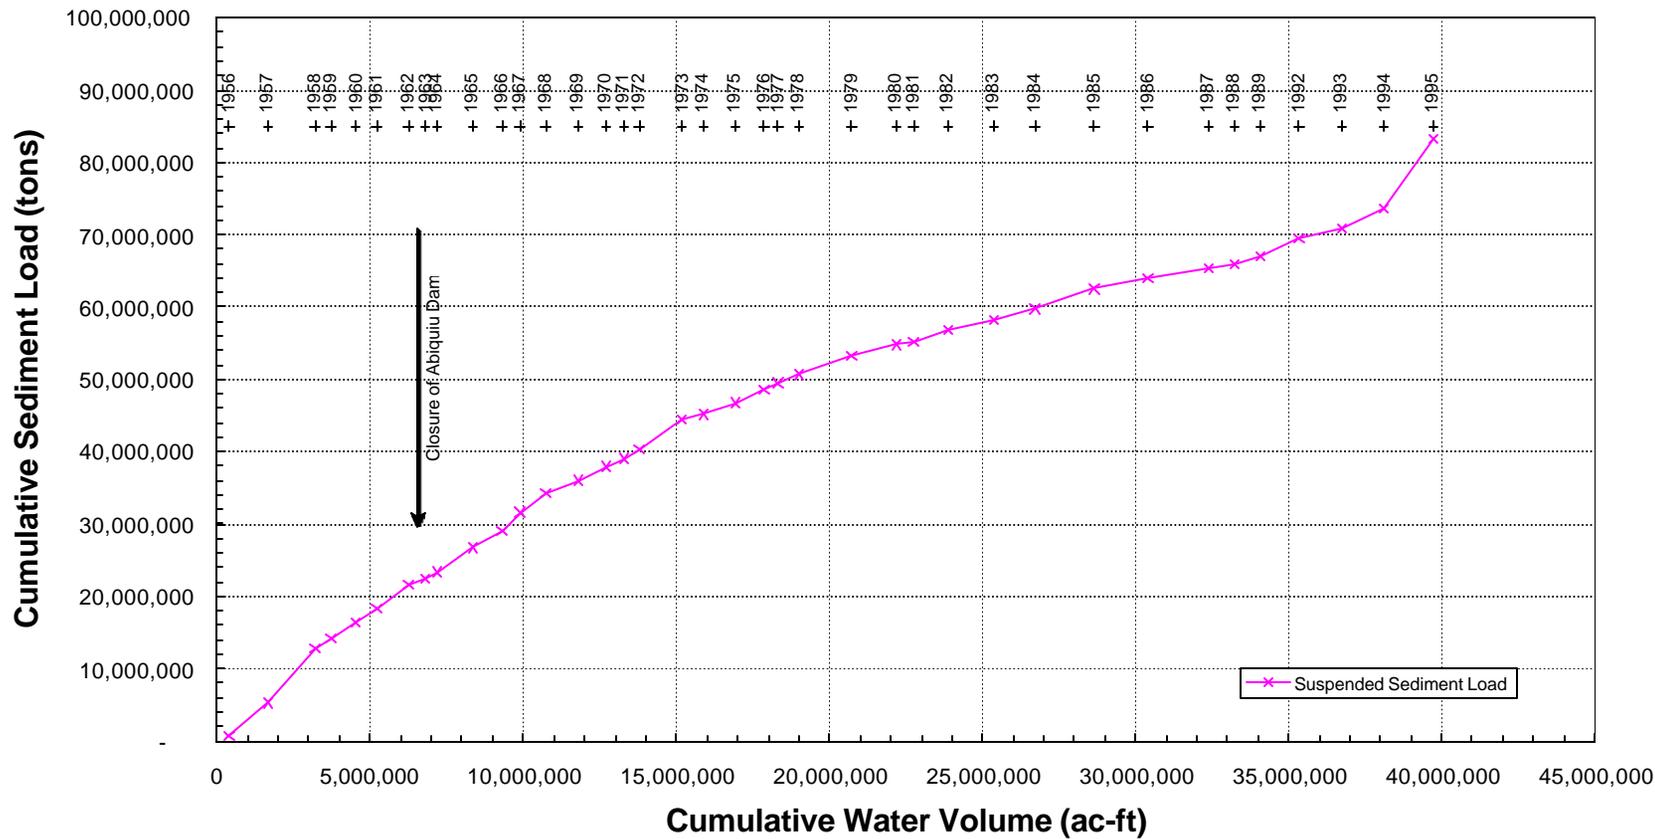
Figure 3.56. Cumulative quantity of suspended sediment that passed the Otowi gage as a function of cumulative water volume during the period 1956 through 1995.

Except for Water Year 1995, the slope of the curve for the Otowi gage progressively decreases with time (Figure 3.56), indicating that watershed factors, including construction of upstream dams caused a progressive reduction in suspended-sediment load at that location. The reason for the sharp increase in slope in 1995 is not known, but is likely related to an upstream disturbance that increased the suspended-sediment concentration. Review of the daily sediment loads indicates that higher than normal suspended-sediment concentrations occurred between late-April and mid-July 1995.

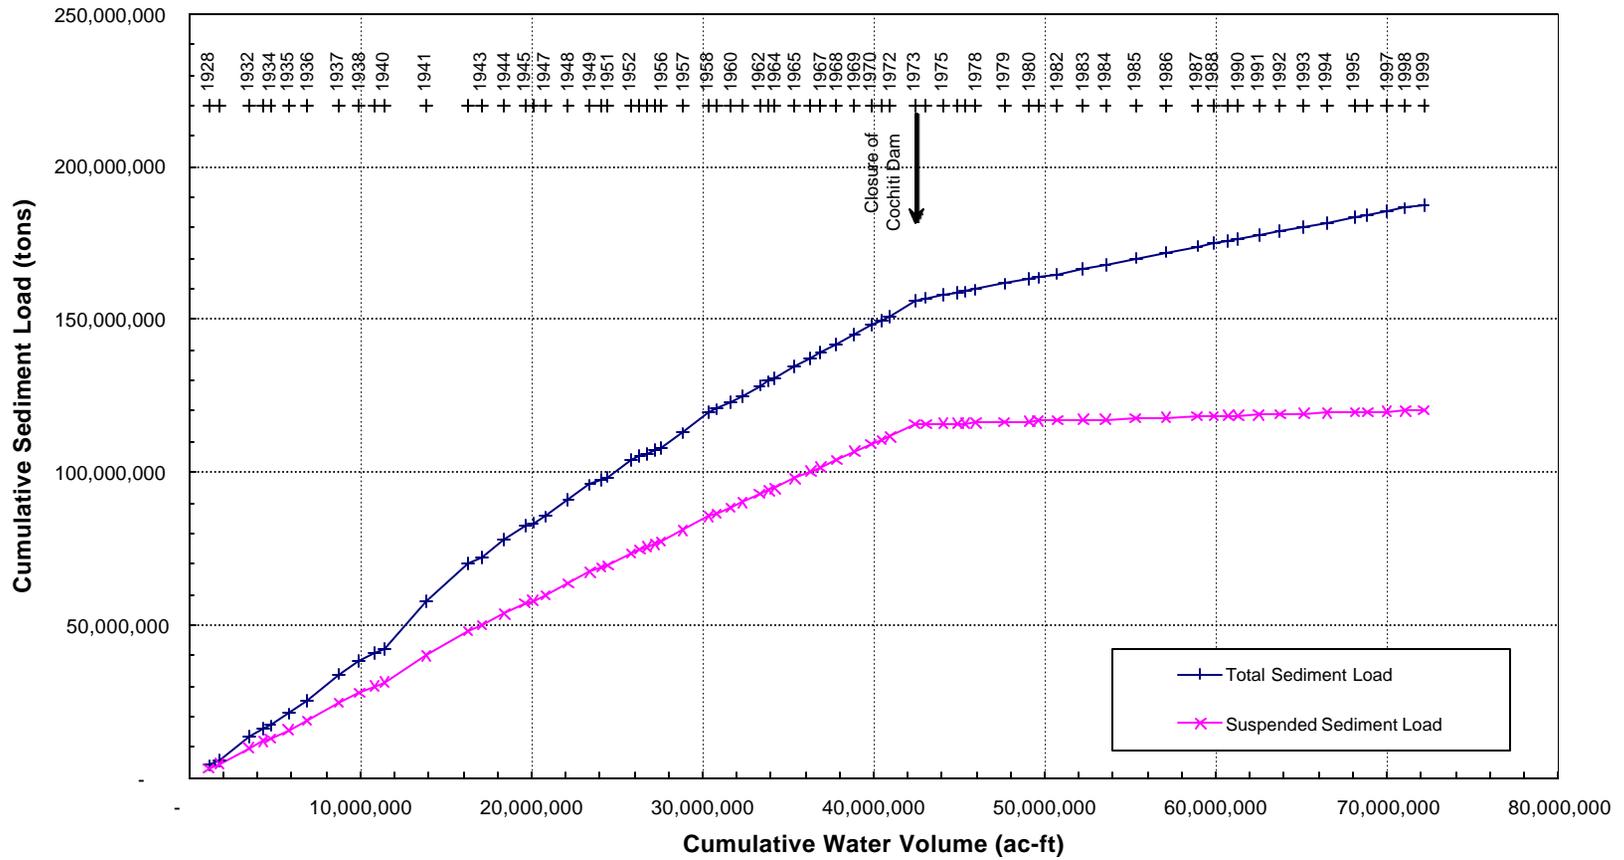
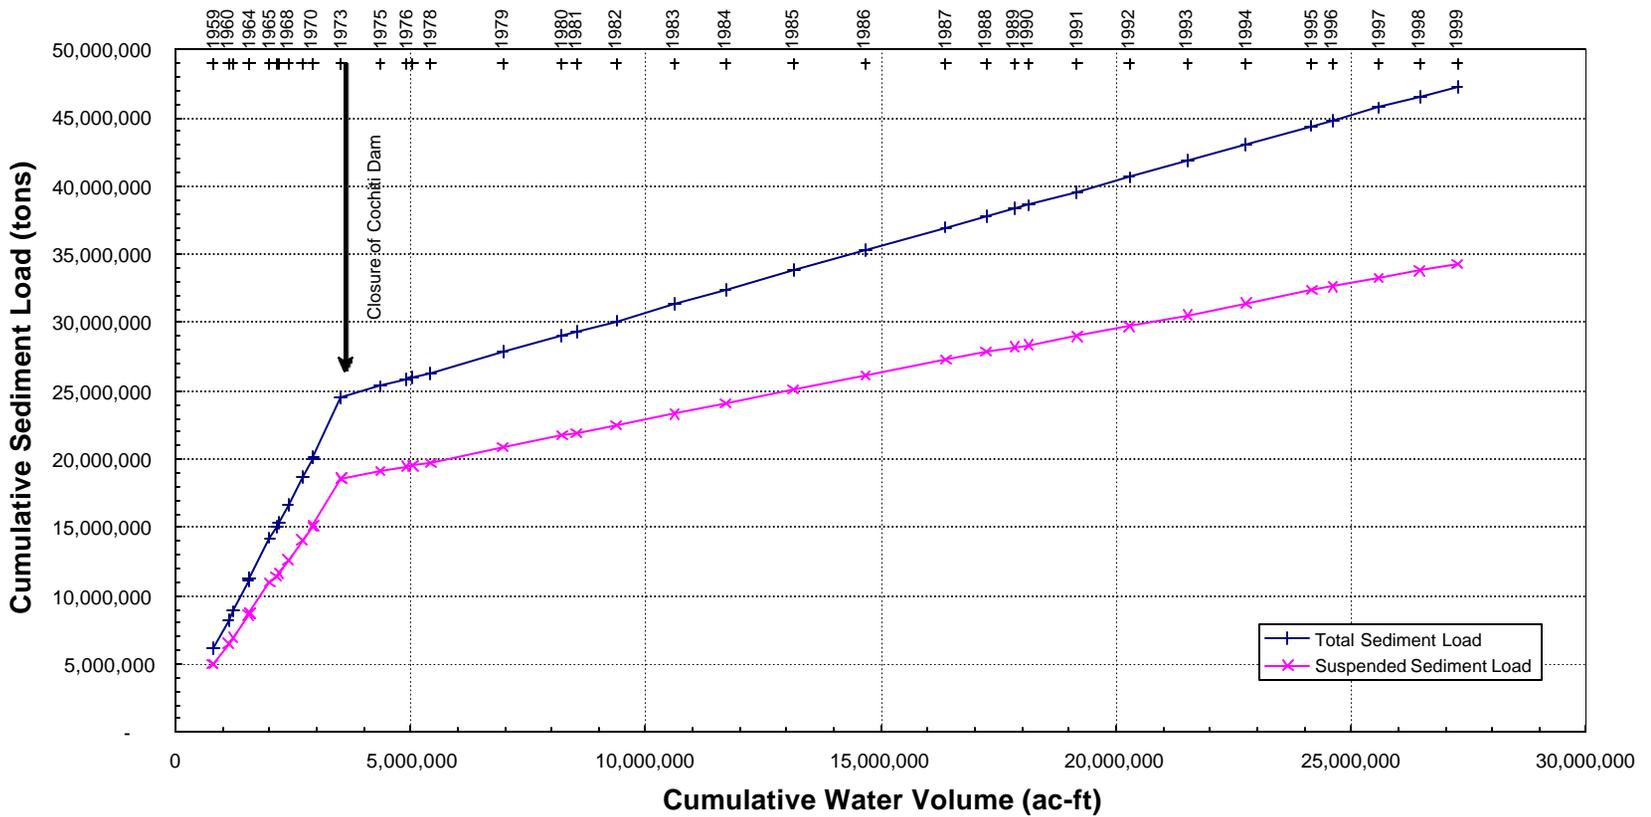
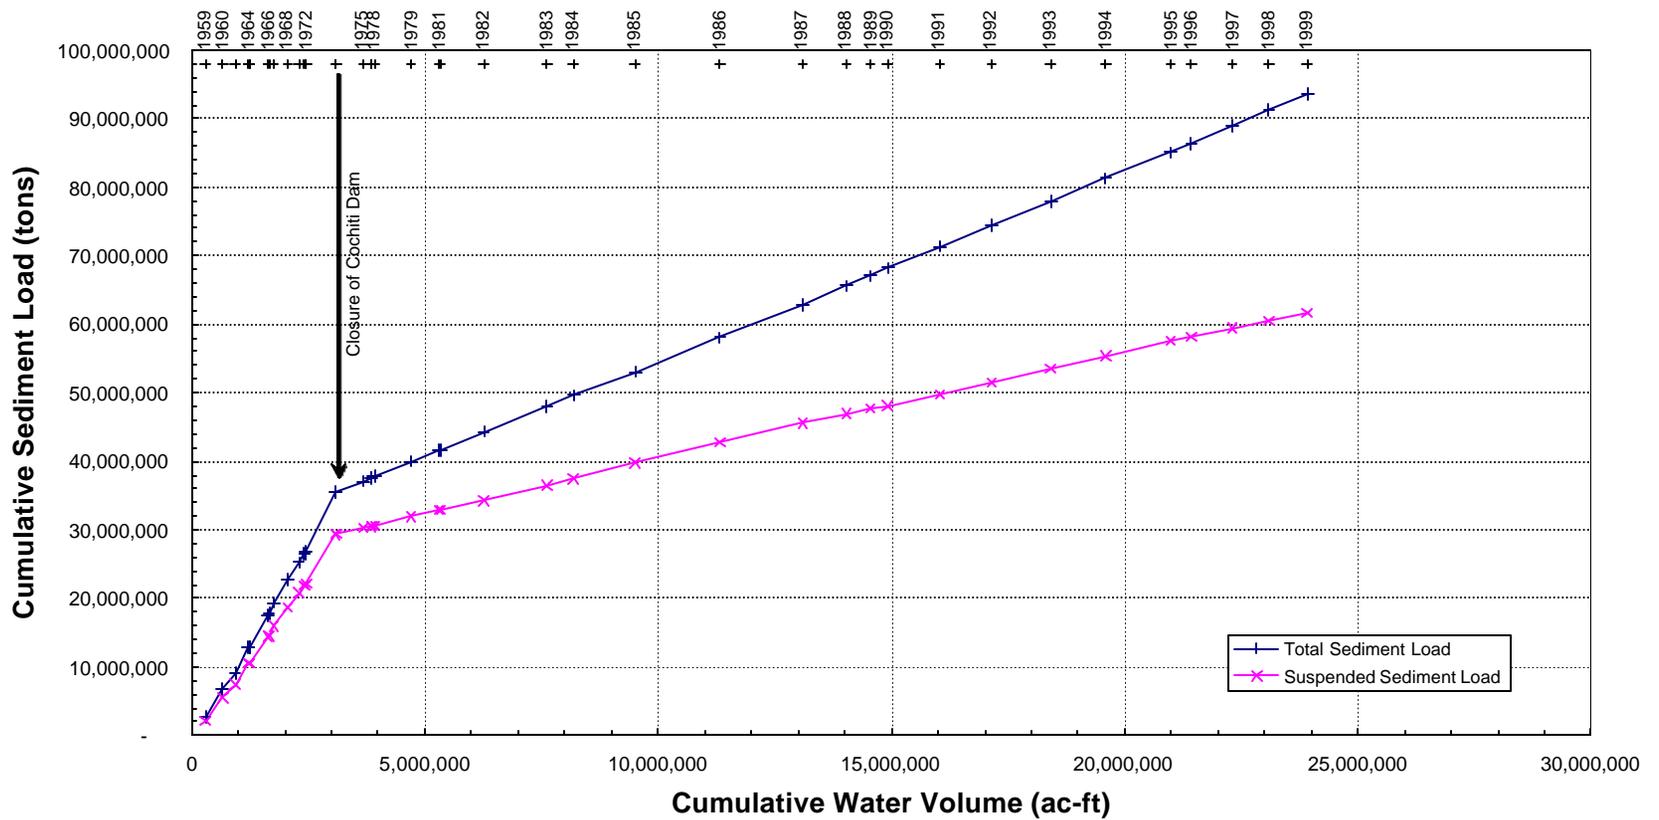
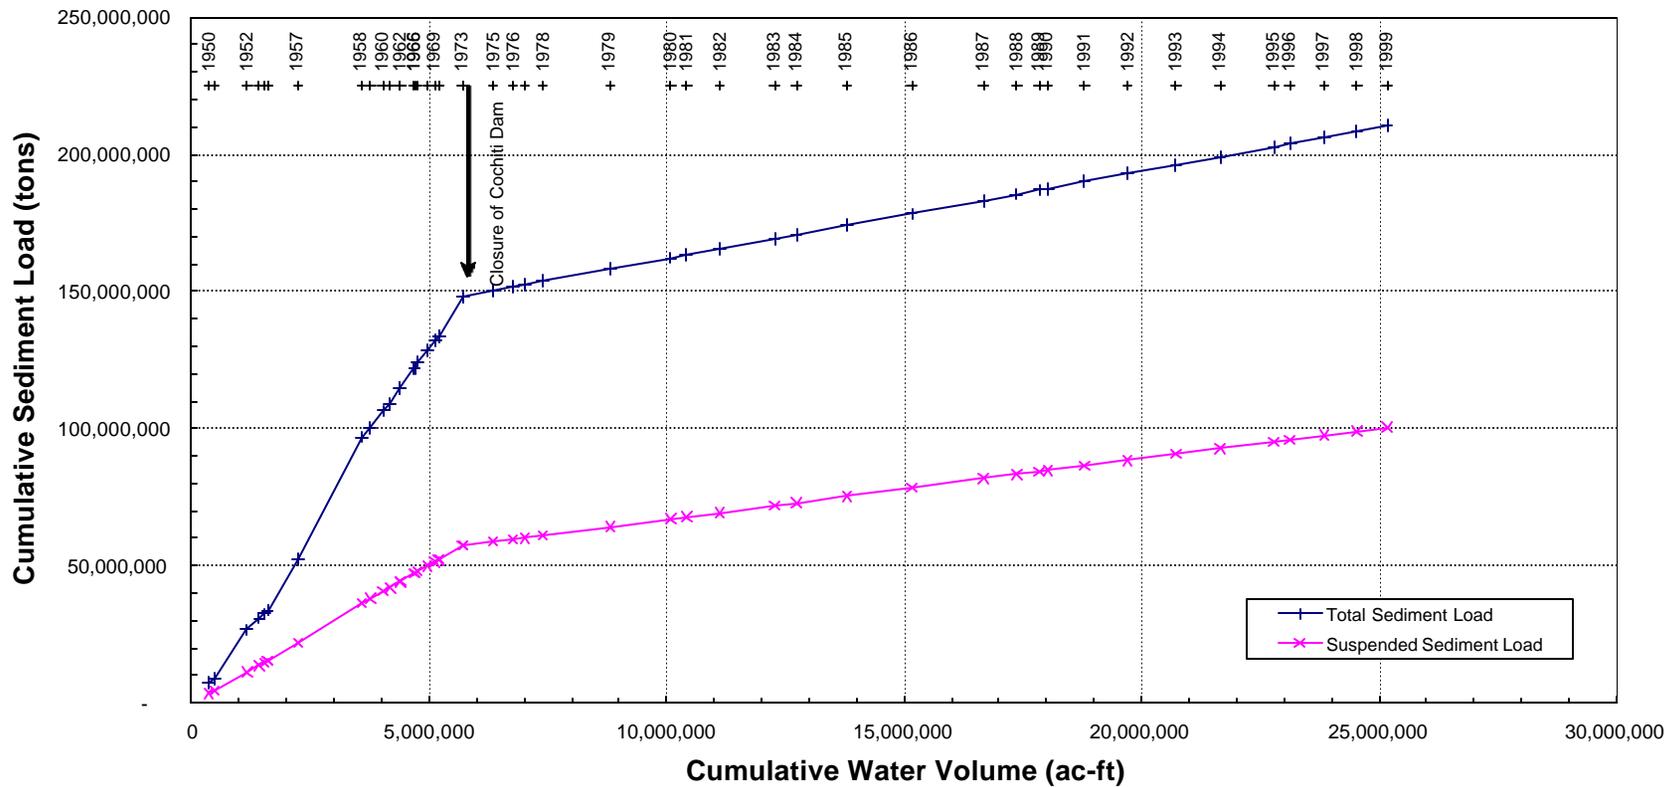
Figure 3.58. Cumulative quantity of total and suspended sediment that passed the San Felipe gage as a function of cumulative water volume during the period 1928 through 1999.

Figure 3.60. Cumulative quantity of total and suspended sediment that passed the Bernardo gage as a function of cumulative water volume during the period 1959 through 1999.

Figure 3.61. Cumulative quantity of total and suspended sediment that passed the San Acacia gage as a function of cumulative water volume during the period 1959 through 1999.

Figure 3.62. Cumulative quantity of total and suspended sediment that passed the San Marcial gage as a function of cumulative water volume during the period 1950 through 1999.

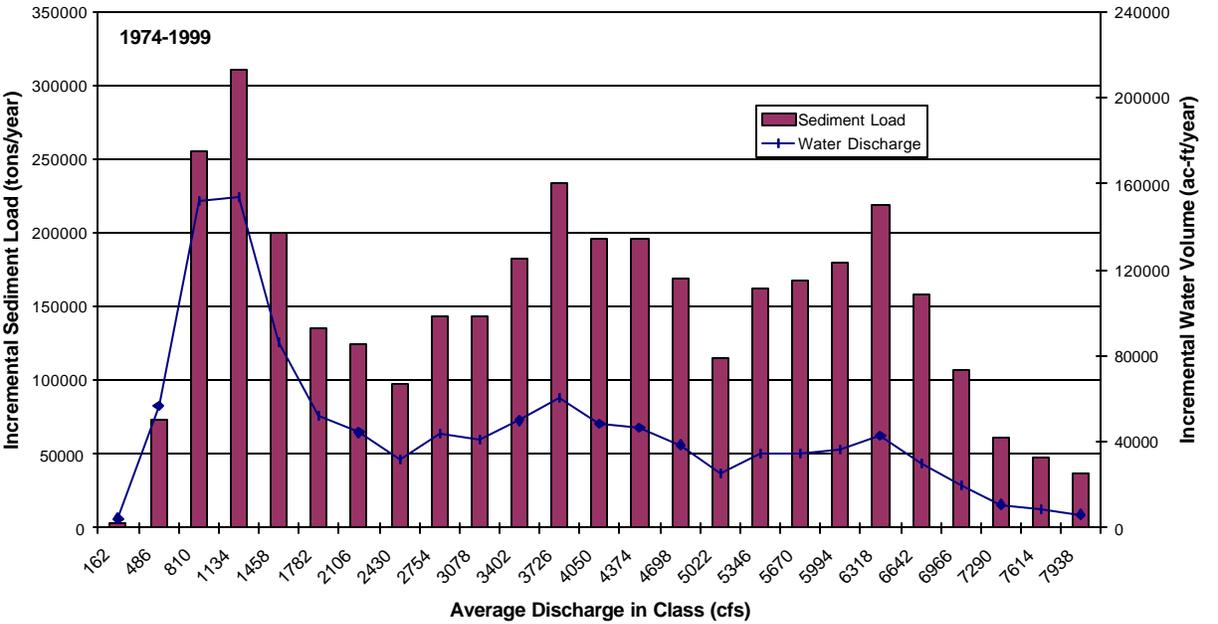
Figure 3.71. Histograms of incremental bed-material load by discharge class for the pre- and post-Cochiti Dam periods at the San Felipe gage. Also shown is the incremental water volume within each discharge class.

USGS for the pre- and post-Abiquiu Dam periods at the Otowi gage (**Figure 3.69**), and the computations were made using the bed-material rating curves for the gages downstream from Cochiti Dam (**Figures 3.70 through 3.76**). (Suspended-sediment loads were used for the Otowi gage because bed-material load data were not available.) The results of these computations are summarized in **Table 3.8**. For comparison purposes, the effective discharges were also computed using the reported suspended-sediment loads, where available, and these results are summarized in **Table 3.9**.

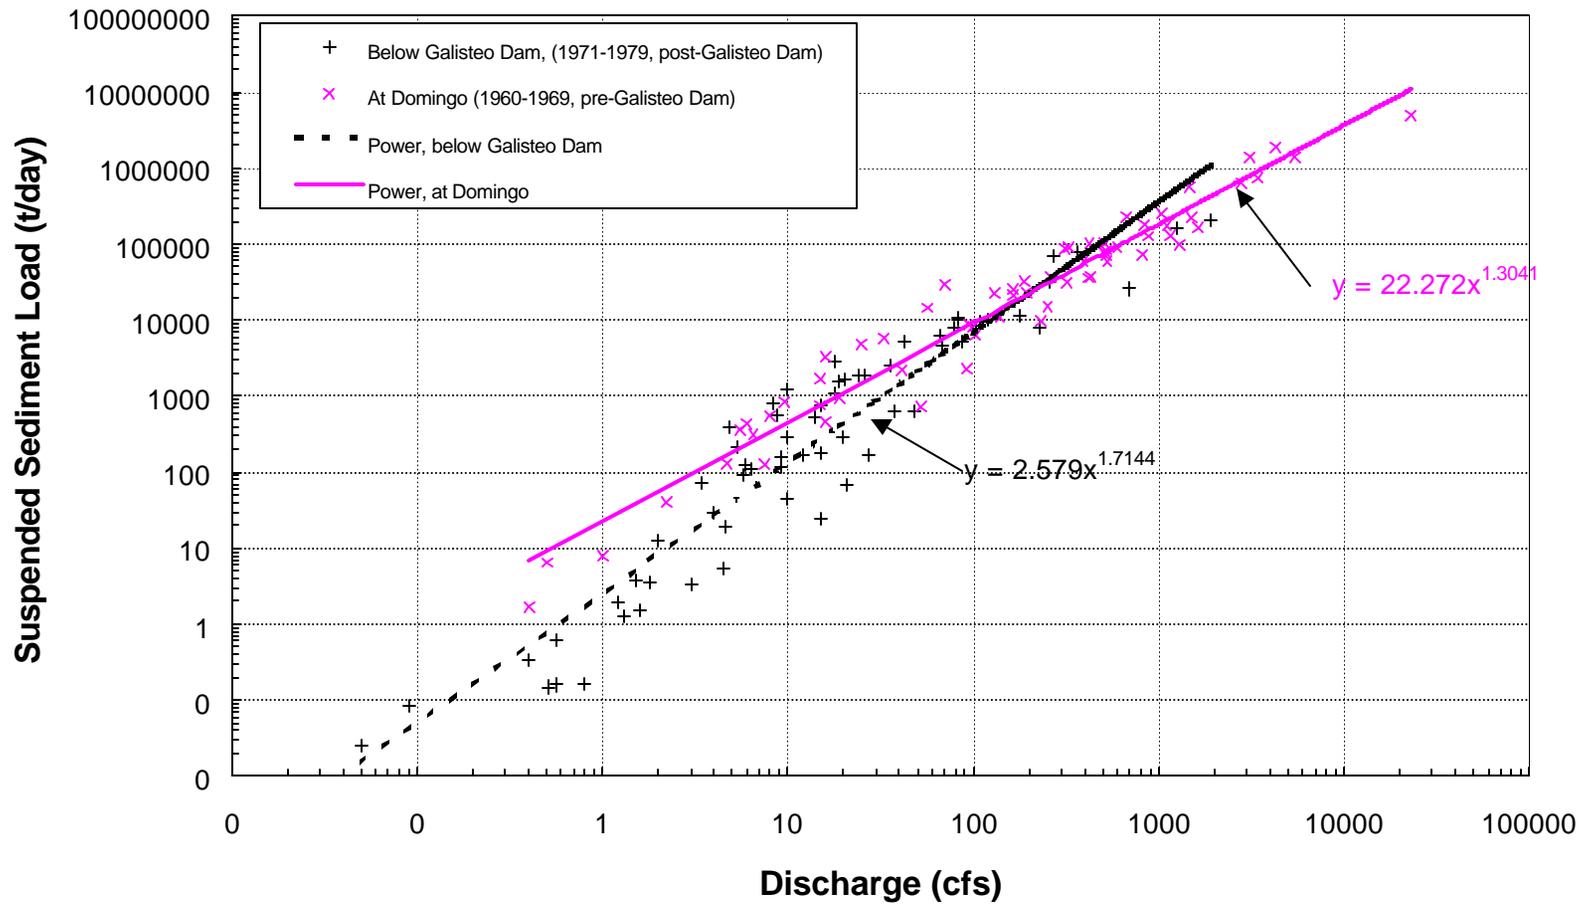
Figure 3.77. Suspended-sediment rating curves for Galisteo Creek at Santo Domingo (1960-1969) and below Galisteo Dam (1971-1979).

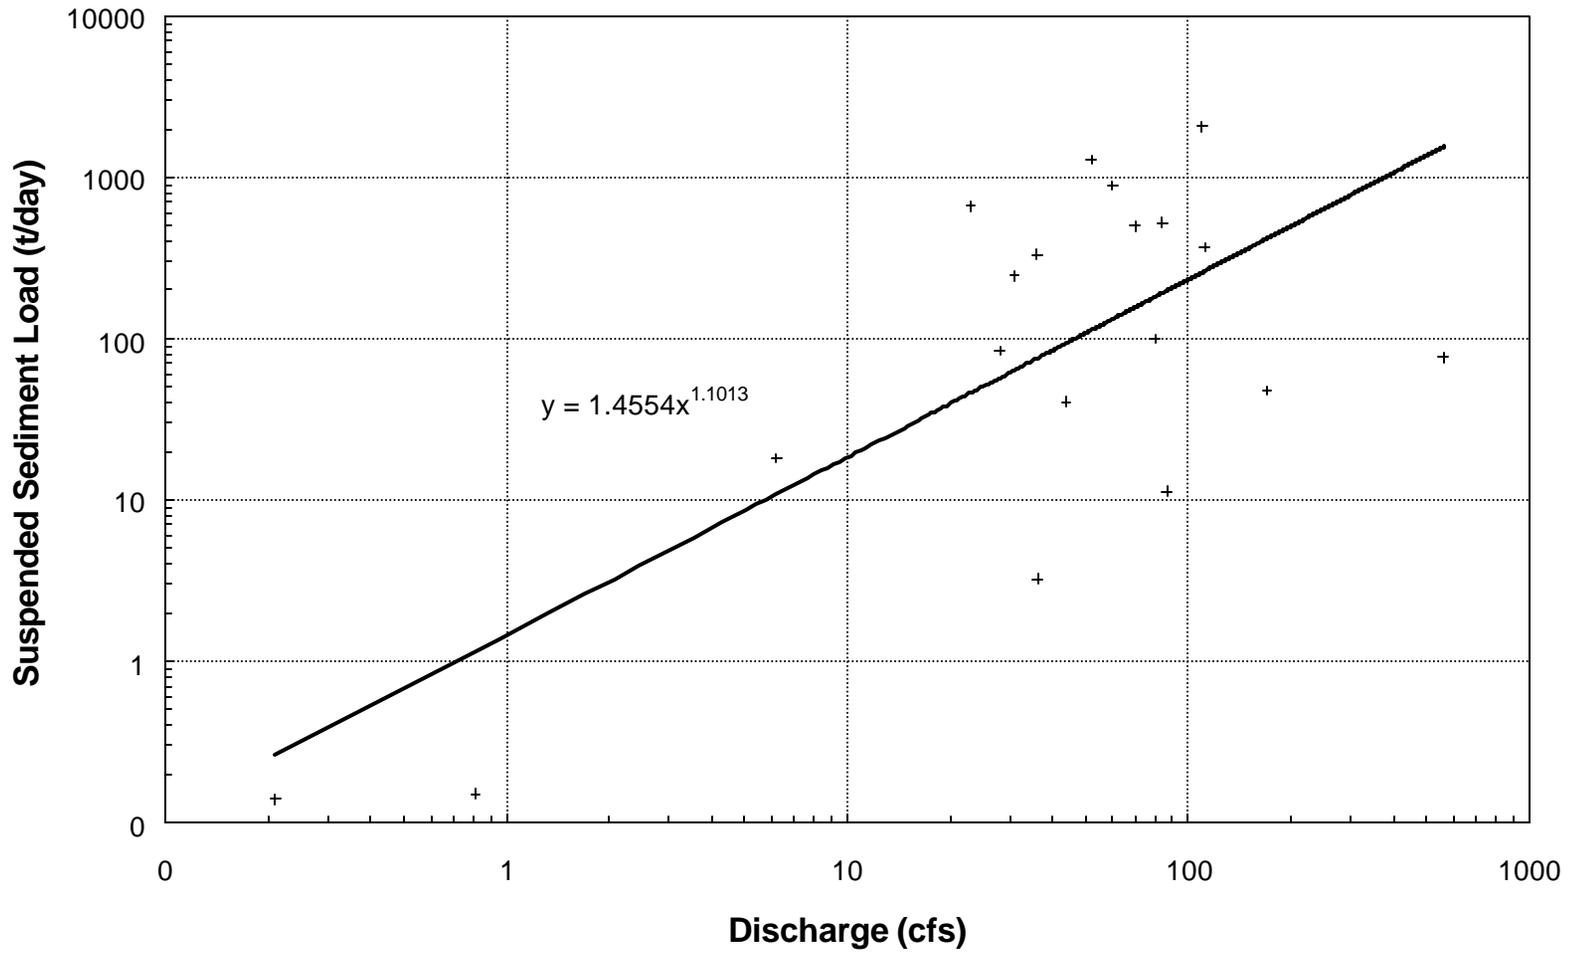
Figure 3.78. Suspended-sediment rating curve for Jemez River downstream of Jemez Reservoir for the period from 1974 to 1996.

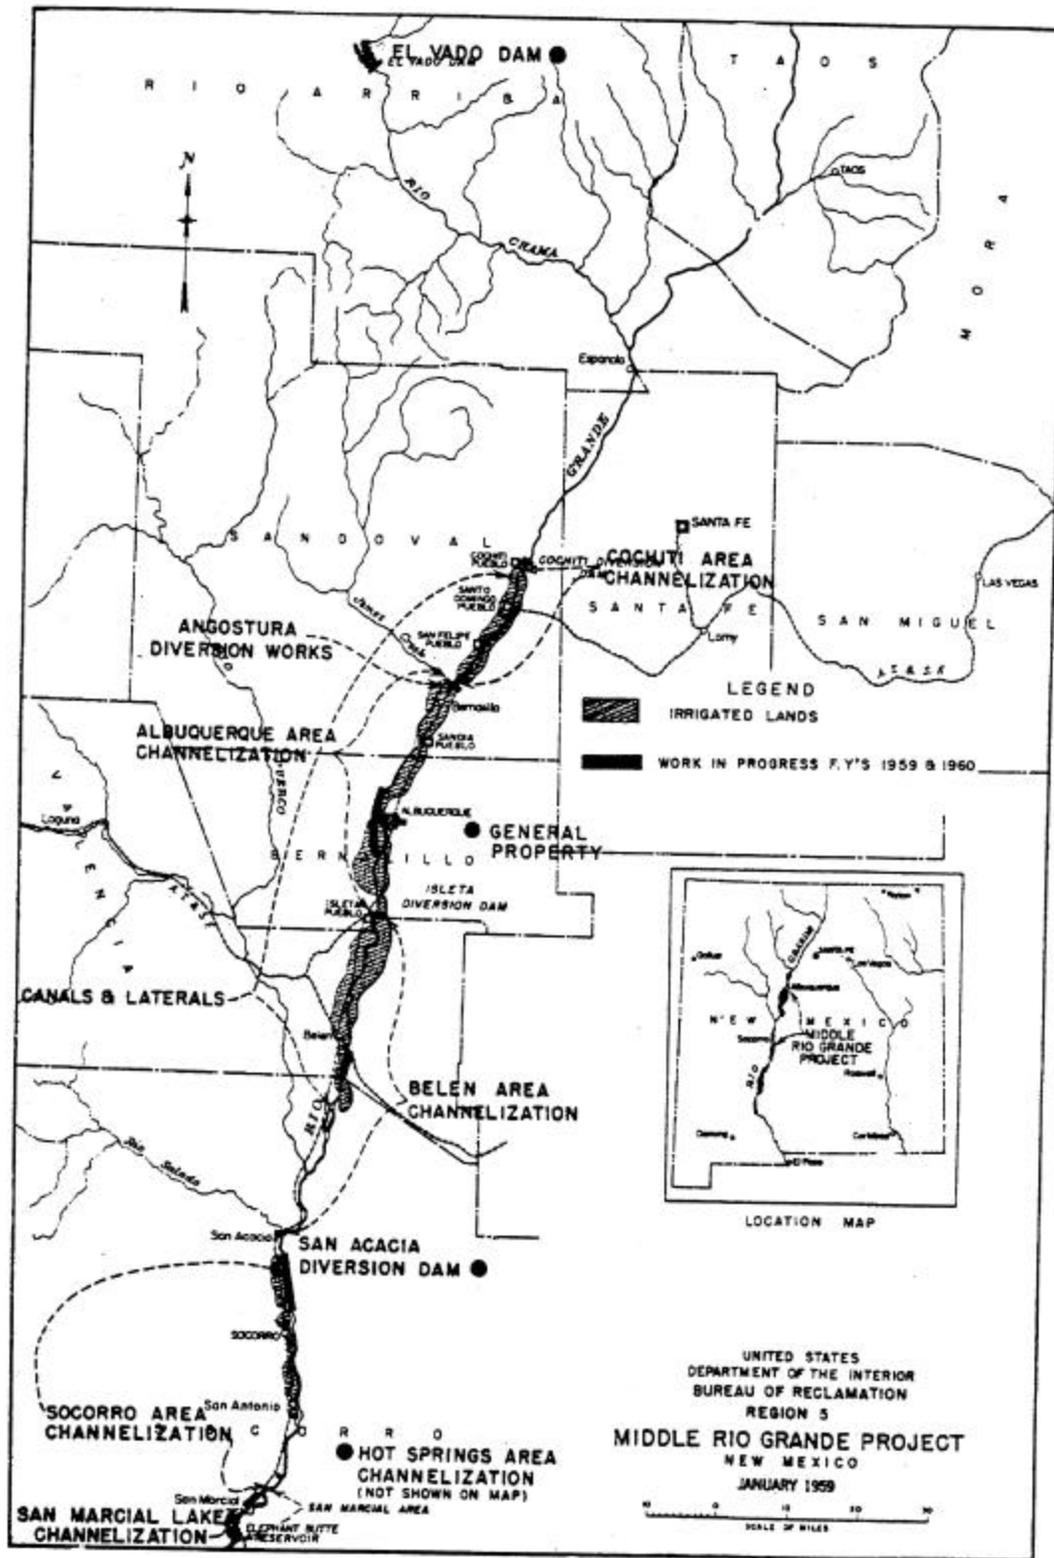
Figure 3.81. Map showing the extent of modification of the Middle Rio Grande for the purposes of irrigation and flood control (COE, 1963).

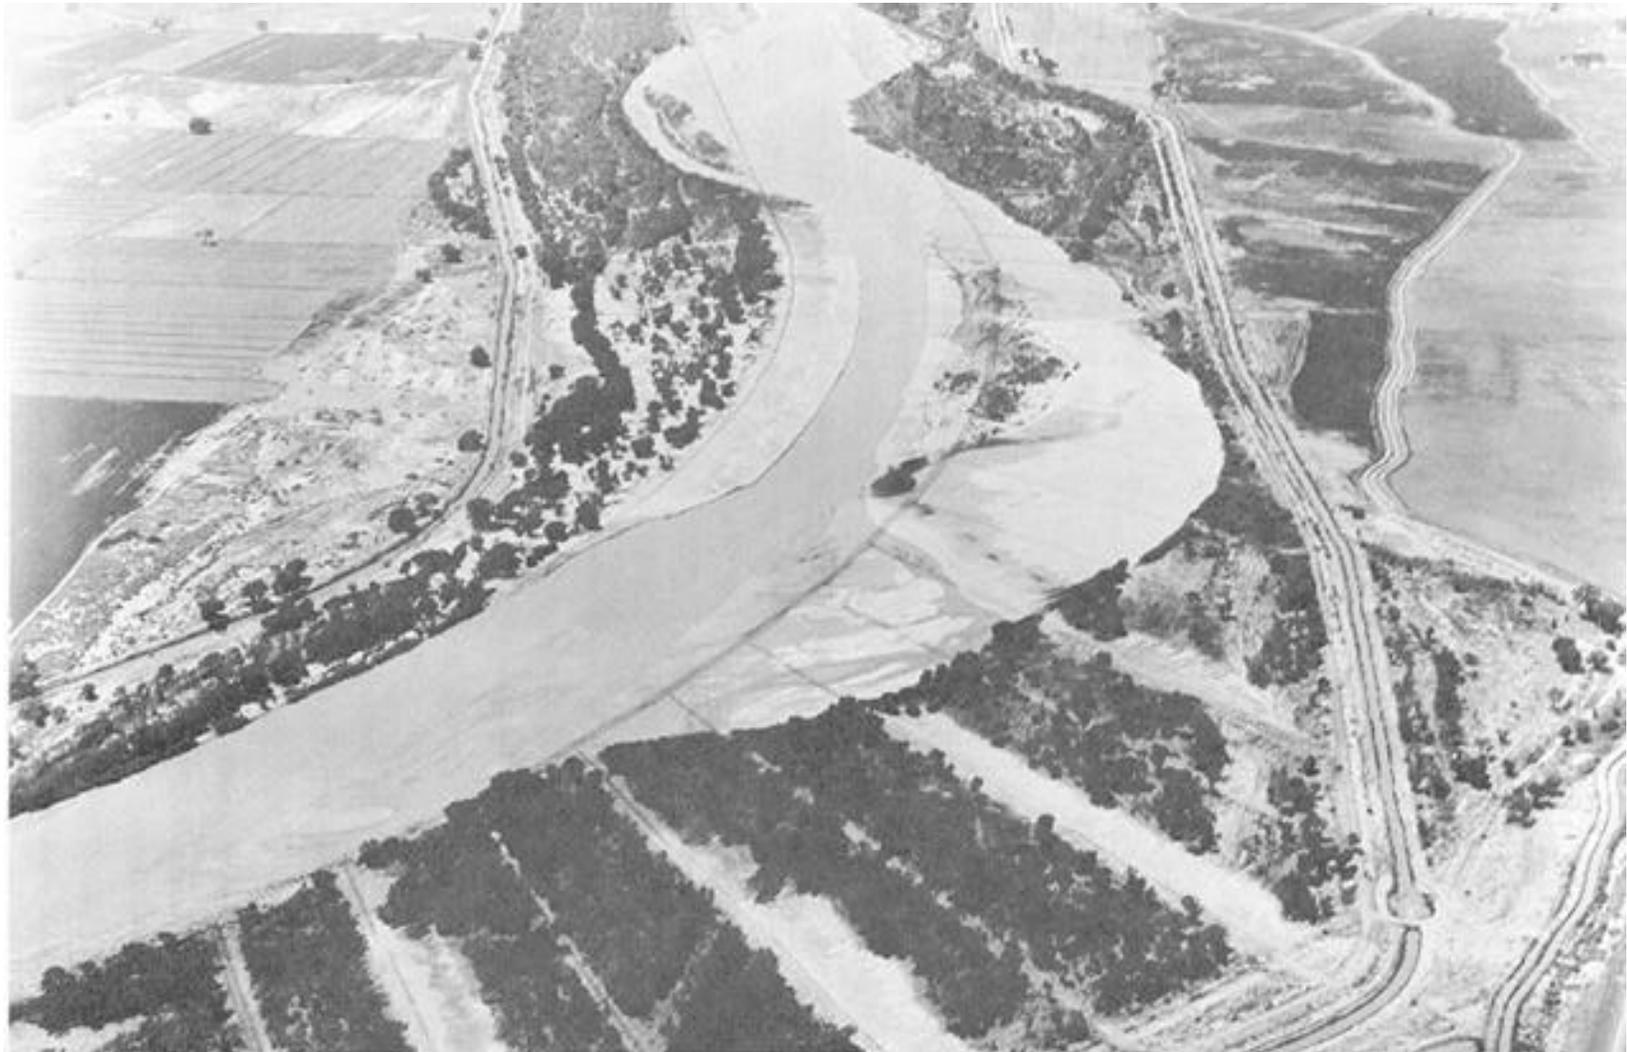
Figure 3.82. Aerial view of a completed jetty system, including a dredged pilot channel on the Middle Rio Grande (COE, 1963).

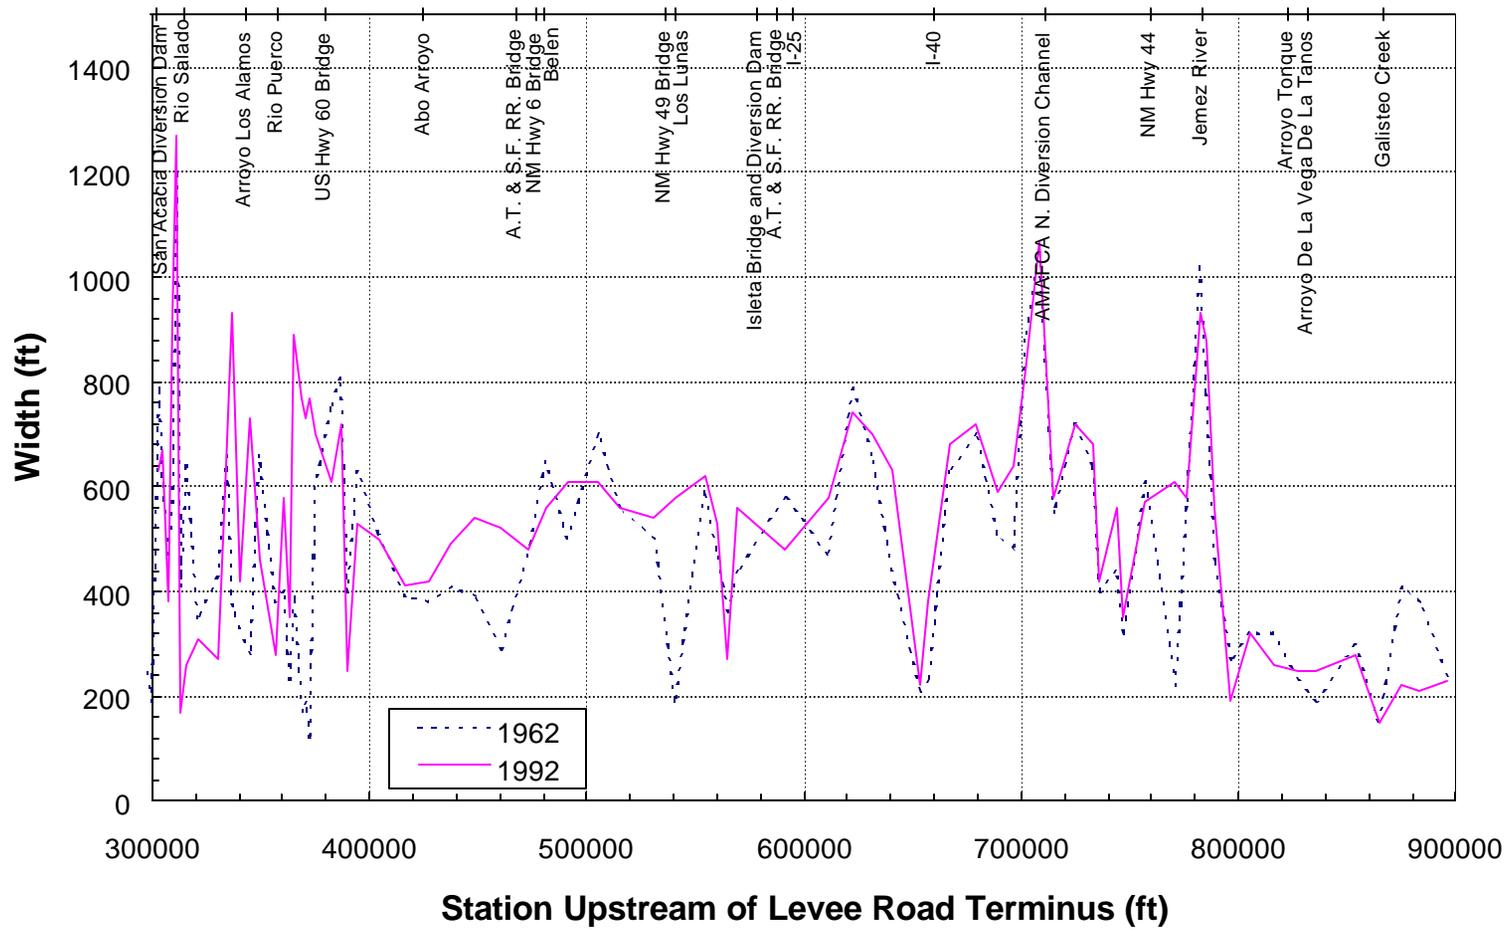
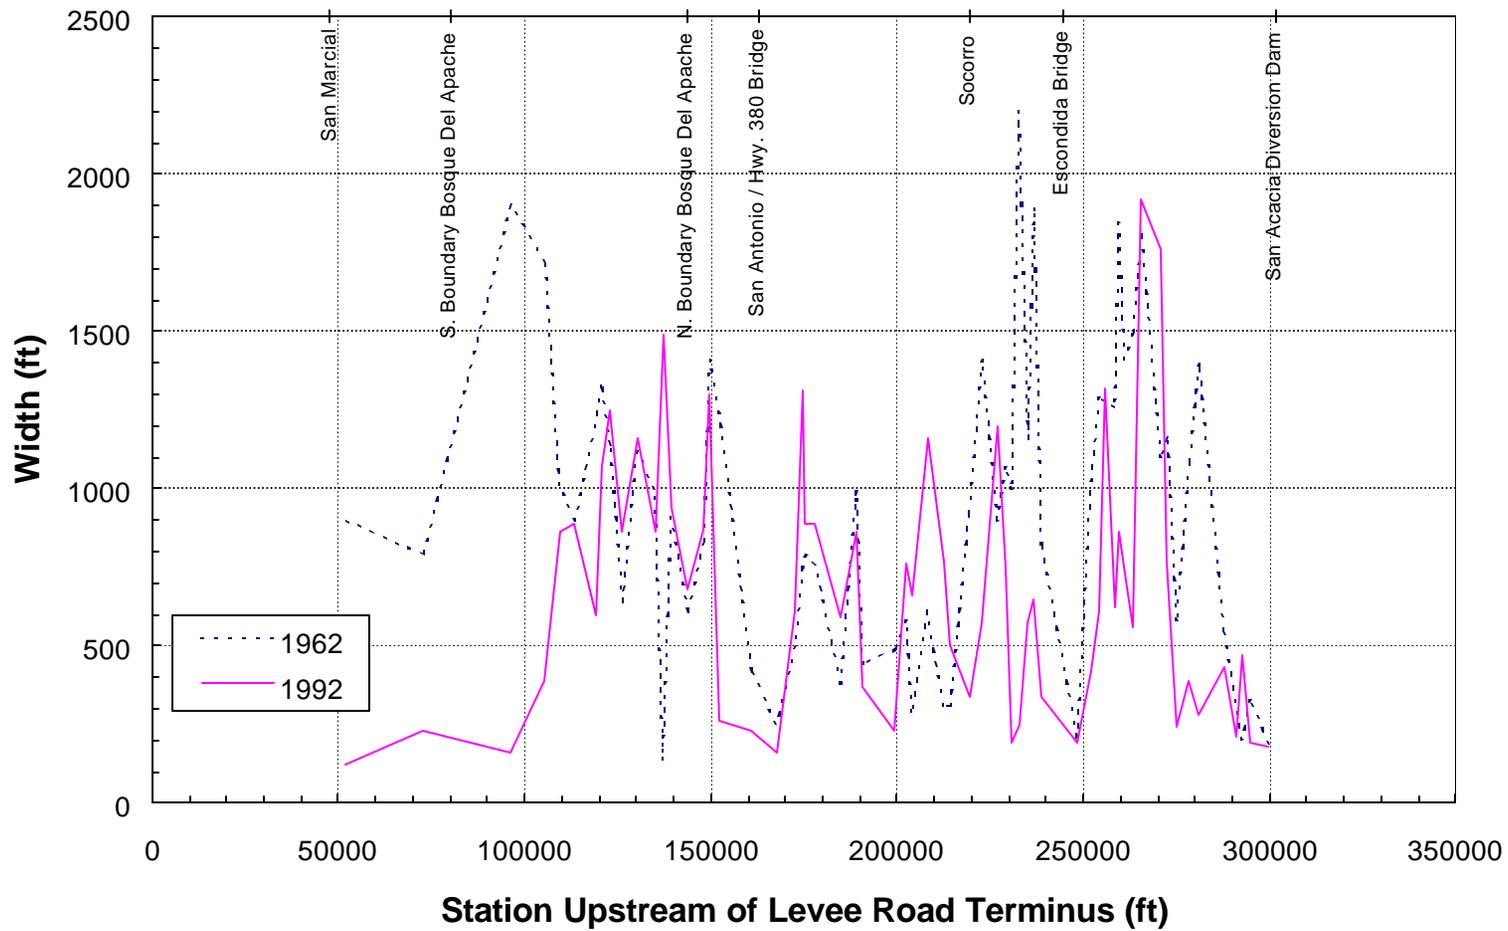
Figure 4.1a. Channel widths between San Acacia and Cochiti Reservoir plotted against station for 1962 and 1992 periods.

Figure 4.1b. Channel widths between San Marcial and San Acacia plotted against station for 1962 and 1992 periods.

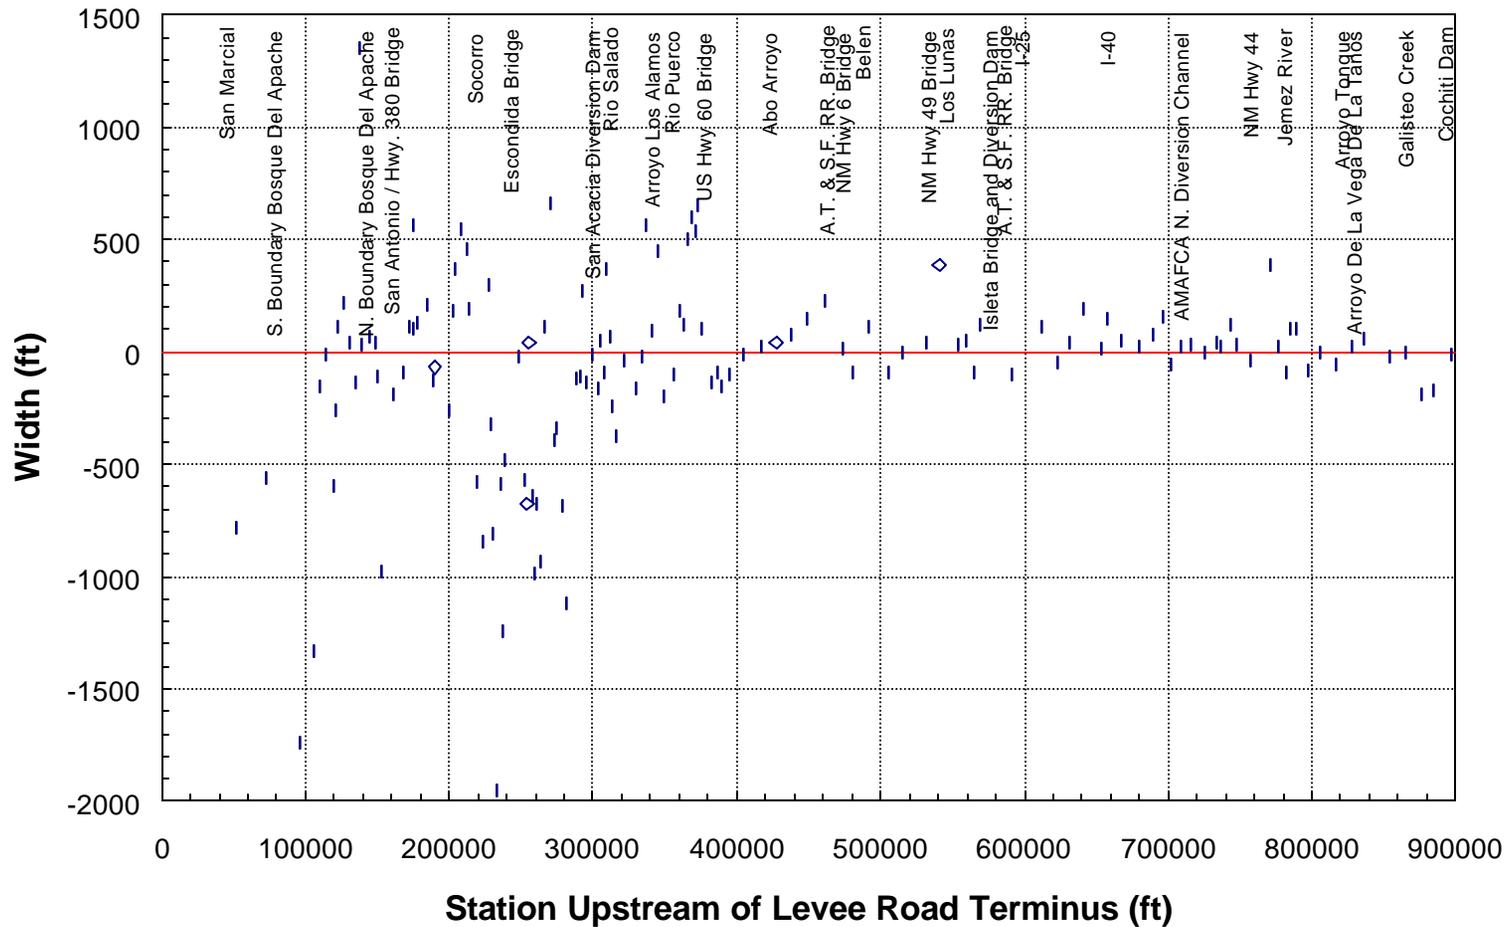
Figure 4.2. Changes in channel width between 1962 and 1992 plotted against station between San Marcial and Cochiti Reservoir. Positive values indicate an increase in width and negative values indicate a decrease in width.
