# 1. INTRODUCTION

## 1.1. Background

The Middle Rio Grande, as defined in this report, is that part of the Rio Grande in New Mexico that extends from Cochiti Dam to Elephant Butte Reservoir, a distance of about 165 miles (**Figure 1.1**). The Rio Grande valley has been a home to the Pueblo people, Spanish colonizers, and Americans (Horgan, 1954; Crawford et al., 1993). The valley has a complex geomorphic and geologic history (Belcher, 1975) and hydrologic conditions are unusual (Graf, 1994). For example, discharge decreases as the river flows from areas of higher to lower precipitation (**Figure 1.2**). However, contributions from Rio Puerco and Rio Salado increase flood peaks between Albuquerque and San Marcial (**Figure 1.3**). Both suspended load and bed load are increased dramatically by contributions from the Rio Puerco and Rio Salado (**Figures 1.4 and 1.5**).

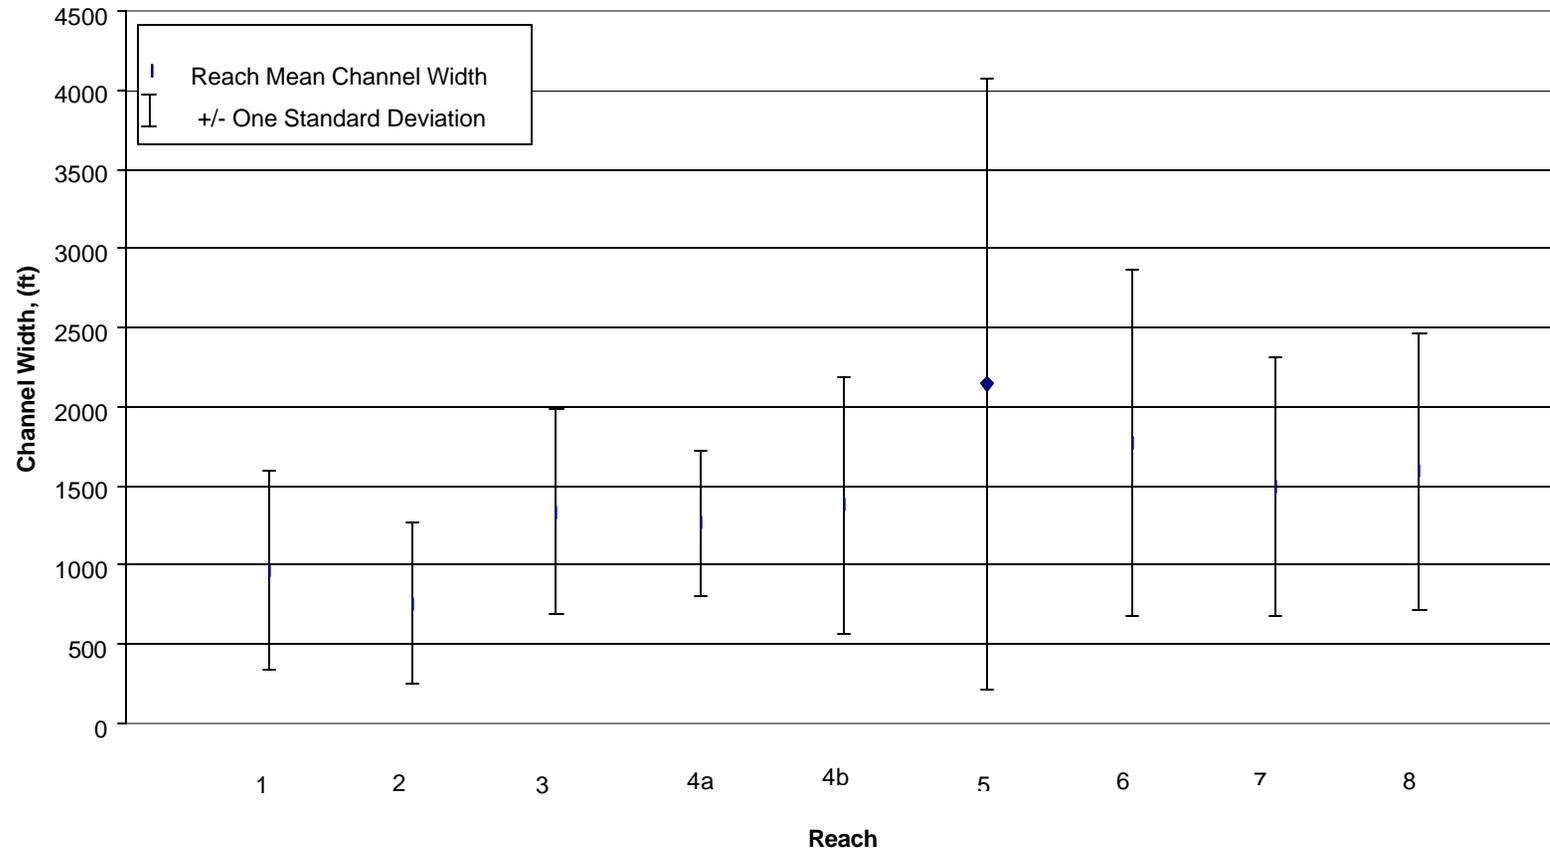
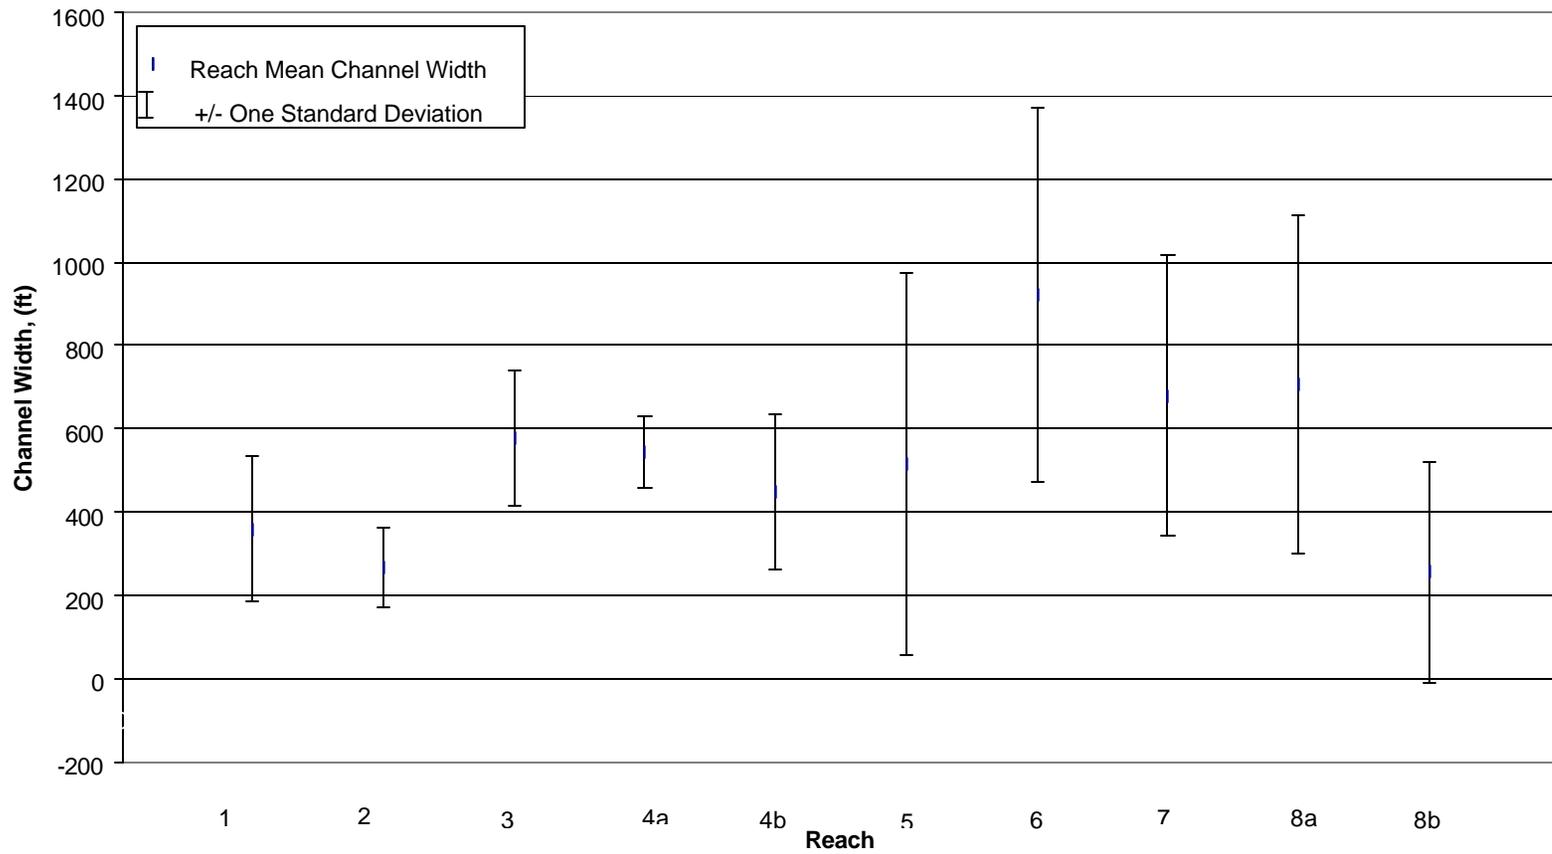
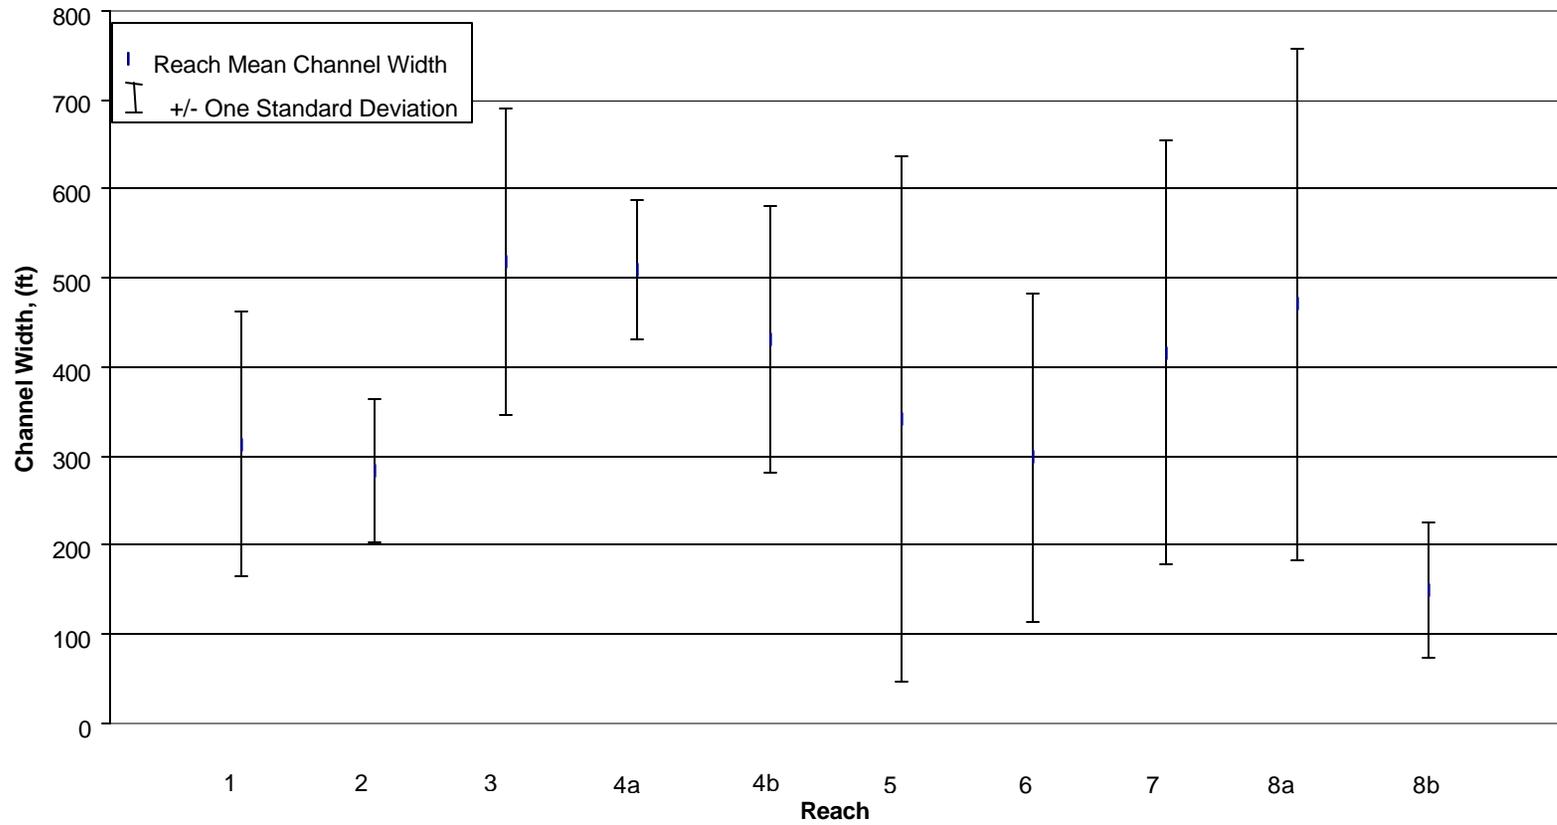
Figure 4.3. 1917-1918 mean widths and standard deviations about the mean for the identified reaches of the Middle Rio Grande.

Figure 4.4. 1972 mean widths and standard deviations about the mean for the identified reaches of the Middle Rio Grande.

Figure 4.5. 1982 mean widths and standard deviations about the mean for the identified reaches of the Middle Rio Grande.

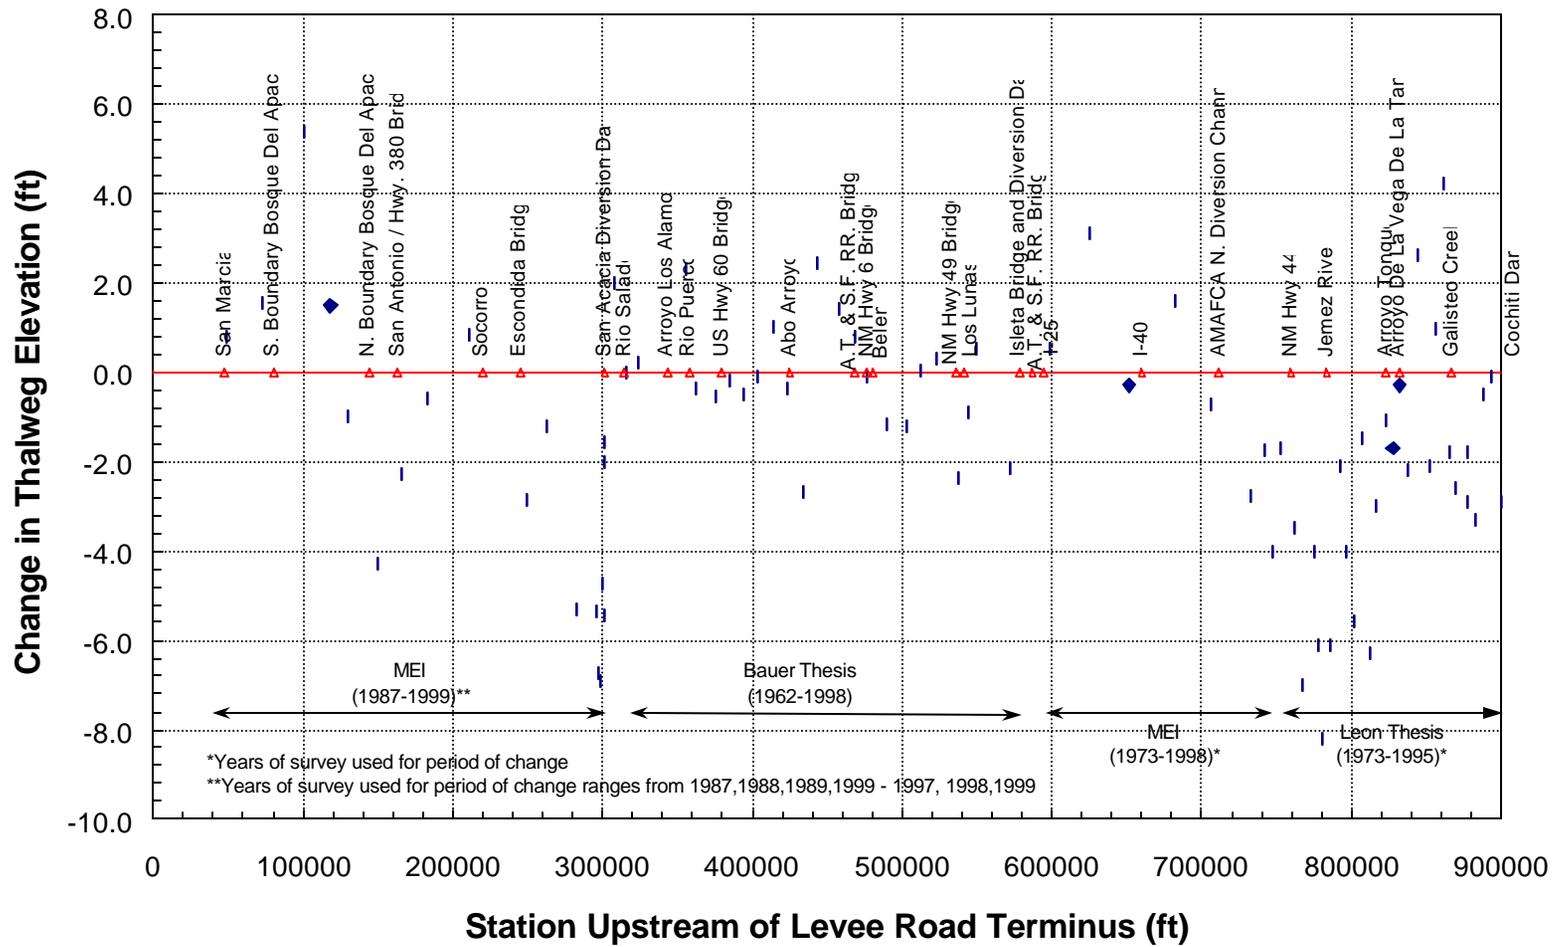
Figure 4.6. Changes in thalweg elevation along the Rio Grande between Cochiti Reservoir and Elephant Butte Reservoir. Positive values indicate aggradation and negative values indicate degradation.

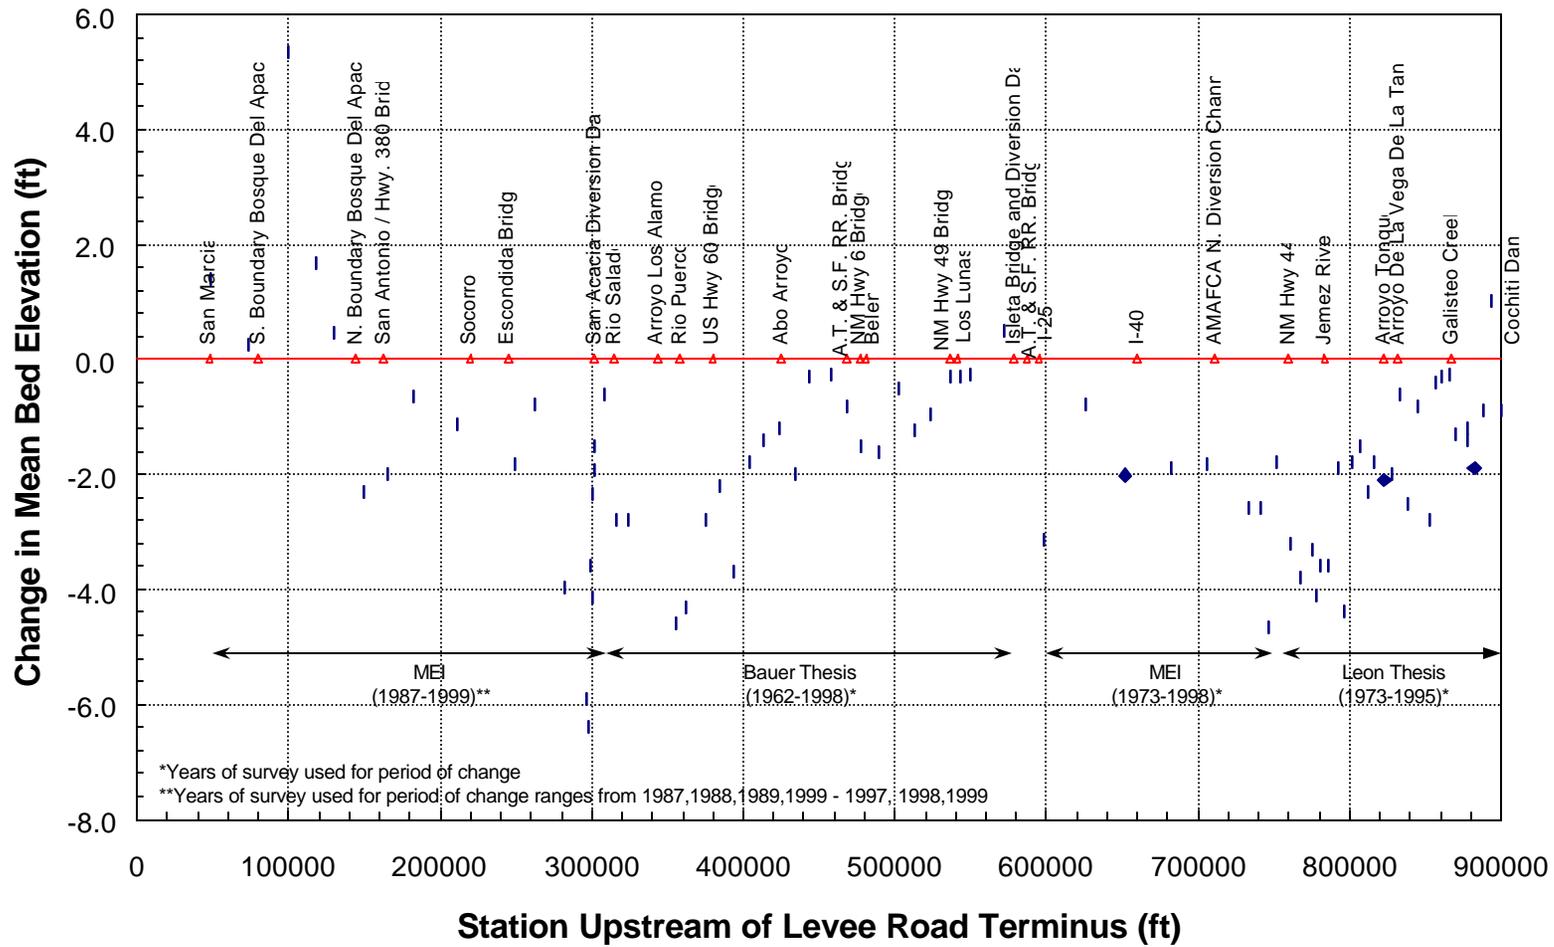
Figure 4.7. Changes in mean bed elevation along the Rio Grande between Cochiti Reservoir and Elephant Butte Reservoir. Positive values indicate aggradation and negative values indicate degradation.

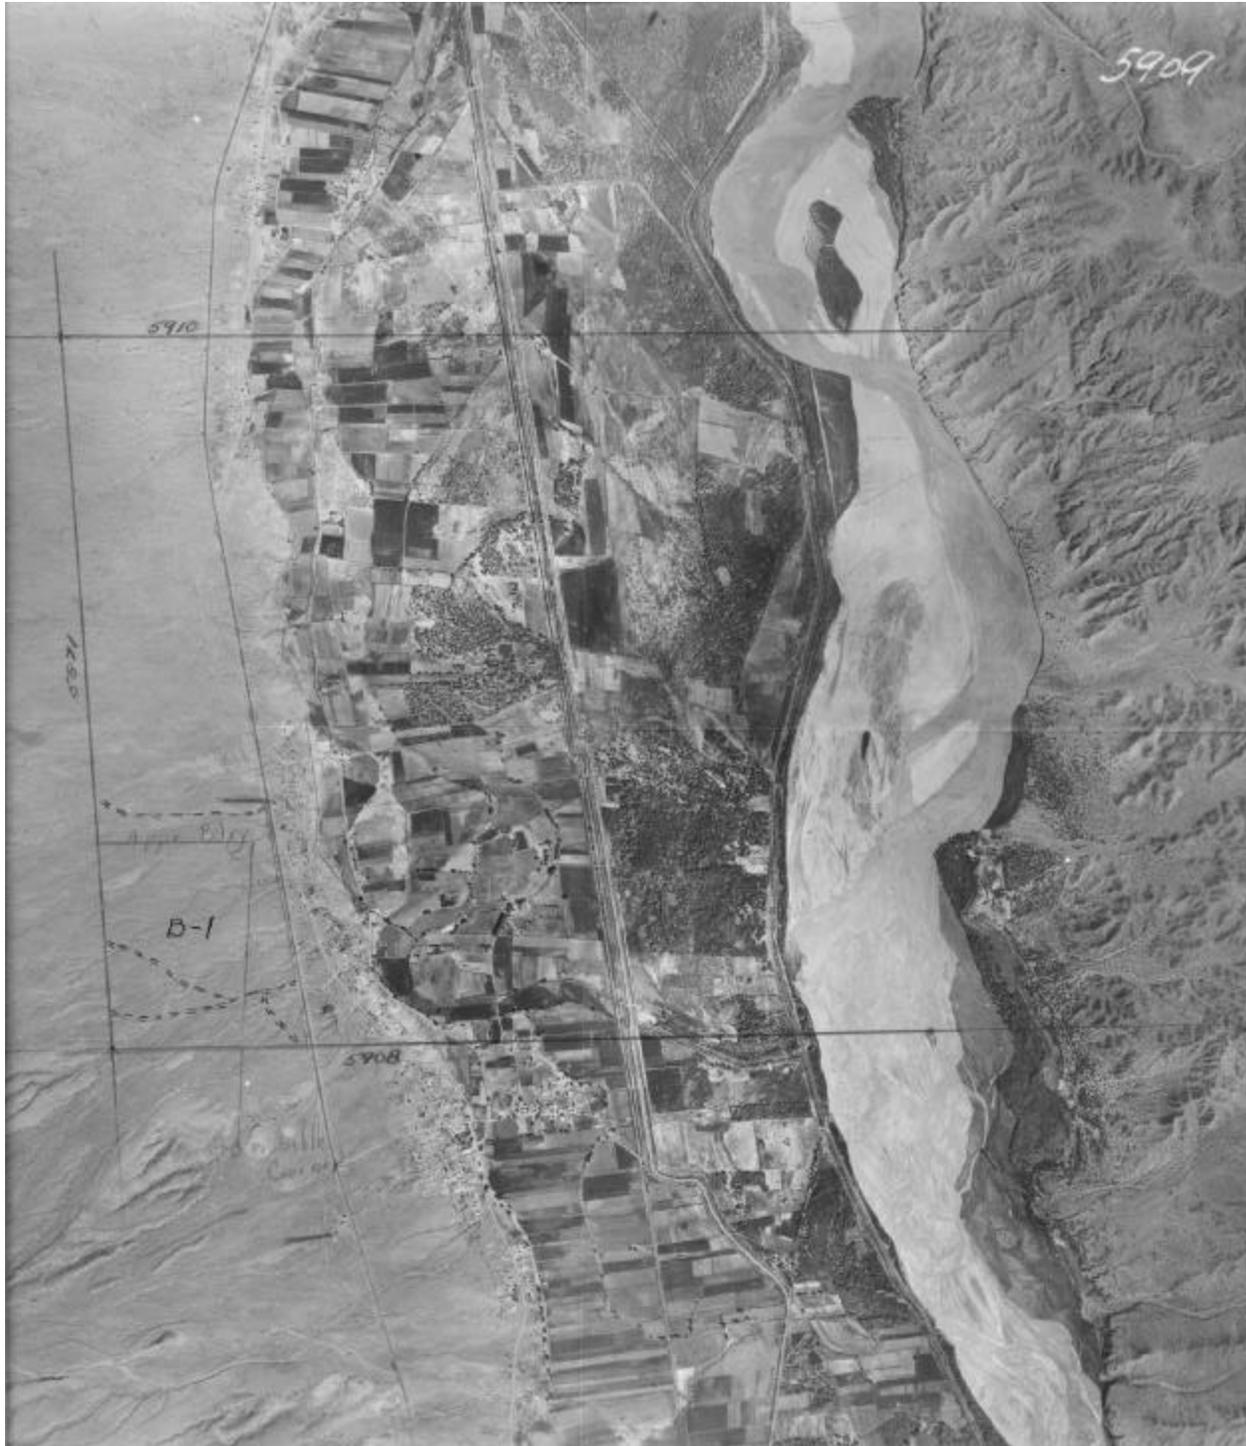
Figure 4.9. 1935 aerial photograph (#5909A) of the Rio Grande between Escondida and San Antonio showing the destruction of riparian vegetation by the floods of the early 1930s (RM 96-RM 101).

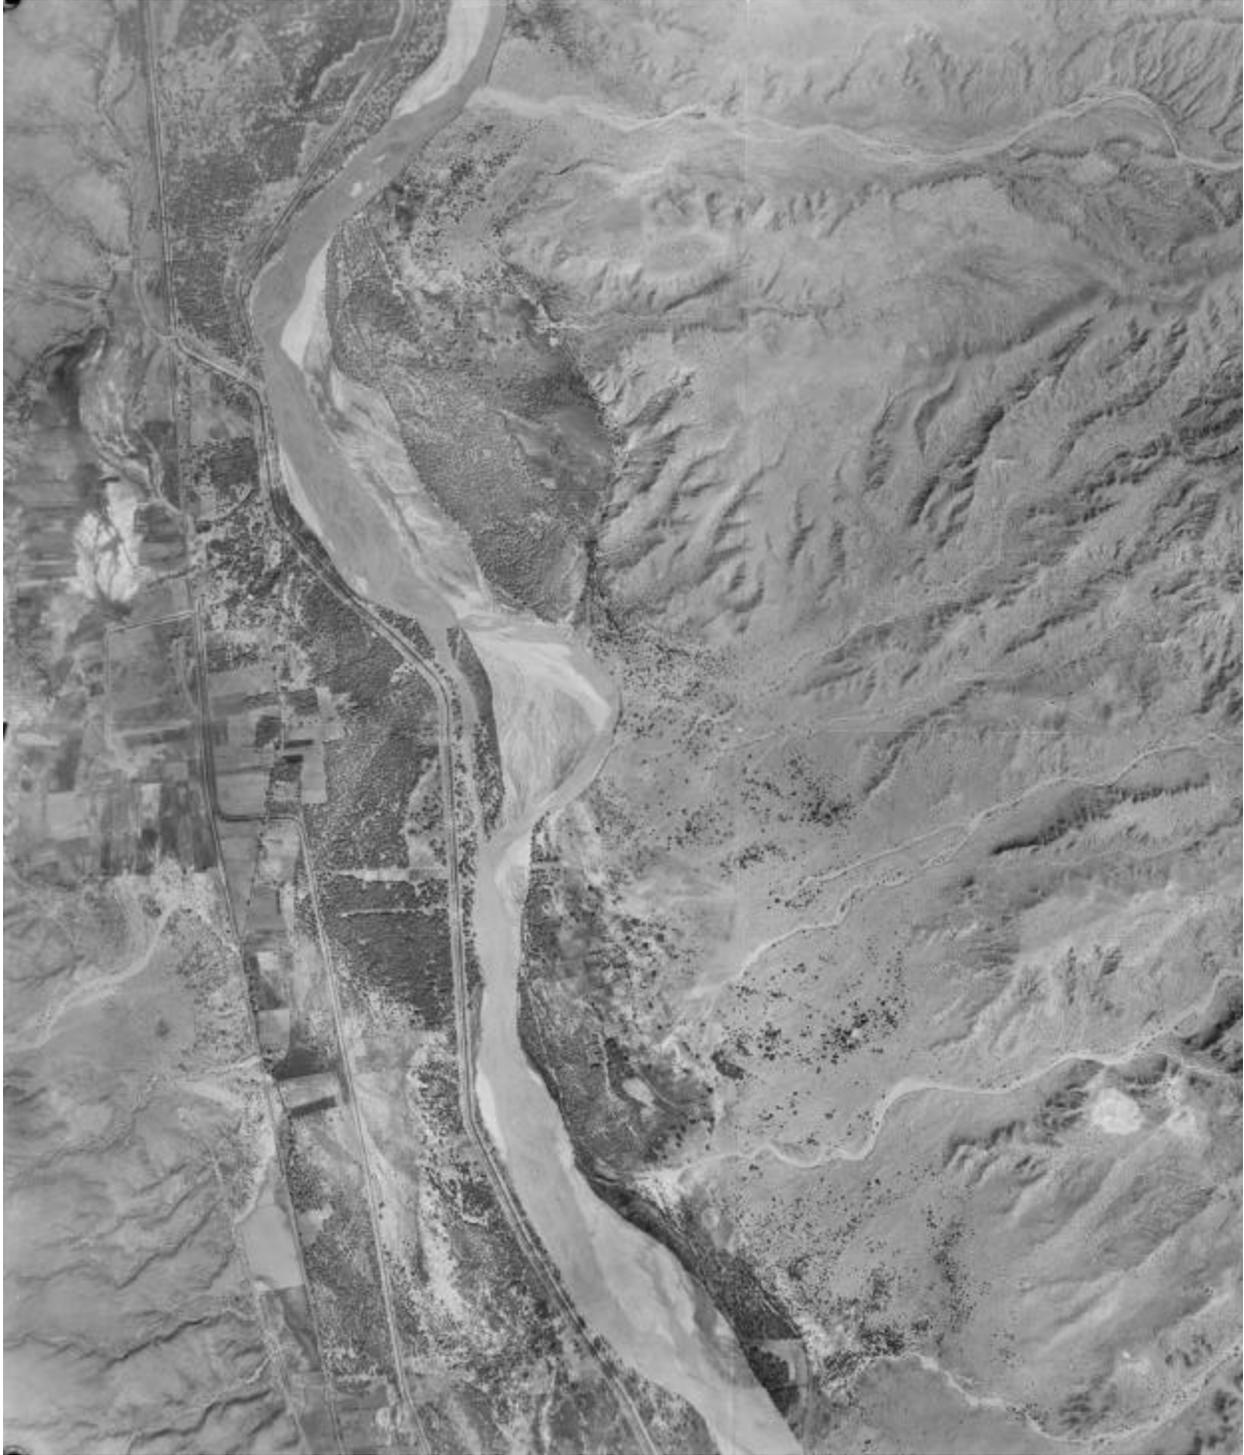
Figure 4.10. 1935 aerial photograph (#5927A) of the Rio Grande downstream of San Lorenzo showing the cutoff of a bend following the floods of the early 1930s (RM 112-RM 114).
