APPENDIX 12. 5 - LAND USE

Land Use History of North America - (LUHNA): Repeat Photography By: **Craig D. Allen**, *U.S. Geological Survey, Midcontinent Ecological Science Center*; **Julio L. Betancourt**, *U.S. Geological Survey, Desert Laboratory*; y **Thomas W. Swetnam**, *University of Arizona, Laboratory of Tree-Ring Research*

IMPACTS AND CHANGES IN THE RIO PUERCO, 1846–1980: A CASE STUDY

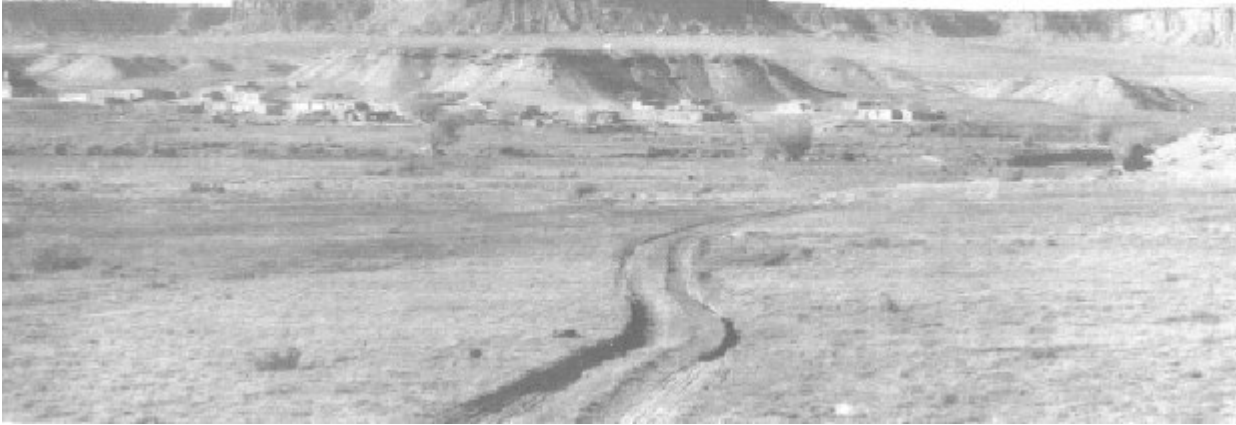
Figure 73a—View north of the town of Cabezón (center) and entrenched Rio Puerco (lower center,) 1917. Note four cottonwoods.
Photo by W.T. Lee, courtesy US Geological Survey Photo Archives, Denver.

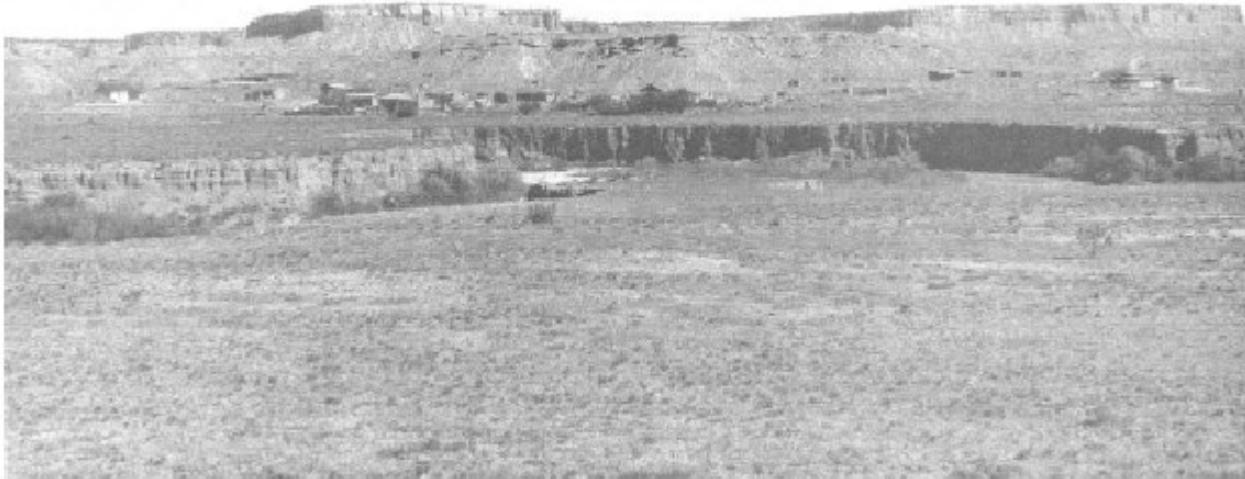
Figure 73b—Repeat photograph of Figure 73a, 1995. Note deeper and wider river channel and salt cedar. Photo by author.
