12.4. PHYSICAL CHARACTERISTICS OR WHY WE LOOK THE WAY WE DO

12.4.1. Introduction

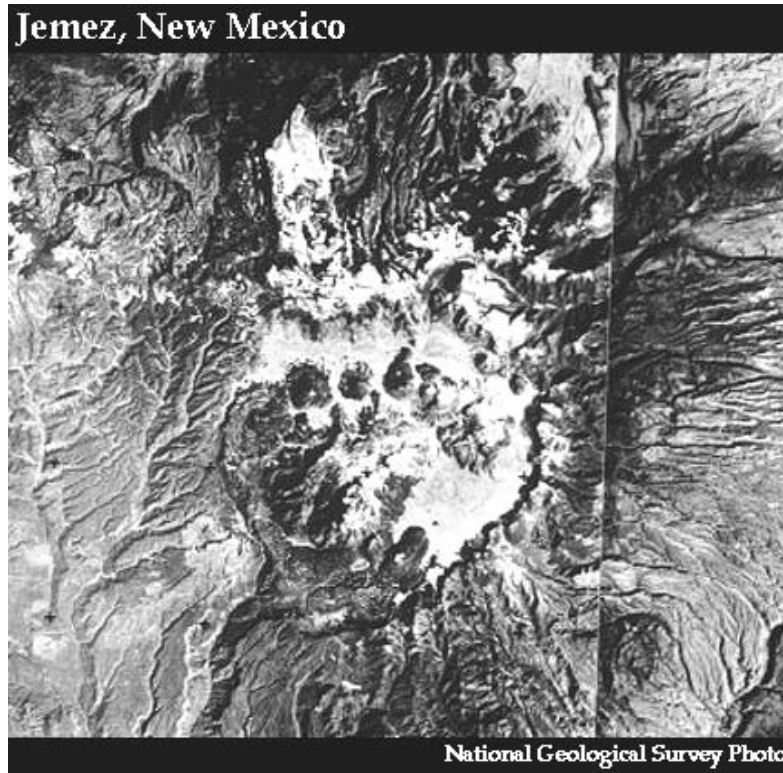
Figure 12.4-2 A Volcanic Beginning

The mountains known as the Jemez are really two geologically different areas: the remnants of a giant volcano that erupted and collapsed a million years ago and the Nacimiento Uplift, a derivative of the same mountain building process, which built the Rockies more than 65 million years ago.

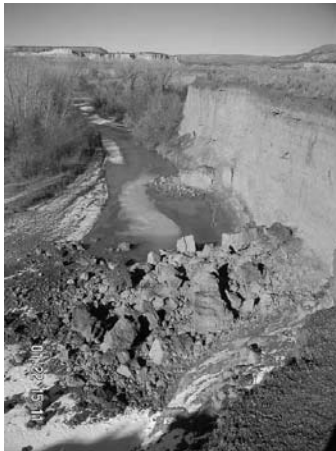
Figure 12.4-7 Río Puerco--Detail of Erosion

Photograph of a collapsing wall of the Río Puerco arroyo. Thousands of similar collapses along all sections of the arroyo place loose sediment directly in the stream channel. With such a constant supply, streams are fully saturated with sediment.

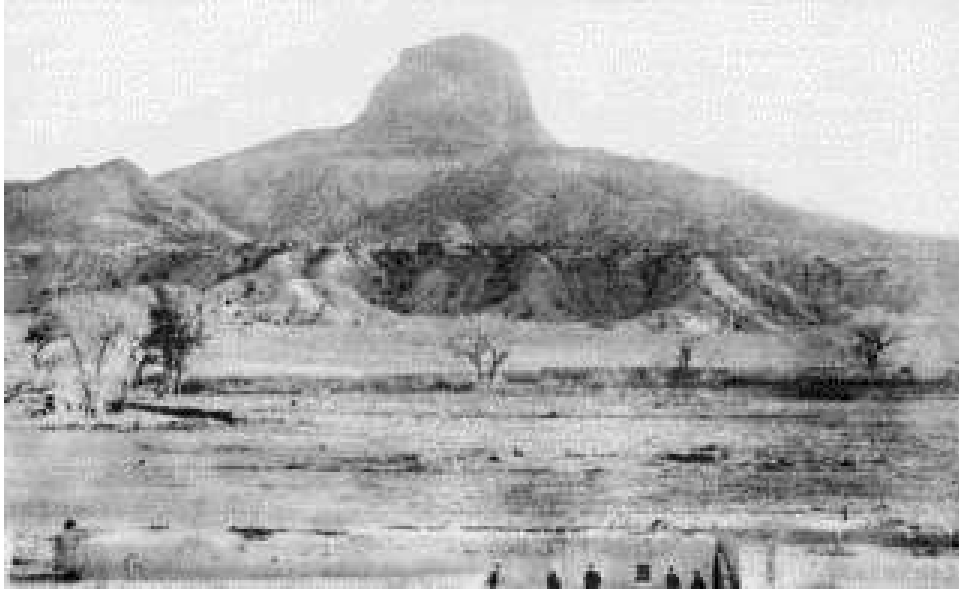
Figure 12.4-8 Río Puerco Arroyo Cycle and the History of Landscape Changes

The Río Puerco near Cabezon in 1885 (photograph by E.A. Bass).

A photograph of the Río Puerco in flood by R.H. Chapman in 1905 shows the main channel to be unincised and flood flow is spread over at least a hundred meters of broad valley floor.

When a valley is filled with fine sediments, as is the valley of the Río Puerco, erosion causes steep-walled gullies called arroyos. These channels significant barriers to transportation, access of livestock to water, and diversion of water for crop irrigation. The process of cutting arroyos into valley bottoms is called incision.

Río Puerco has not always had continuous arroyos. Prior to the 1880's, the area around the nearly abandoned town of San Luis was a broad flood plain. Annual renewal of soils by flood-borne silt encouraged vigorous grass cover. Historical accounts state that this was prime grazing land, and that residents of San Luis irrigated crops by diverting river waters into their fields.

Incision of the arroyo caused drastic changes. The river now flows entirely within the arroyo; without floods, the valley bottom supports desert shrubs rather than grass. Diversion of river water to fields near San Luis would have to originate far upstream, and it is impractical to maintain the needed diversion and transport structures.

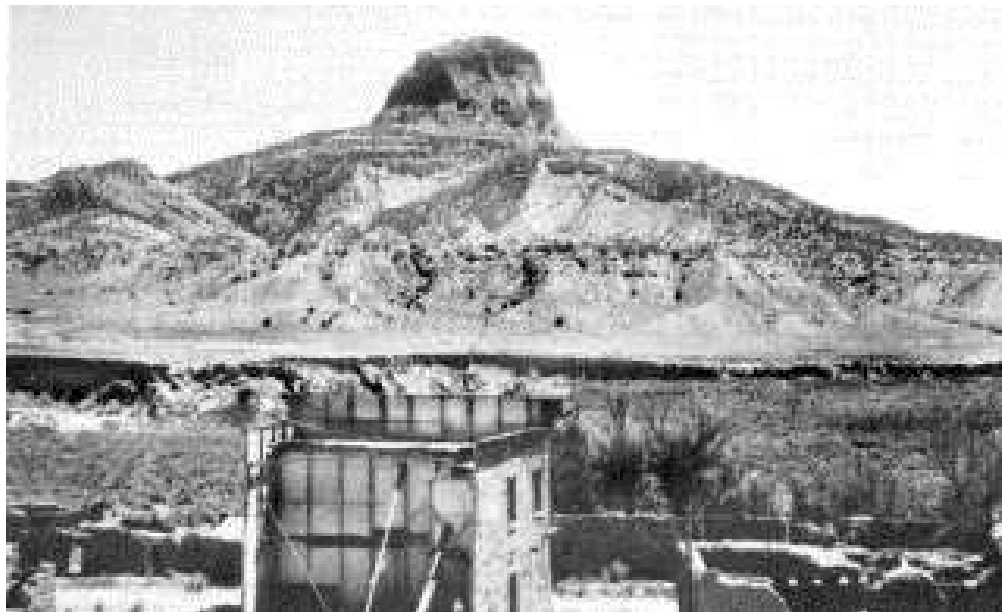
The same reach taken in 1977 (photograph by H.E. Malde).
