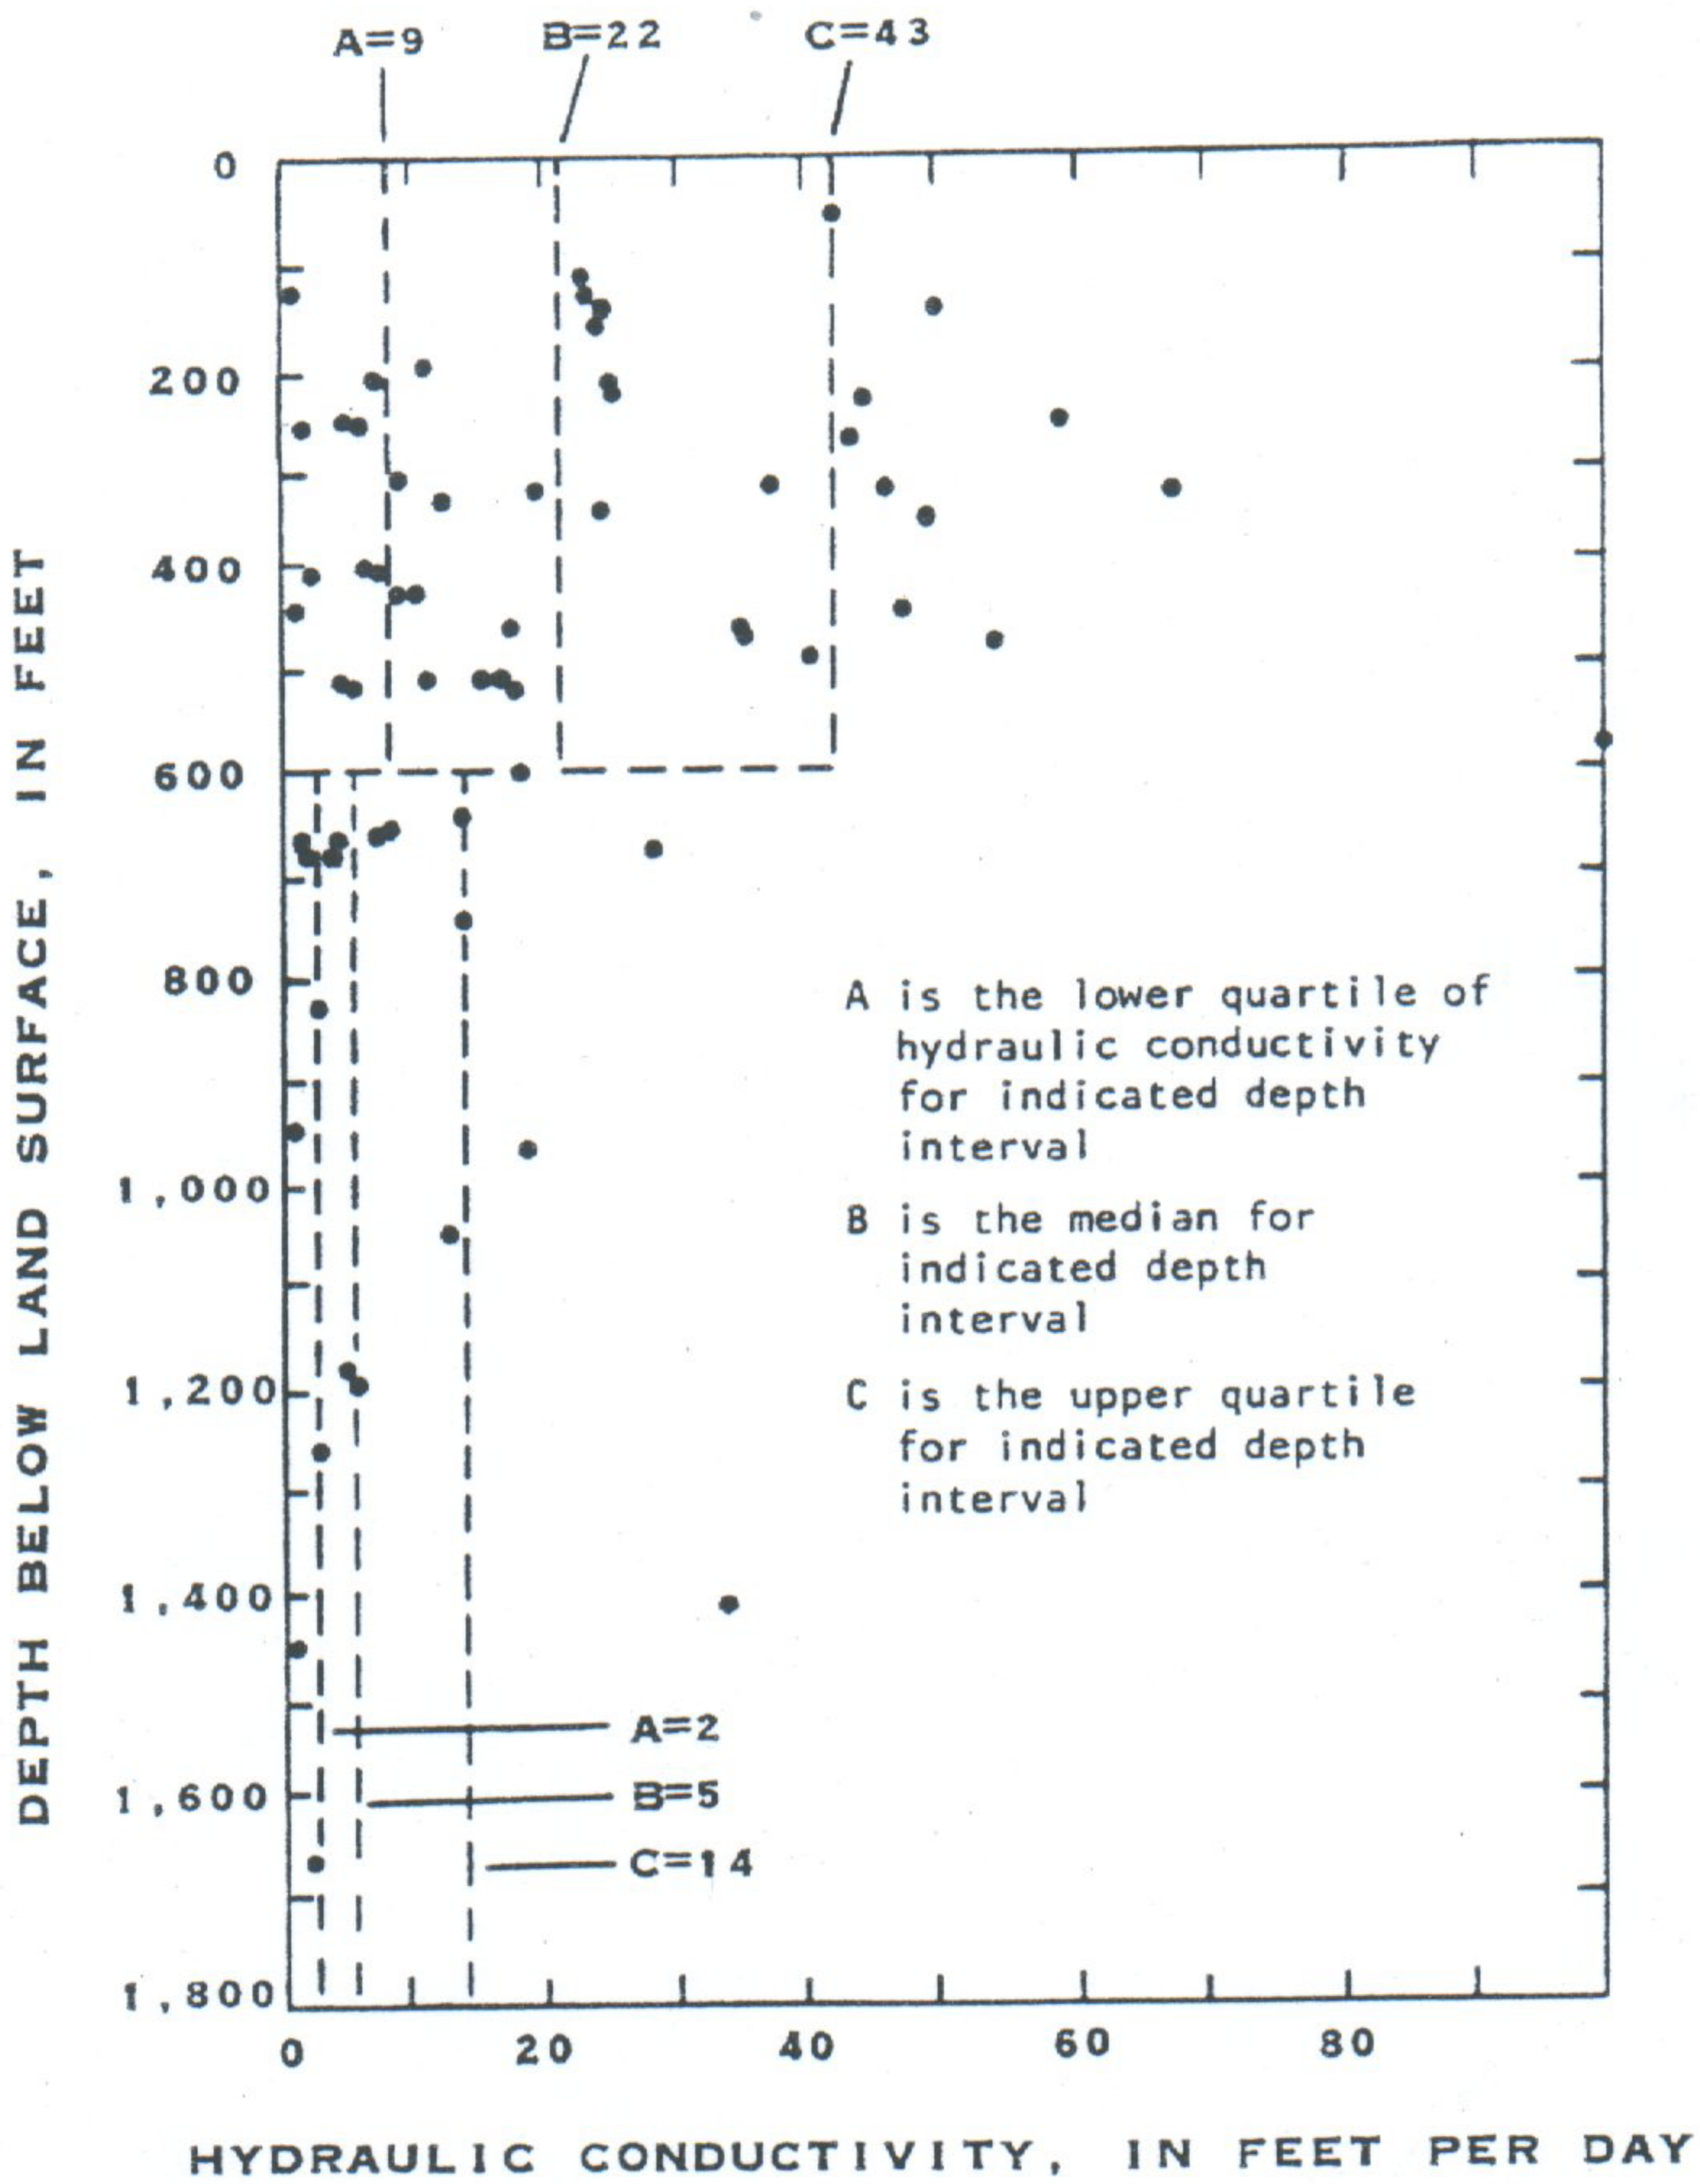
Figure 6.21 Illustration showing hydraulic conductivity distribution with depth, Mesilla Basin, Dona Ana County, New Mexico.

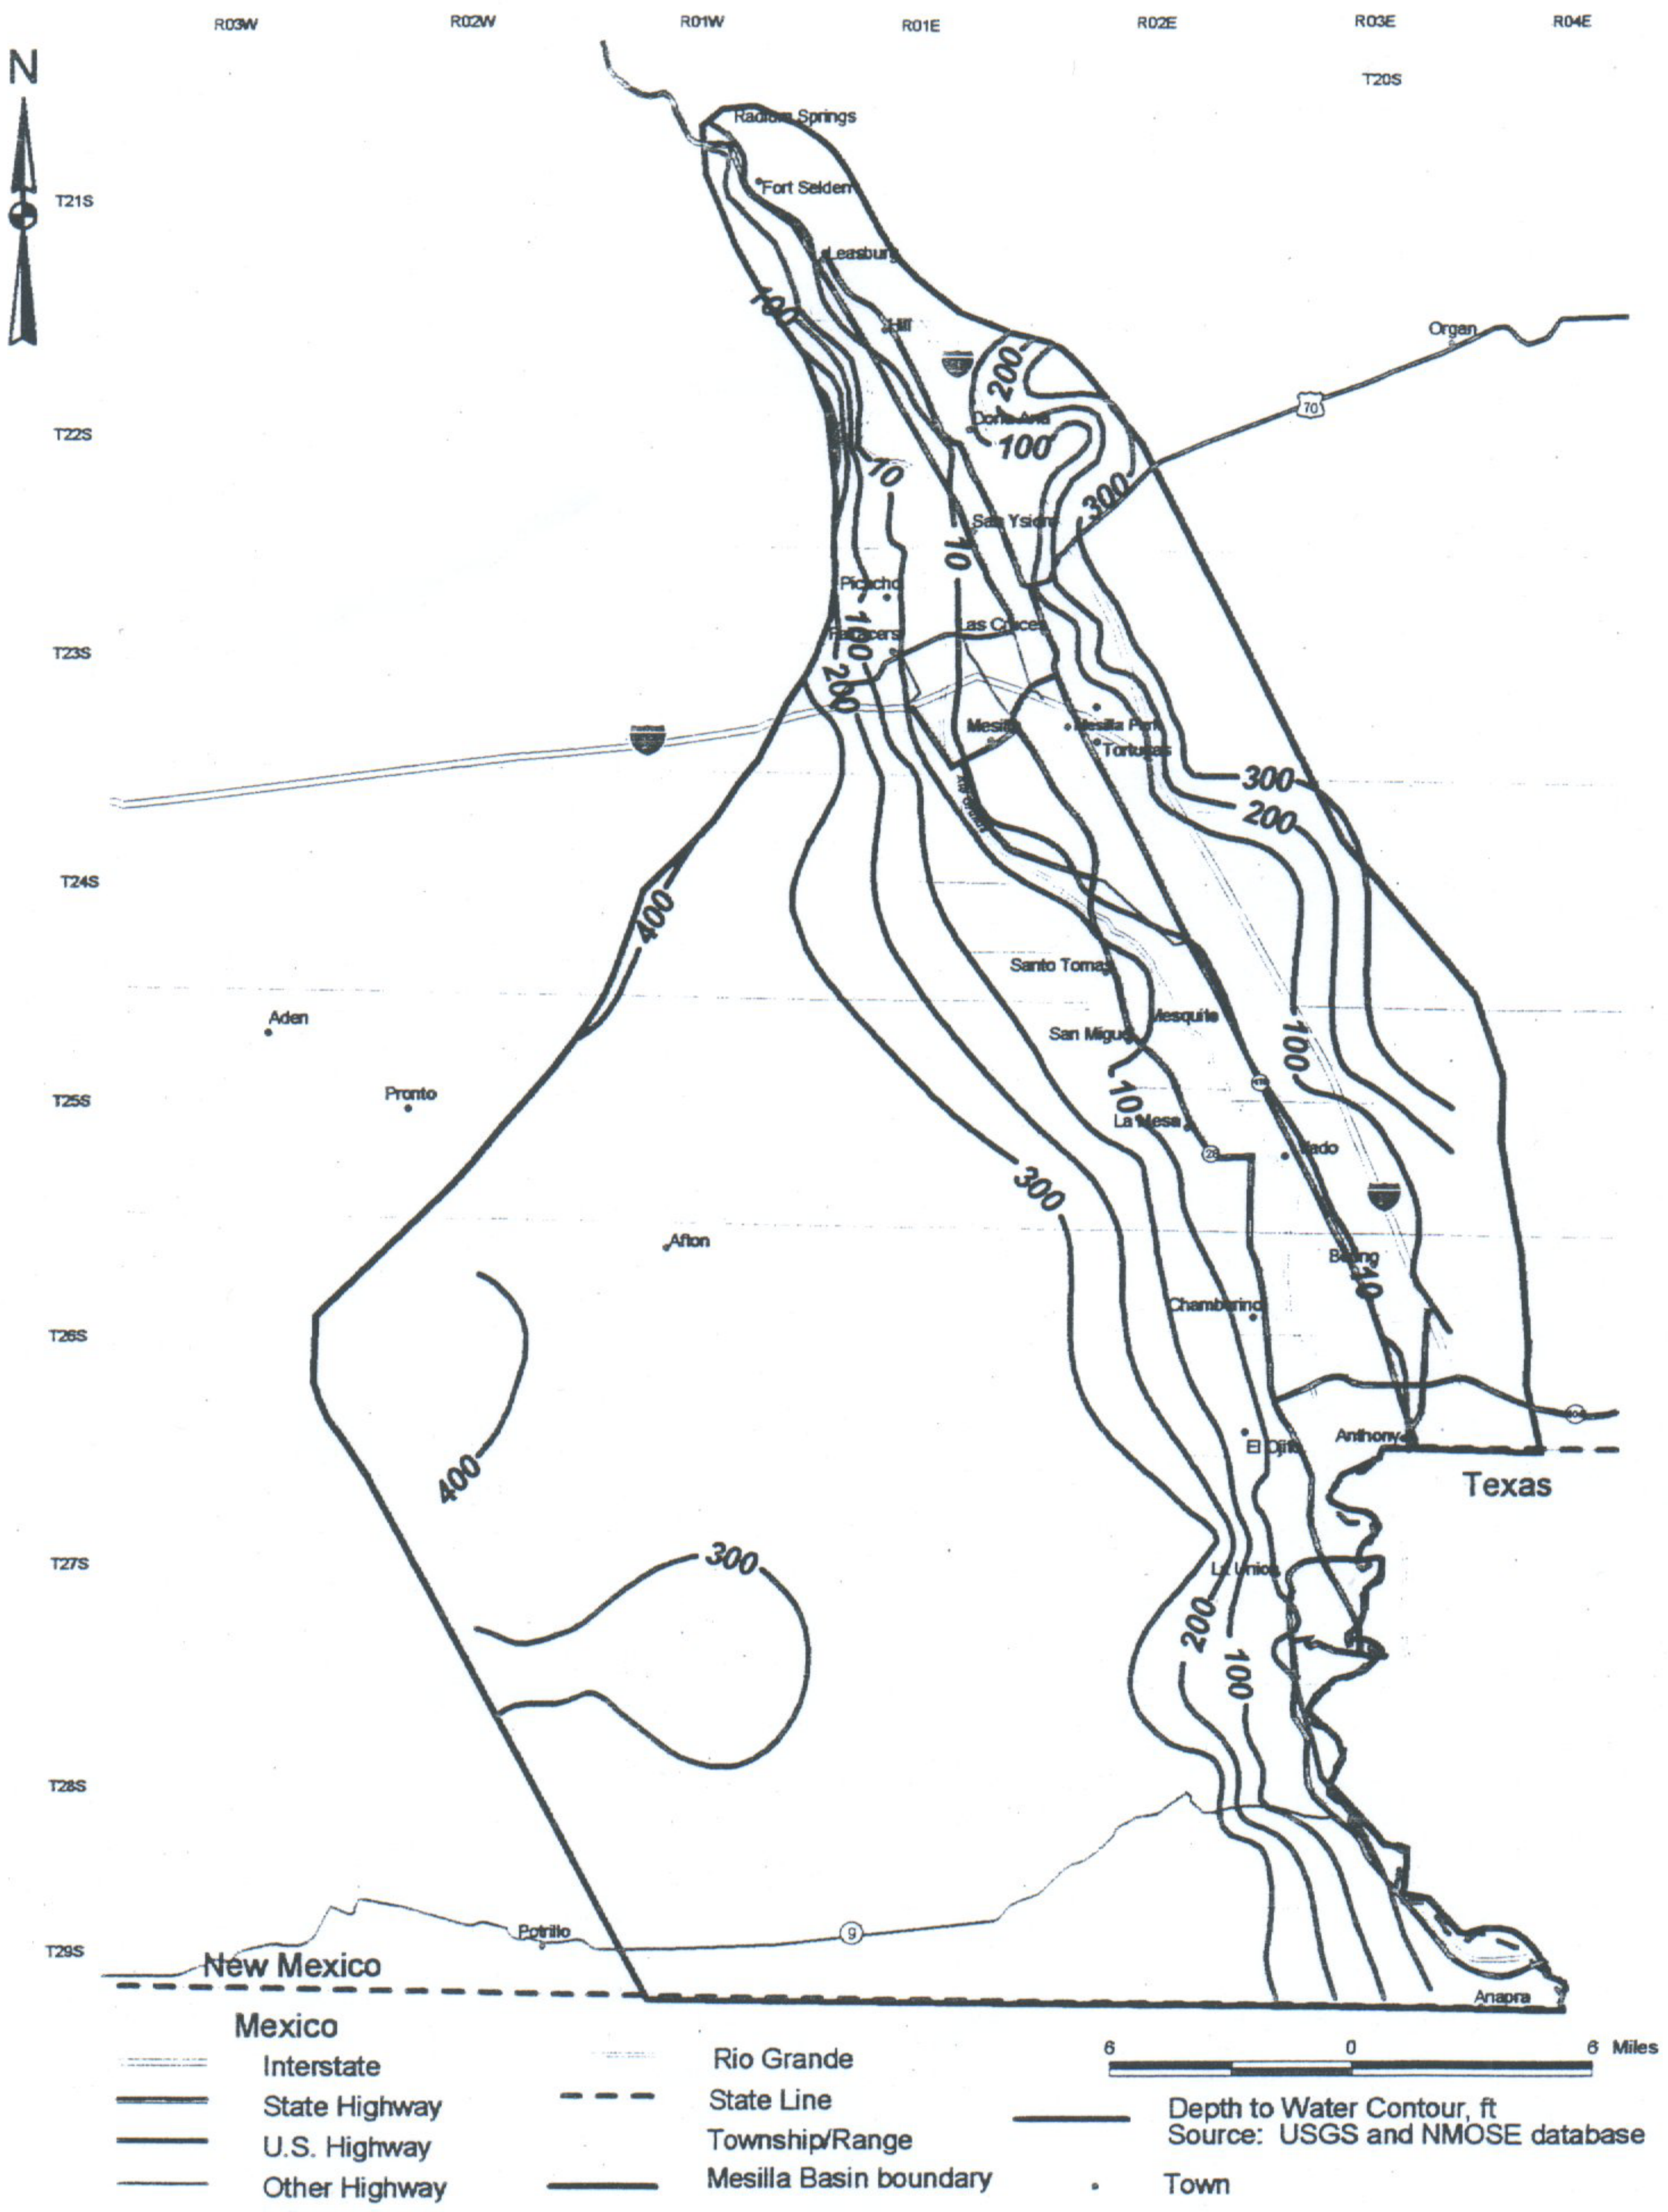
Figure 6.22 Map showing depth to water contours, 1995-2000, Mesilla Basin, Dona Ana County, New Mexico.

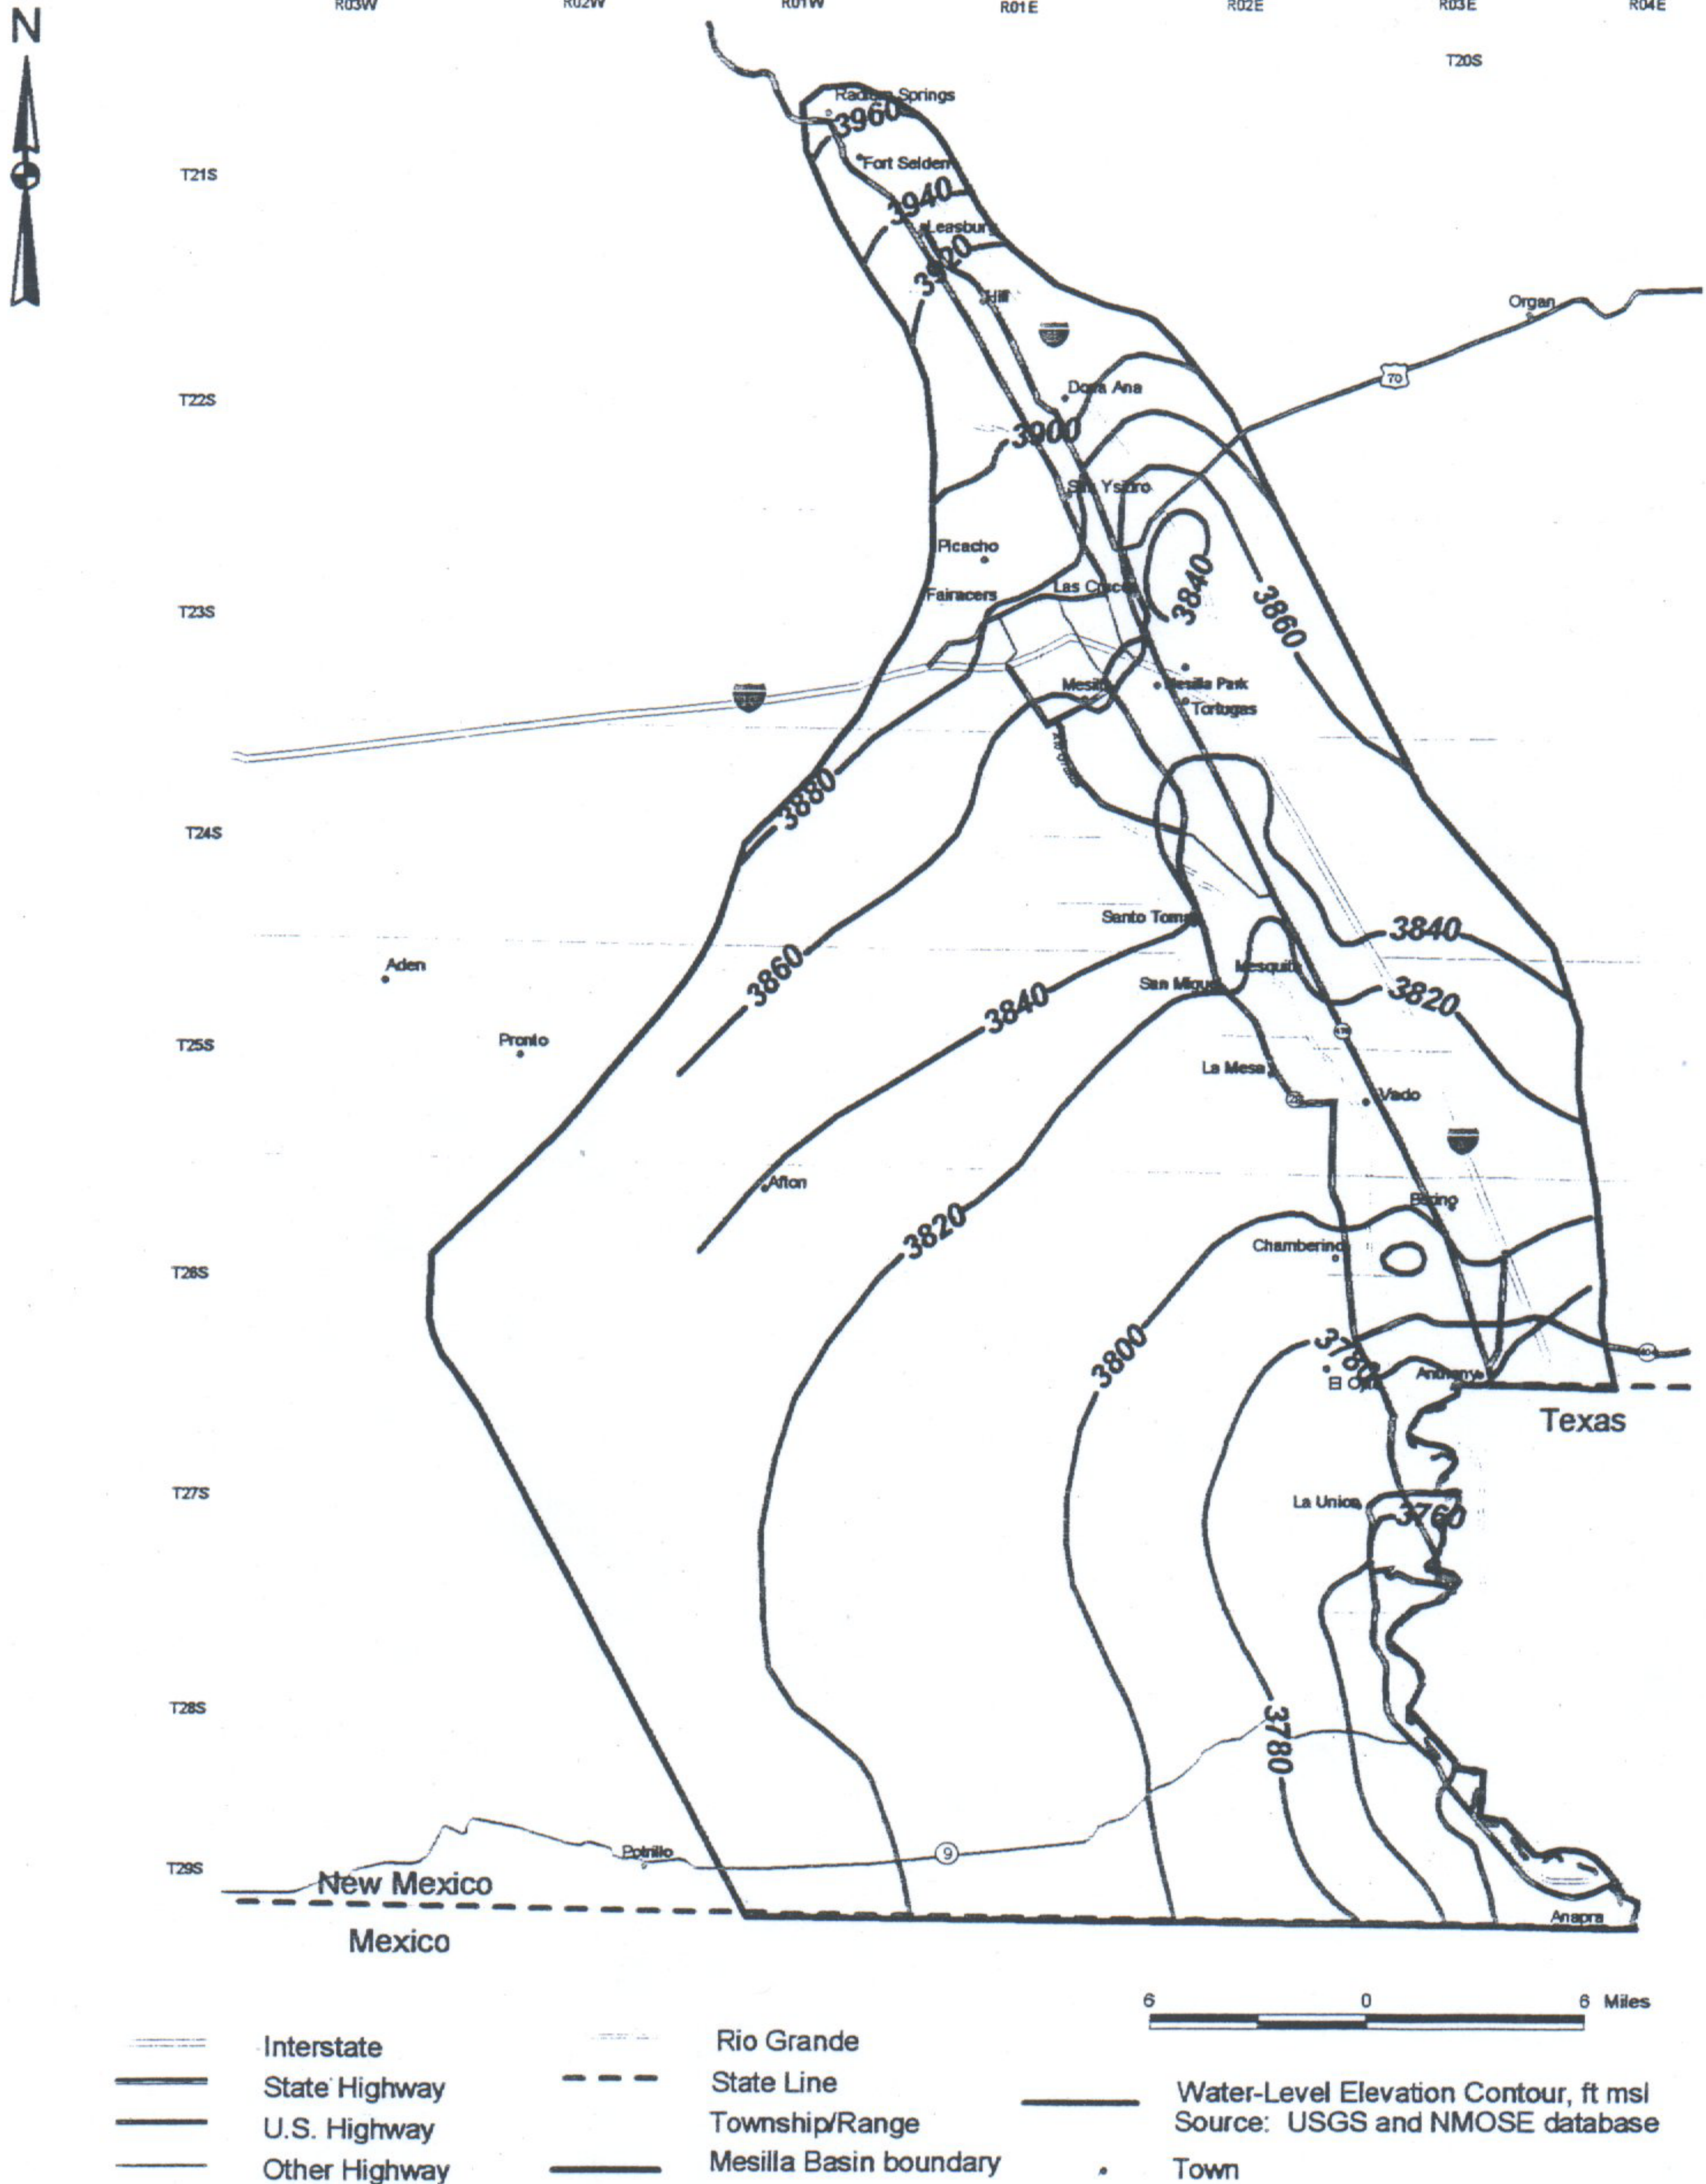
Figure 6.23 Map showing water-level elevation contours, 1960 and before, Mesilla Basin, Dona Ana County, New Mexico.

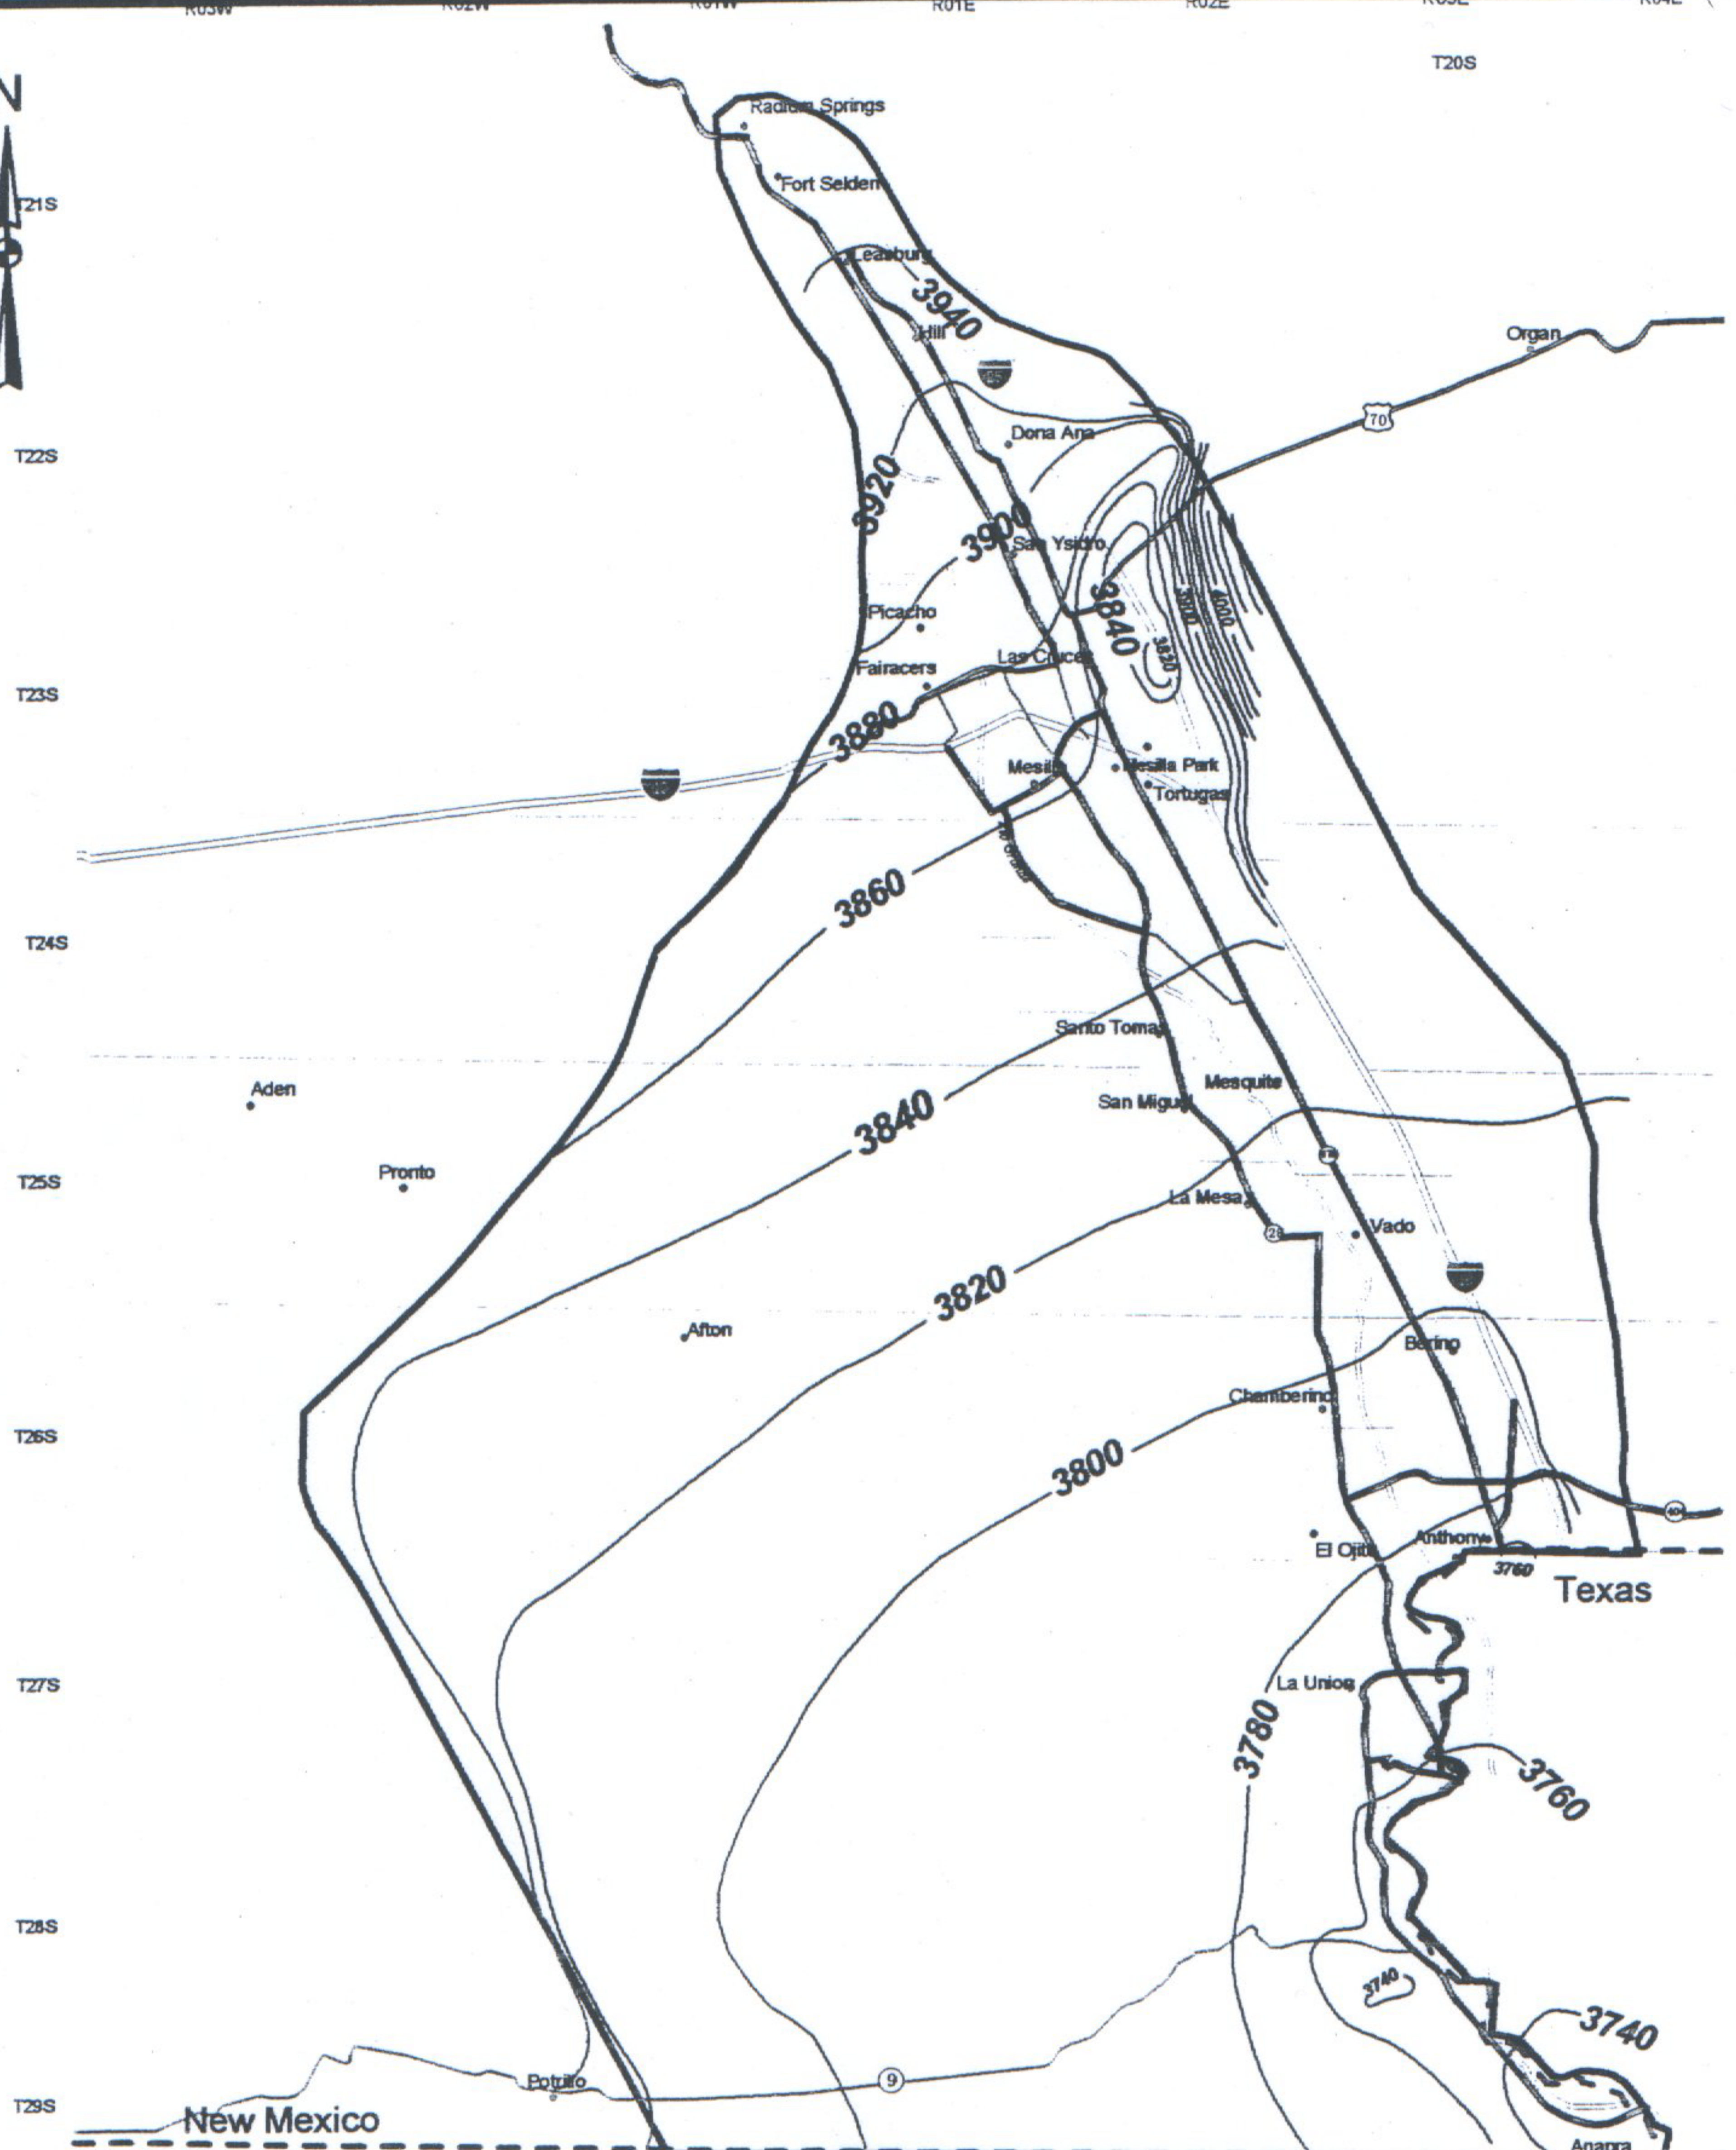
Figure 6.24 Map showing water-level elevation contours, 1978, Mesilla Basin, Dona Ana County, New Mexico.
